Profile/Photo Observation Report

Date:	04/25/2018	Weather:		Coding:	PACP 6.0
Pipe Length (ft):		Owner:	City of Hobart	Pre Clean:	No Pre-Cleaning
P.O.#:	85	Surveyor:	M. Pielacha	PSR:	P-405-008-069
Customer:	City of Hobart	Clean Date:		Shape:	C

Street:	3rd Street	Flow Control:	Not Controlled
City:	Hobart, IN	Year Renewed:	
Location:	Light Highway	Tape/Media #:	DEP 85
Purpose:	Routine Assessment	Dia/Height:	15"
Use:	Sanitary	Material:	CP
Drain Area:		Lining:	
Category:	NA		
Comment:	YES501824 Submittal 2		
Location Details:		Direction of Survey:	Upstream
US MH:	M-405-008	DS MH:	M-405-069
		Total Length Surveyed (ft):	41.1

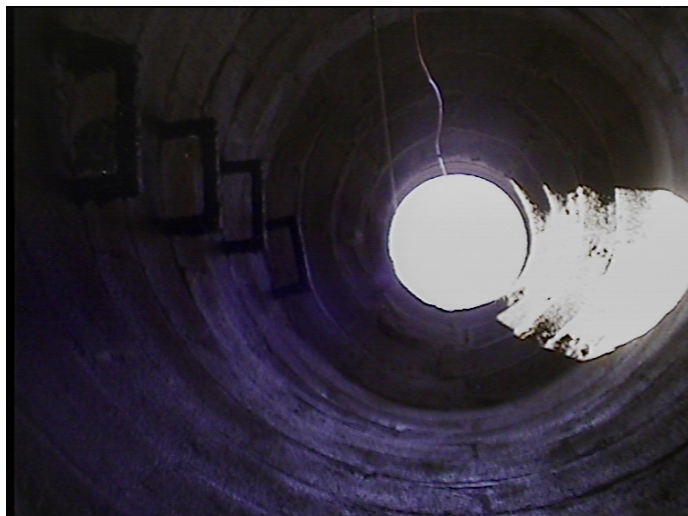
Code: **AMH**
 Description: **Manhole**

Distance (ft): **.0**
 Structural Grade: **0**
 O&M Grade: **0**
 Clock Start/From:
 Clock To:
 1st Value:
 2nd Value:
 Value Percent:
 Continuous Index:
 Within 8" of Joint: **NO**
 Remarks: **M-405-069**

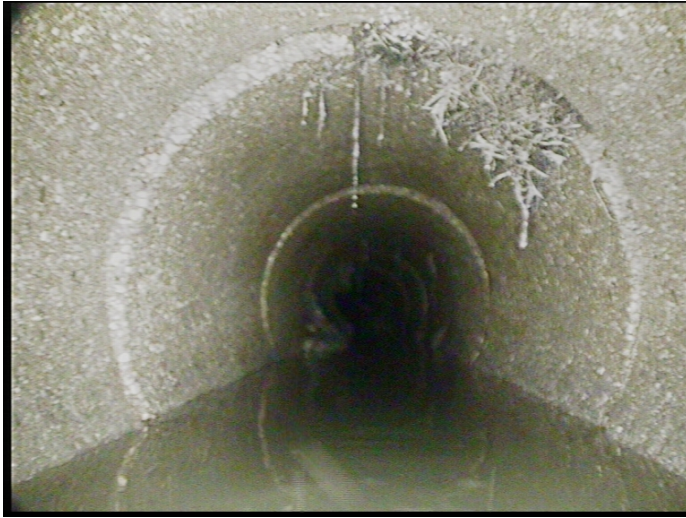
Code: **MWL**
Description: **Water Level**

Distance (ft): **.0**
Structural Grade: **0**
O&M Grade: **0**
Clock Start/From:
Clock To:
1st Value:
2nd Value:
Value Percent: **10.000**
Continuous Index:
Within 8" of Joint: **NO**
Remarks:
