Profile/Photo Observation Report

Date:	02/15/2024	Weather:		Coding:	PACP 7.0
Pipe Length (ft):	63.0	Owner:	City of Hobart	Pre Clean:	Heavy Cleaning
P.O.#:	YES502259	Surveyor:	S. Bucklin	PSR:	P-405-013-012
Customer:	City of Hobart	Clean Date:	03/15/2023	Shape:	C

Street:	LASALLE PL	Flow Control:	Not Controlled
City:	Hobart, IN	Year Renewed:	
Location:	Easement/Right of Way	Tape/Media #:	
Purpose:	Routine Assessment	Dia/Height:	8"
Use:	Sanitary Sewage Pipe	Material:	DIP
Drain Area:		Lining:	None
Category:	NA		
Comment:			
Location Details:		Direction of Survey:	Downstream
US MH:	M-405-012	DS MH:	M-405-013
		Total Length Surveyed (ft):	65.2

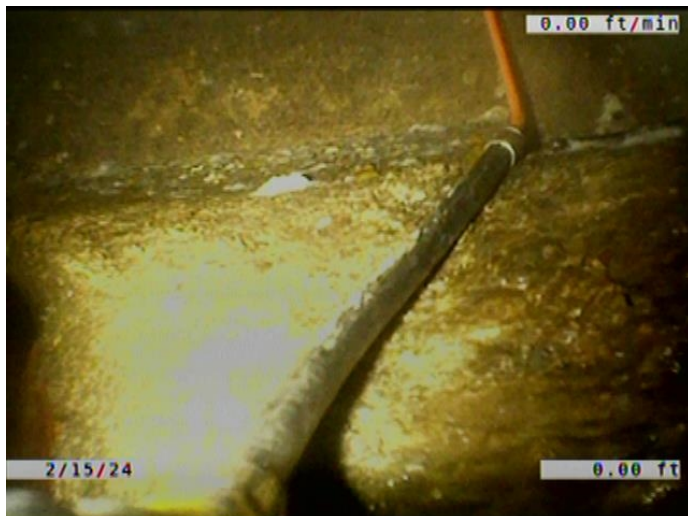
Code: **AMH**
Description: **Manhole**

Distance (ft): **.0**
Structural Grade: **0**
O&M Grade: **0**
Clock Start/From:
Clock To:
1st Value:
2nd Value:
Value Percent:
Continuous Index:
Within 8" of Joint: **NO**
Remarks: **M-405-012**

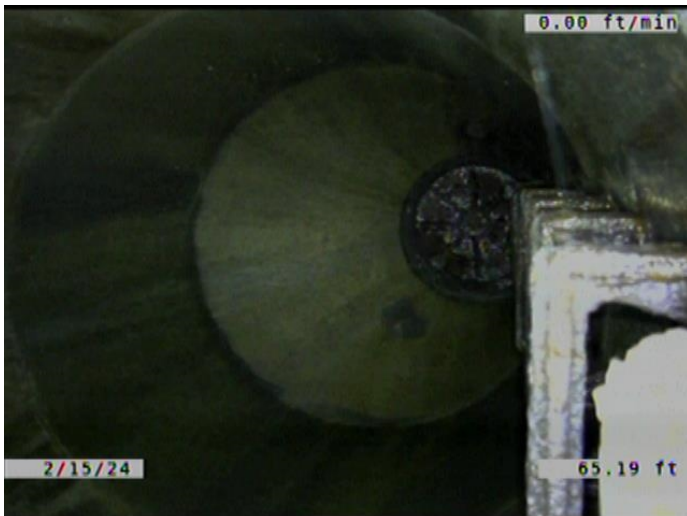
Code:	AMH
Description:	Manhole
Distance (ft):	65.2
Structural Grade:	0
O&M Grade:	0
Clock Start/From:	
Clock To:	
1st Value:	
2nd Value:	
Value Percent:	
Continuous Index:	
Within 8" of Joint:	NO
Remarks:	M-405-013
