Profile/Photo Observation Report

Date:	02/15/2024	Weather:		Coding:	PACP 7.0
Pipe Length (ft):	191.0	Owner:	City of Hobart	Pre Clean:	Heavy Cleaning
P.O.#:	YES502259	Surveyor:	S. Bucklin	PSR:	P-405-014.1-013
Customer:	City of Hobart	Clean Date:	03/15/2023	Shape:	C

Street:	LASALLE PL	Flow Control:	Not Controlled
City:	Hobart, IN	Year Renewed:	
Location:	Easement/Right of Way	Tape/Media #:	
Purpose:	Routine Assessment	Dia/Height:	8"
Use:	Sanitary Sewage Pipe	Material:	VCP
Drain Area:		Lining:	None
Category:	NA		
Comment:			
Location Details:		Direction of Survey:	Downstream
US MH:	M-405-014.1	DS MH:	M-405-013
		Total Length Surveyed (ft):	191.1

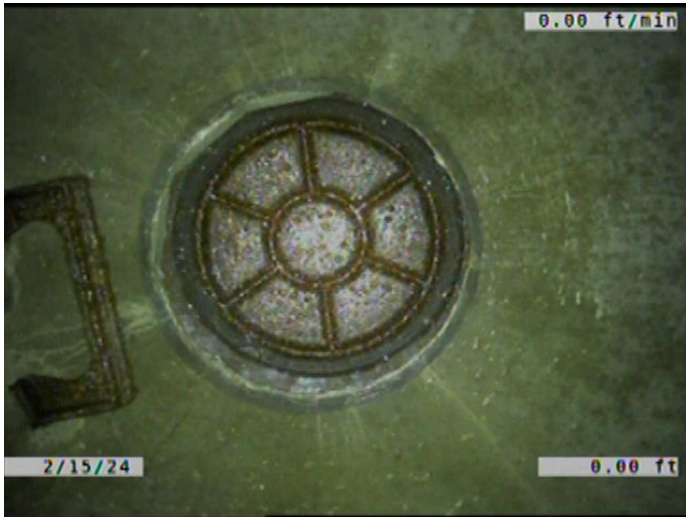
Code: **AMH**
Description: **Manhole**

Distance (ft): **.0**
Structural Grade: **0**
O&M Grade: **0**
Clock Start/From:
Clock To:
1st Value:
2nd Value:
Value Percent:
Continuous Index:
Within 8" of Joint: **NO**
Remarks: **M-405-014.1**

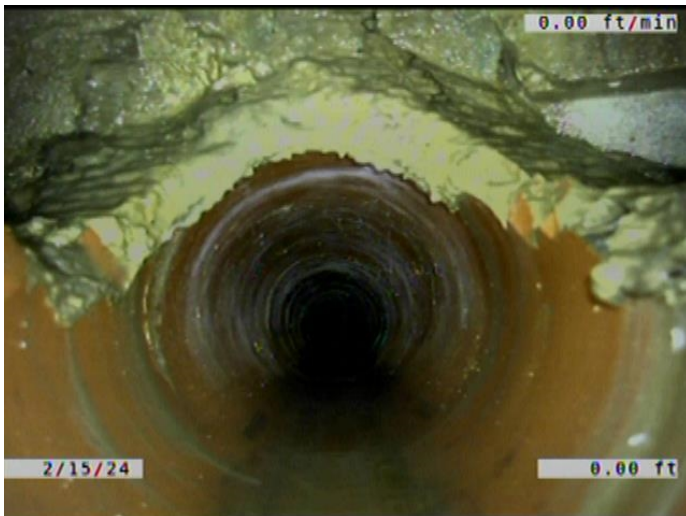
Code: **MWL**
Description: **Miscellaneous Water Level**

Distance (ft): **.0**
Structural Grade: **0**
O&M Grade: **0**
Clock Start/From:
Clock To:
1st Value:
2nd Value:
Value Percent: **5.000**
Continuous Index:
Within 8" of Joint: **NO**
Remarks:

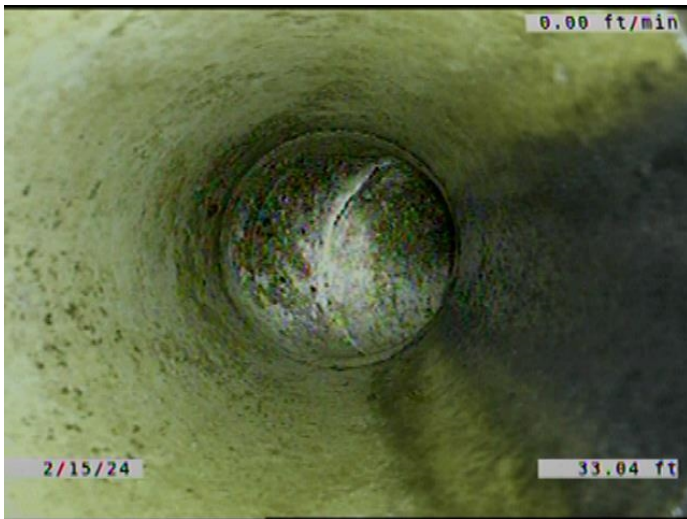
Code: **TF**
Description: **Tap Factory**

Distance (ft): **33.0**
Structural Grade: **0**
O&M Grade: **0**
Clock Start/From: **1**
Clock To:
1st Value: **6.000**
2nd Value:
Value Percent:
Continuous Index:
Within 8" of Joint: **YES**
Remarks:

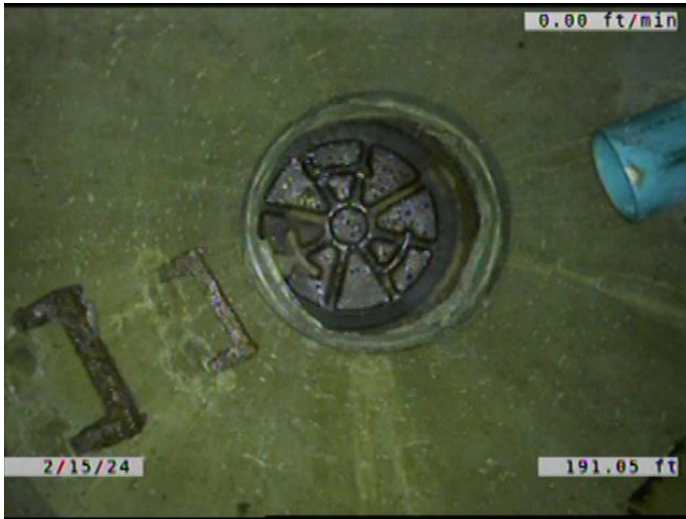
Code:	AMH
Description:	Manhole
Distance (ft):	191.1
Structural Grade:	0
O&M Grade:	0
Clock Start/From:	
Clock To:	
1st Value:	
2nd Value:	
Value Percent:	
Continuous Index:	
Within 8" of Joint:	NO
Remarks:	M-405-013
