## Profile/Photo Observation Report

Date:	<b>02/15/2024</b>	Weather:		Coding:	<b>PACP 7.0</b>
Pipe Length (ft):	<b>157.2</b>	Owner:	<b>City of Hobart</b>	Pre Clean:	<b>Heavy Cleaning</b>
P.O.#:	<b>YES502259</b>	Surveyor:	<b>S. Bucklin</b>	PSR:	<b>P-405-014-014.1</b>
Customer:	<b>City of Hobart</b>	Clean Date:	<b>03/15/2023</b>	Shape:	<b>C</b>

Street:	<b>LASALLE PL</b>	Flow Control:	<b>Not Controlled</b>
City:	<b>Hobart, IN</b>	Year Renewed:	
Location:	<b>Easement/Right of Way</b>	Tape/Media #:	
Purpose:	<b>Routine Assessment</b>	Dia/Height:	<b>8"</b>
Use:	<b>Sanitary Sewage Pipe</b>	Material:	<b>VCP</b>
Drain Area:		Lining:	<b>None</b>
Category:	<b>NA</b>		
Comment:			
Location Details:		Direction of Survey:	<b>Downstream</b>
US MH:	<b>M-405-014</b>	DS MH:	<b>M-405-014.1</b>
		Total Length Surveyed (ft):	<b>157.3</b>

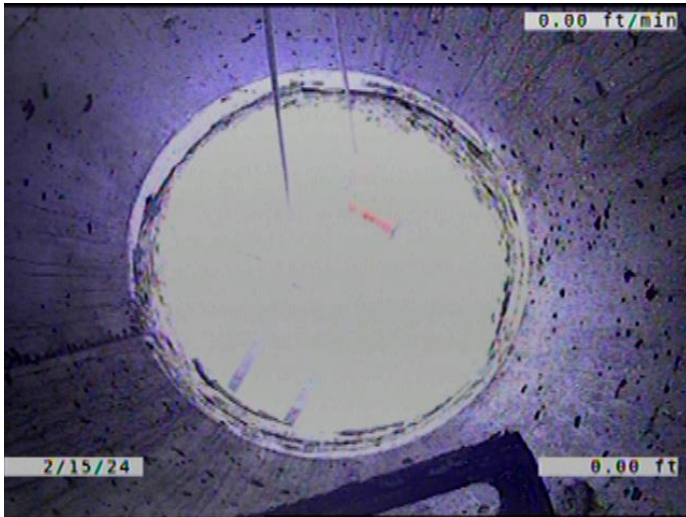
Code: **AMH**  
Description: **Manhole**

Distance (ft): **.0**  
Structural Grade: **0**  
O&M Grade: **0**  
Clock Start/From:  
Clock To:  
1st Value:  
2nd Value:  
Value Percent:  
Continuous Index:  
Within 8" of Joint: **NO**  
Remarks: **M-405-014**

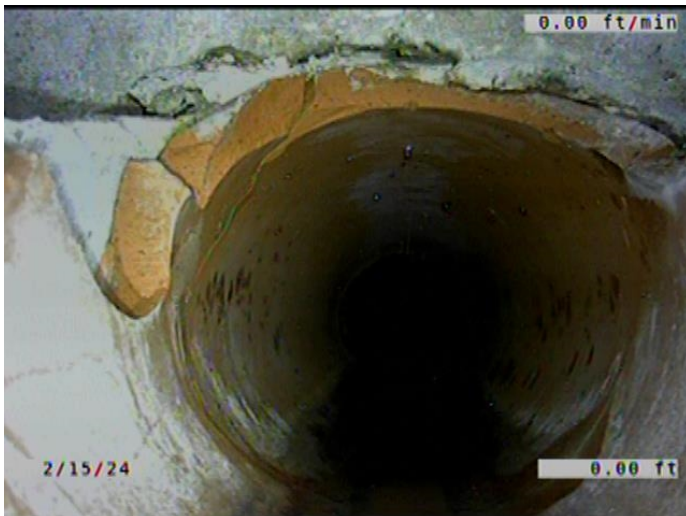
Code: **MWL**  
Description: **Miscellaneous Water Level**

Distance (ft): **.0**  
Structural Grade: **0**  
O&M Grade: **0**  
Clock Start/From:  
Clock To:  
1st Value:  
2nd Value:  
Value Percent: **5.000**  
Continuous Index:  
Within 8" of Joint: **NO**  
Remarks:

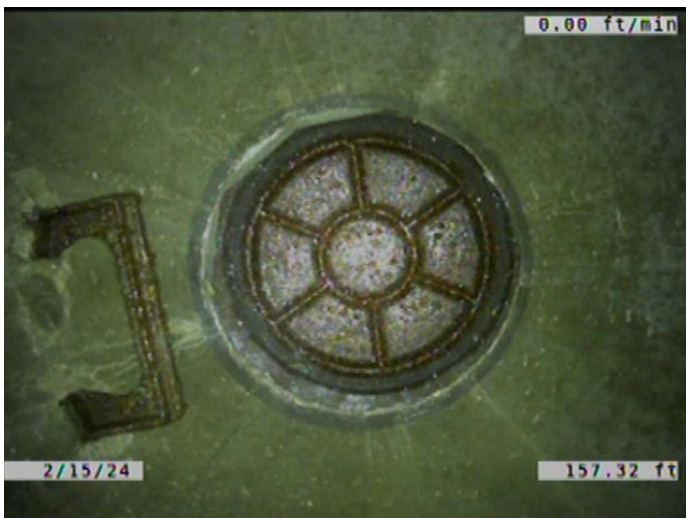
Code: **AMH**  
 Description: **Manhole**

Distance (ft): **157.3**  
 Structural Grade: **0**  
 O&M Grade: **0**  
 Clock Start/From:  
 Clock To:  
 1st Value:  
 2nd Value:  
 Value Percent:  
 Continuous Index:  
 Within 8" of Joint: **NO**  
 Remarks: **M-405-014.1**
