Profile/Photo Observation Report

Date:	04/16/2018	Weather:		Coding:	PACP 6.0
Pipe Length (ft):	289.0	Owner:	NA	Pre Clean:	No Pre-Cleaning
P.O.#:		Surveyor:	Selasie Honu	PSR:	P-405-021-020
Customer:		Clean Date:	01/01/1900	Shape:	C

Street:	W 3RD ST	Flow Control:	Not Controlled
City:	Hobart, IN	Year Renewed:	
Location:	Yard	Tape/Media #:	
Purpose:	Routine Assessment	Dia/Height:	12"
Use:	Sanitary	Material:	VCP
Drain Area:	NA	Lining:	
Category:	NA		
Comment:			
Location Details:		Direction of Survey:	Upstream
US MH:	M-405-021	DS MH:	M-405-020
		Total Length Surveyed (ft):	156.1

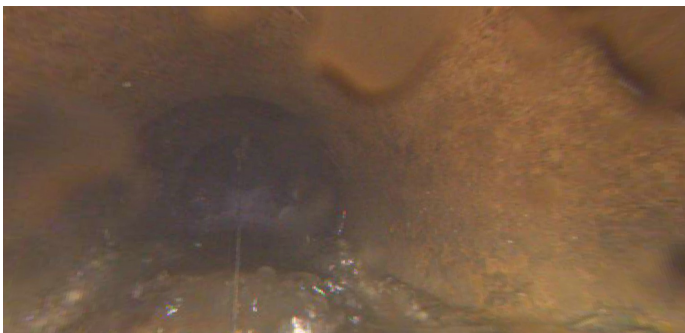
Code: **MGO**
Description: **General Observation**

Distance (ft): **1.8**
Structural Grade: **0**
O&M Grade: **0**
Clock Start/From:
Clock To:
1st Value:
2nd Value:
Value Percent:
Continuous Index:
Within 8" of Joint: **NO**
Remarks: **switching to rear view of camera**

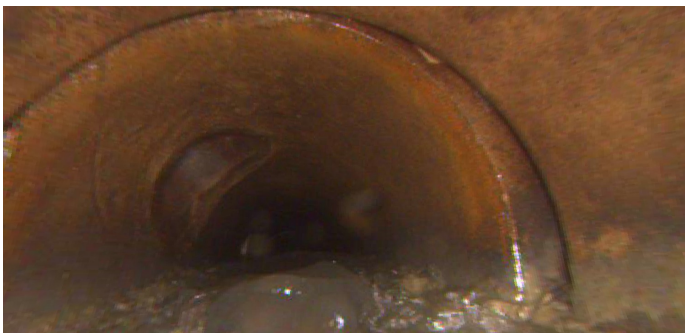
Code: **TF**
Description: **Tap Factory**

Distance (ft): **131.9**
Structural Grade: **0**
O&M Grade: **0**
Clock Start/From: **10**
Clock To:
1st Value: **4.000**
2nd Value:
Value Percent:
Continuous Index:
Within 8" of Joint:
Remarks:
