Profile/Photo Observation Report

Street:	FOXCROFT STREET	Flow Control:	Not Controlled
City:	Hobart, IN	Year Renewed:	
Location:	Yard	Tape/Media #:	
Purpose:	Routine Assessment	Dia/Height:	12"
Use:	Sanitary	Material:	VCP
Drain Area:	NA	Lining:	
Category:	NA		
Comment:

Location Details:		Direction of Survey:	Upstream
US MH:	M-405-021	DS MH:	M-405-020
		Total Length Surveyed (ft):	156.1

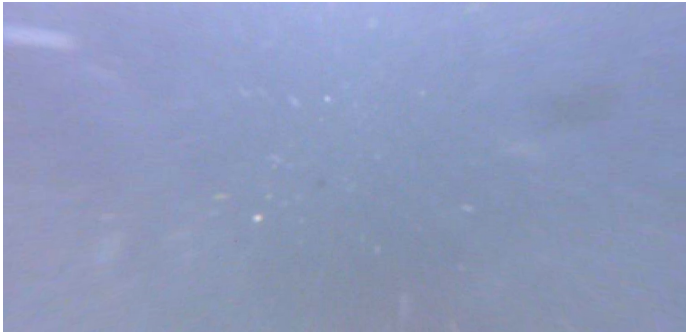
Code: **AMH**
Description: **Manhole**

Distance (ft): **.0**
Structural Grade: **0**
O&M Grade: **0**
Clock Start/From:
Clock To:
1st Value:
2nd Value:
Value Percent:
Continuous Index:
Within 8" of Joint: **NO**
Remarks: **M-405-020**

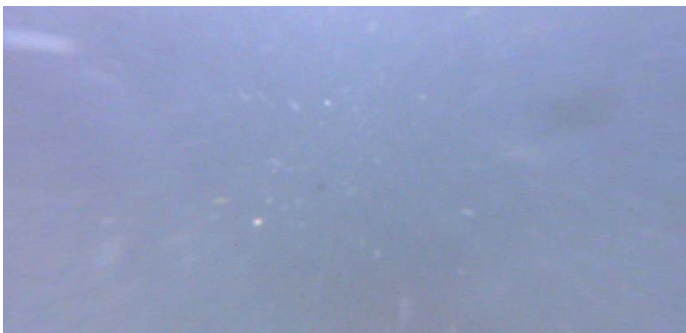
Code: **MWL**
Description: **Water Level**

Distance (ft): **.0**
Structural Grade: **0**
O&M Grade: **0**
Clock Start/From:
Clock To:
1st Value:
2nd Value:
Value Percent: **5.000**
Continuous Index:
Within 8" of Joint: **NO**
Remarks:

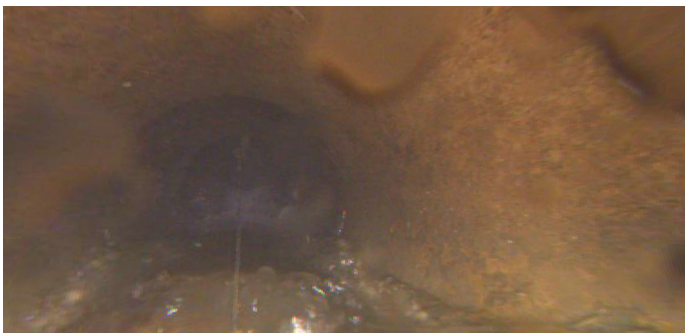
Code: **MGO**
Description: **General Observation**

Distance (ft): **1.8**
Structural Grade: **0**
O&M Grade: **0**
Clock Start/From:
Clock To:
1st Value:
2nd Value:
Value Percent:
Continuous Index:
Within 8" of Joint: **NO**
Remarks: **switching to rear view of camera**

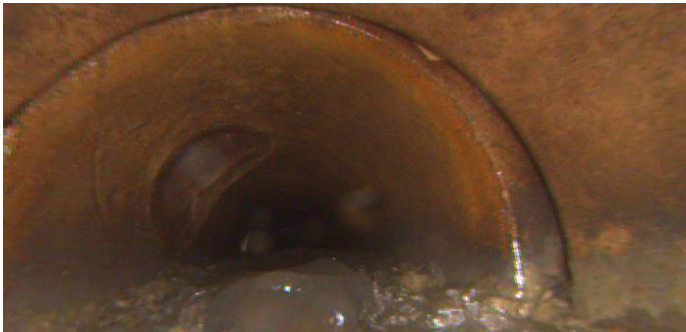
Code: **TF**
Description: **Tap Factory**

Distance (ft): **131.9**
Structural Grade: **0**
O&M Grade: **0**
Clock Start/From: **10**
Clock To:
1st Value: **4.000**
2nd Value:
Value Percent:
Continuous Index:
Within 8" of Joint:
Remarks:
