RedZone
ROBOTICS

Total Length Surveyed (ft): **285.2**

M-405-020

M-405-021

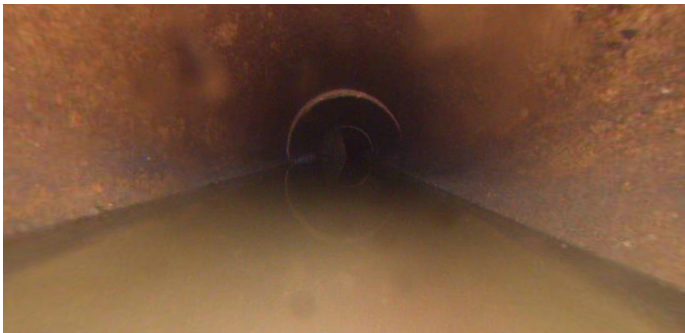
Code: **AMH**
Description: **Manhole**

Distance (ft): **.0**
Structural Grade: **0**
O&M Grade: **0**
Clock Start/From:
Clock To:
1st Value:
2nd Value:
Value Percent:
Continuous Index:
Within 8" of Joint: **NO**
Remarks: **M-405-020**

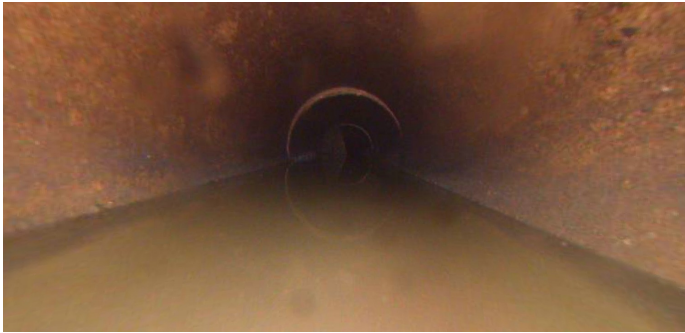
Code: **MWL**
Description: **Water Level**

Distance (ft): **.0**
Structural Grade: **0**
O&M Grade: **0**
Clock Start/From:
Clock To:
1st Value:
2nd Value:
Value Percent: **30.000**
Continuous Index:
Within 8" of Joint: **NO**
Remarks:

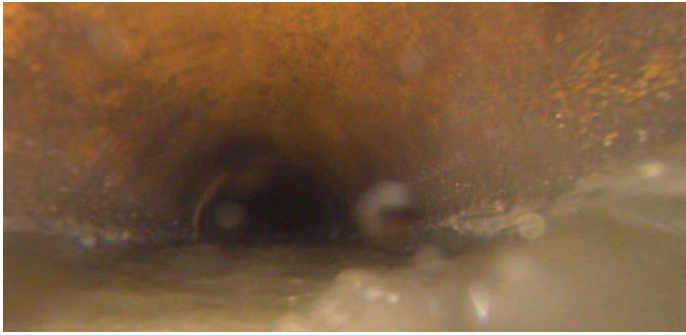
Code: **MGO**
Description: **General Observation**

Distance (ft): **32.2**
Structural Grade: **0**
O&M Grade: **0**
Clock Start/From:
Clock To:
1st Value:
2nd Value:
Value Percent:
Continuous Index:
Within 8" of Joint: **NO**
Remarks: **rear camera**

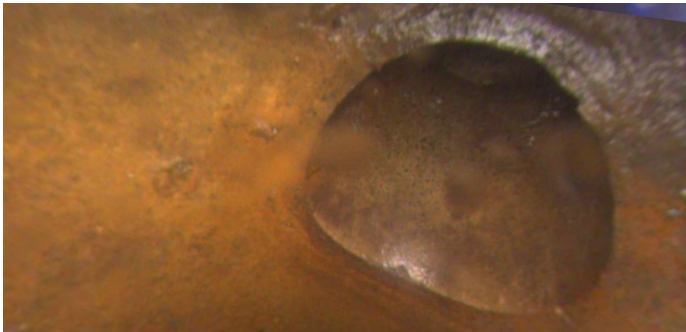
Code: **TF**
Description: **Tap Factory**

Distance (ft): **68.6**
Structural Grade: **0**
O&M Grade: **0**
Clock Start/From: **11**
Clock To:
1st Value: **4.000**
2nd Value:
Value Percent:
Continuous Index:
Within 8" of Joint:
Remarks:

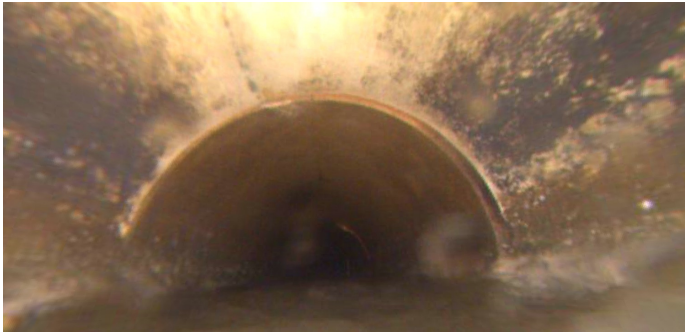
Code: **MMC**
Description: **Material Change**

Distance (ft): **75.0**
Structural Grade: **0**
O&M Grade: **0**
Clock Start/From:
Clock To:
1st Value:
2nd Value:
Value Percent:
Continuous Index:
Within 8" of Joint: **NO**
Remarks: **PVC**

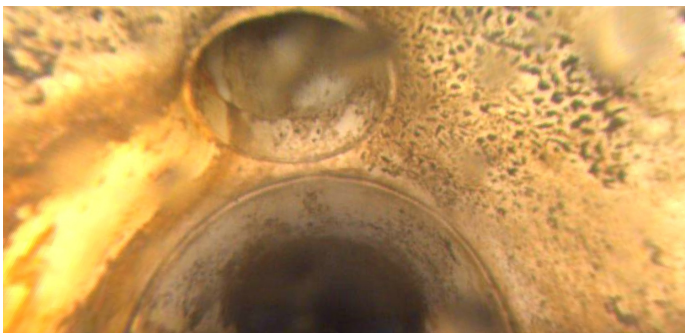
Code: **TF**
Description: **Tap Factory**

Distance (ft): **82.5**
Structural Grade: **0**
O&M Grade: **0**
Clock Start/From: **12**
Clock To:
1st Value: **4.000**
2nd Value:
Value Percent:
Continuous Index:
Within 8" of Joint:
Remarks:

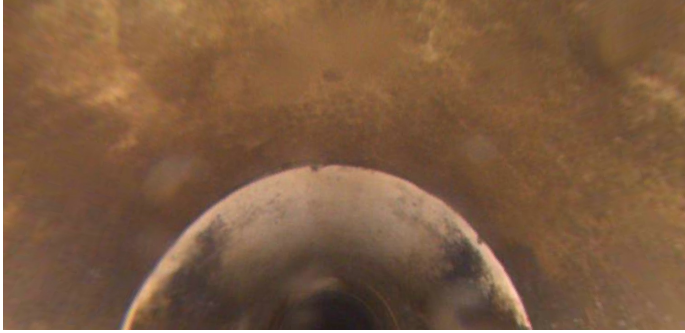
Code: **MMC**
Description: **Material Change**

Distance (ft): **84.7**
Structural Grade: **0**
O&M Grade: **0**
Clock Start/From:
Clock To:
1st Value:
2nd Value:
Value Percent:
Continuous Index:
Within 8" of Joint: **NO**
Remarks: **vcp**

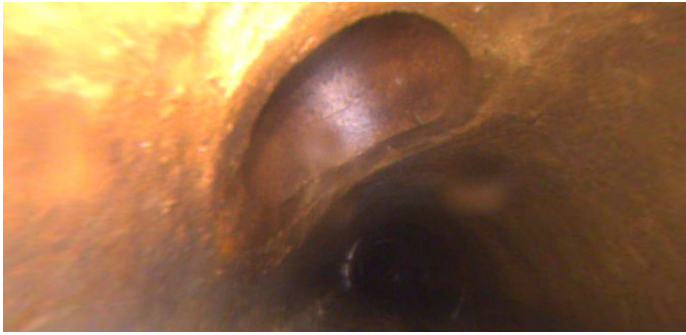
Code: **TF**
Description: **Tap Factory**

Distance (ft): **131.7**
Structural Grade: **0**
O&M Grade: **0**
Clock Start/From: **1**
Clock To:
1st Value: **4.000**
2nd Value:
Value Percent:
Continuous Index:
Within 8" of Joint:
Remarks:

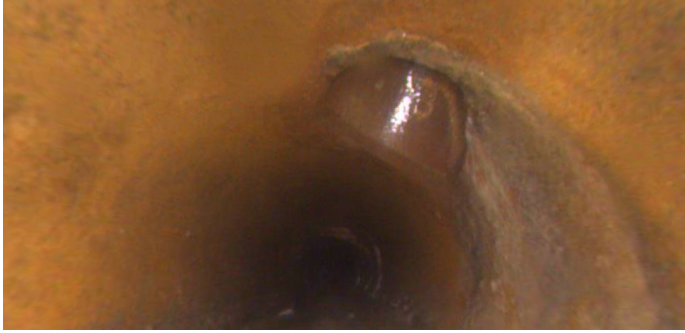
Code: **TFA**
Description: **Tap Factory Active**

Distance (ft): **195.4**
Structural Grade: **0**
O&M Grade: **0**
Clock Start/From: **11**
Clock To:
1st Value: **4.000**
2nd Value:
Value Percent:
Continuous Index:
Within 8" of Joint:
Remarks:

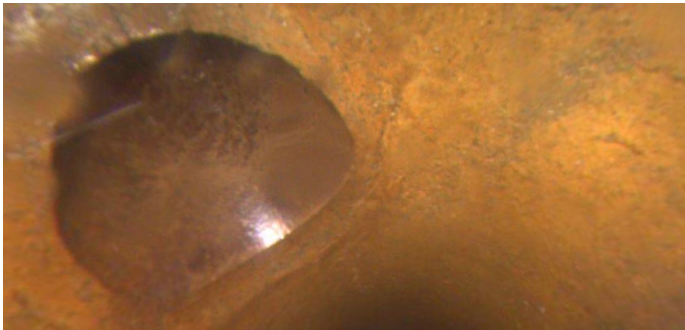
Code: **TF**
Description: **Tap Factory**

Distance (ft): **212.9**
Structural Grade: **0**
O&M Grade: **0**
Clock Start/From: **1**
Clock To:
1st Value: **4.000**
2nd Value:
Value Percent:
Continuous Index:
Within 8" of Joint:
Remarks:

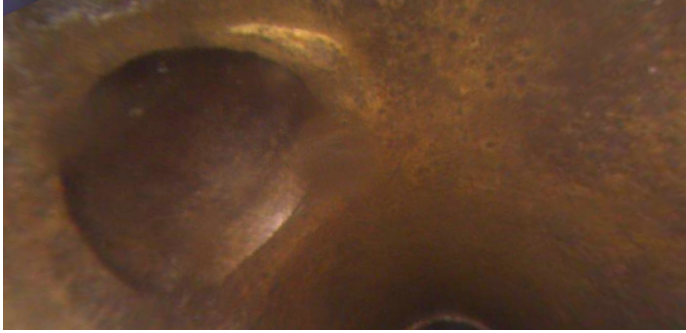
Code: **TF**
Description: **Tap Factory**

Distance (ft): **272.8**
Structural Grade: **0**
O&M Grade: **0**
Clock Start/From: **2**
Clock To:
1st Value: **4.000**
2nd Value:
Value Percent:
Continuous Index:
Within 8" of Joint:
Remarks:

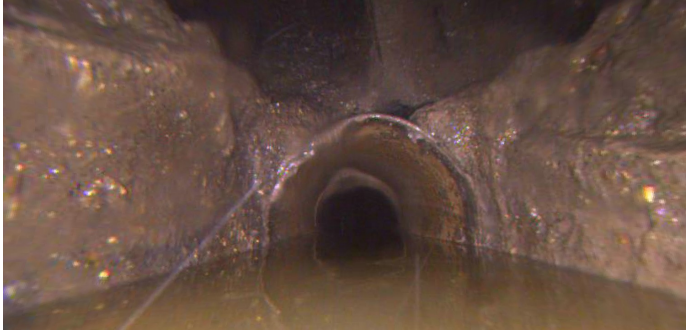
Code:	AMH
Description:	Manhole
Distance (ft):	285.2
Structural Grade:	0
O&M Grade:	0
Clock Start/From:	
Clock To:	
1st Value:	
2nd Value:	
Value Percent:	
Continuous Index:	
Within 8" of Joint:	NO
Remarks:	M-405-021
