Profile/Photo Observation Report

Street:	FOXCROFT STREET	Flow Control:	Not Controlled
City:	Hobart, IN	Year Renewed:	
Location:	Yard	Tape/Media #:	
Purpose:	Routine Assessment	Dia/Height:	12"
Use:	Sanitary	Material:	CP
Drain Area:	NA	Lining:	
Category:	NA		
Comment:

Location Details:		Direction of Survey:	Downstream
US MH:	M-405-022	DS MH:	M-405-021
		Total Length Surveyed (ft):	129.4

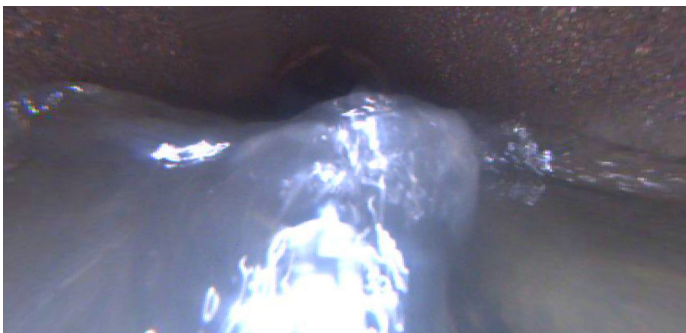
Code: **AMH**
Description: **Manhole**

Distance (ft): **.0**
Structural Grade: **0**
O&M Grade: **0**
Clock Start/From:
Clock To:
1st Value:
2nd Value:
Value Percent:
Continuous Index:
Within 8" of Joint: **NO**
Remarks: **M-405-022**

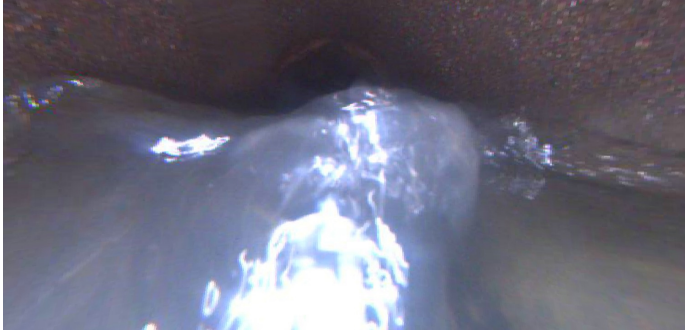
Code: **MWL**
Description: **Water Level**

Distance (ft): **.0**
Structural Grade: **0**
O&M Grade: **0**
Clock Start/From:
Clock To:
1st Value:
2nd Value:
Value Percent: **5.000**
Continuous Index:
Within 8" of Joint: **NO**
Remarks:

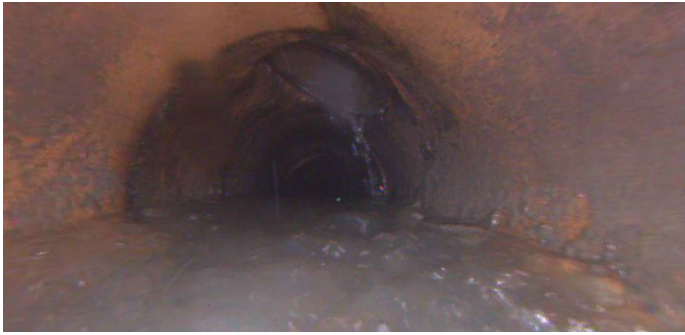
Code: **TFA**
Description: **Tap Factory Active**

Distance (ft): **89.9**
Structural Grade: **0**
O&M Grade: **0**
Clock Start/From: **1**
Clock To:
1st Value: **4.000**
2nd Value:
Value Percent:
Continuous Index:
Within 8" of Joint:
Remarks:

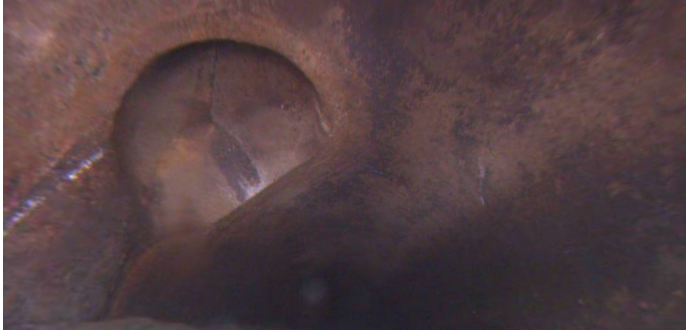
Code: **TF**
Description: **Tap Factory**

Distance (ft): **95.3**
Structural Grade: **0**
O&M Grade: **0**
Clock Start/From: **11**
Clock To:
1st Value: **4.000**
2nd Value:
Value Percent:
Continuous Index:
Within 8" of Joint:
Remarks:
