# Profile/Photo Observation Report

Date:	<b>04/23/2018</b>	Weather:		Coding:	<b>PACP 6.0</b>
Pipe Length (ft):	<b>262.5</b>	Owner:	<b>NA</b>	Pre Clean:	<b>No Pre-Cleaning</b>
P.O.#:		Surveyor:	<b>Jen Costello</b>	PSR:	<b>P-405-022-021</b>
Customer:		Clean Date:	<b>01/01/1900</b>	Shape:	<b>C</b>

Street:	<b>ALLEY BETWEEN DRIFTWOOD DR &amp;</b>	Flow Control:	<b>Not Controlled</b>
City:	<b>Hobart, IN</b>	Year Renewed:	
Location:	<b>Yard</b>	Tape/Media #:	
Purpose:	<b>Routine Assessment</b>	Dia/Height:	<b>12"</b>
Use:	<b>Sanitary</b>	Material:	<b>CP</b>
Drain Area:	<b>NA</b>	Lining:	
Category:	<b>NA</b>		
Comment:	<b>P_C at 247 ft debris</b>		
Location Details:		Direction of Survey:	<b>Downstream</b>
US MH:	<b>M-405-022</b>	DS MH:	<b>M-405-021</b>
		Total Length Surveyed (ft):	<b>249.0</b>

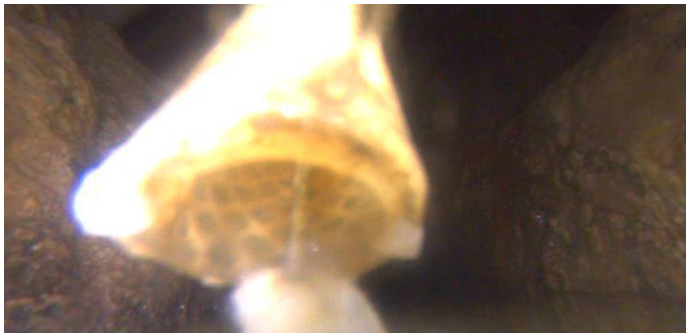
Code: **AMH**  
Description: **Manhole**

Distance (ft): **.0**  
Structural Grade: **0**  
O&M Grade: **0**  
Clock Start/From:  
Clock To:  
1st Value:  
2nd Value:  
Value Percent:  
Continuous Index:  
Within 8" of Joint: **NO**  
Remarks: **M-405-022**

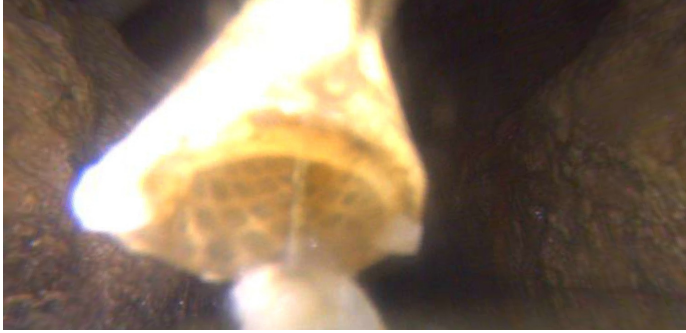
Code: **MWL**  
Description: **Water Level**

Distance (ft): **.0**  
Structural Grade: **0**  
O&M Grade: **0**  
Clock Start/From:  
Clock To:  
1st Value:  
2nd Value:  
Value Percent: **20.000**  
Continuous Index:  
Within 8" of Joint: **NO**  
Remarks:

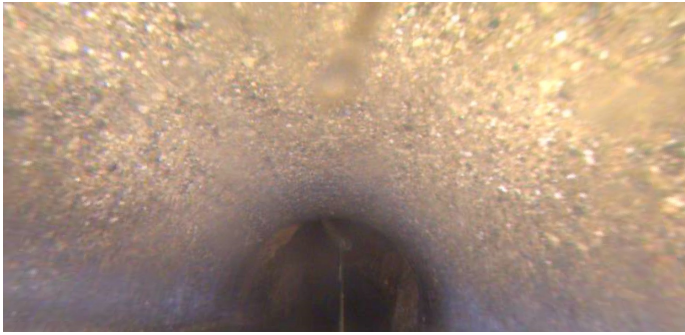
Code: **MGO**  
Description: **General Observation**

Distance (ft): **1.2**  
Structural Grade: **0**  
O&M Grade: **0**  
Clock Start/From:  
Clock To:  
1st Value:  
2nd Value:  
Value Percent:  
Continuous Index:  
Within 8" of Joint: **NO**  
Remarks: **rear camera**

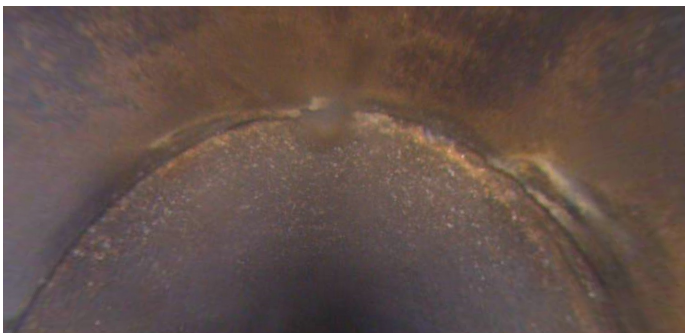
Code: **MMC**  
Description: **Material Change**

Distance (ft): **19.9**  
Structural Grade: **0**  
O&M Grade: **0**  
Clock Start/From:  
Clock To:  
1st Value:  
2nd Value:  
Value Percent:  
Continuous Index:  
Within 8" of Joint: **NO**  
Remarks: **VCP**

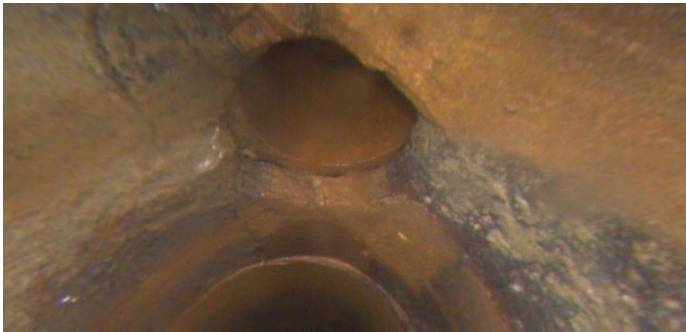
Code: **TB**  
Description: **Tap Break-in**

Distance (ft): **83.5**  
Structural Grade: **0**  
O&M Grade: **0**  
Clock Start/From: **12**  
Clock To:  
1st Value: **4.000**  
2nd Value:  
Value Percent:  
Continuous Index:  
Within 8" of Joint:  
Remarks:

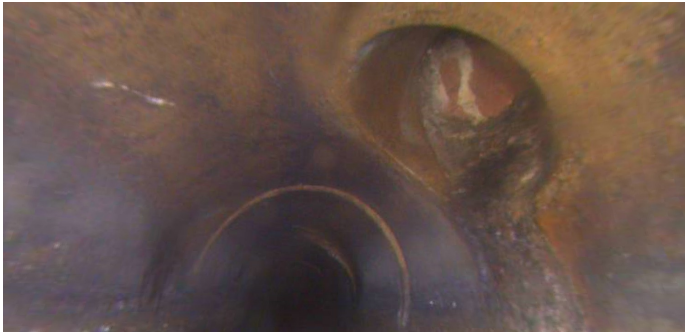
Code: **TFC**  
Description: **Tap Factory Capped**

Distance (ft): **95.7**  
Structural Grade: **0**  
O&M Grade: **0**  
Clock Start/From: **10**  
Clock To:  
1st Value: **4.000**  
2nd Value:  
Value Percent:  
Continuous Index:  
Within 8" of Joint:  
Remarks:

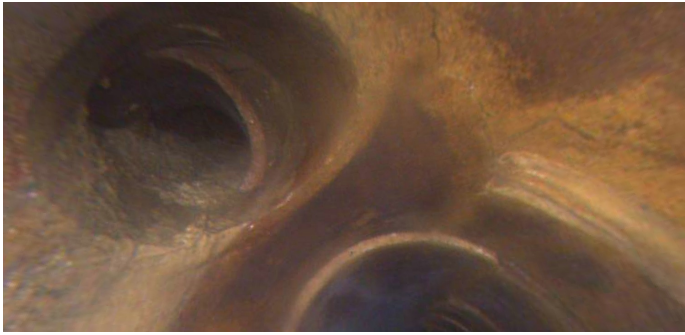
Code: **TF**  
Description: **Tap Factory**

Distance (ft): **155.3**  
Structural Grade: **0**  
O&M Grade: **0**  
Clock Start/From: **1**  
Clock To:  
1st Value: **4.000**  
2nd Value:  
Value Percent:  
Continuous Index:  
Within 8" of Joint:  
Remarks:

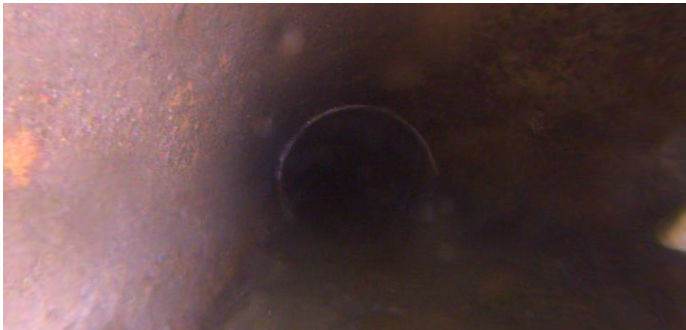
Code: **MSA**  
Description: **Abandoned Survey**

Distance (ft): **249.0**  
Structural Grade: **0**  
O&M Grade: **0**  
Clock Start/From:  
Clock To:  
1st Value:  
2nd Value:  
Value Percent:  
Continuous Index:  
Within 8" of Joint: **NO**  
Remarks: **ROOTS**
