Profile/Photo Observation Report

Street:	FOXCROFT STREET	Flow Control:	Not Controlled
City:	Hobart, IN	Year Renewed:	
Location:	Yard	Tape/Media #:	
Purpose:	Routine Assessment	Dia/Height:	12"
Use:	Sanitary	Material:	CP
Drain Area:	NA	Lining:	
Category:	NA		
Comment:	P_C at 247 ft debris		
Location Details:		Direction of Survey:	Downstream
US MH:	M-405-022	DS MH:	M-405-021
		Total Length Surveyed (ft):	249.0

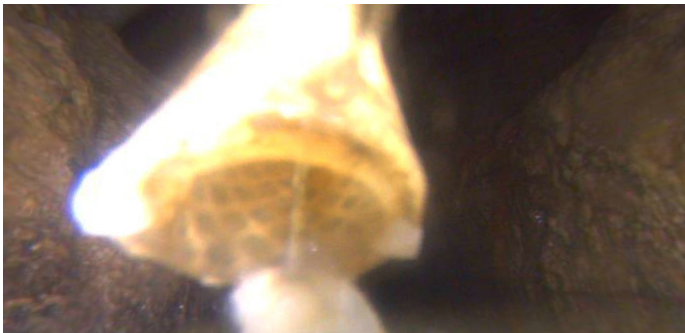
Code: **AMH**
Description: **Manhole**

Distance (ft): **.0**
Structural Grade: **0**
O&M Grade: **0**
Clock Start/From:
Clock To:
1st Value:
2nd Value:
Value Percent:
Continuous Index:
Within 8" of Joint: **NO**
Remarks: **M-405-022**

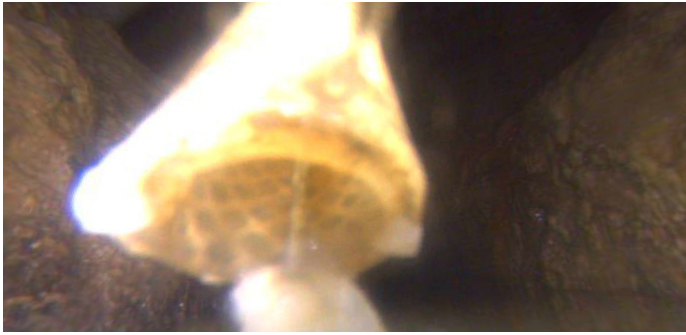
Code: **MWL**
Description: **Water Level**

Distance (ft): **.0**
Structural Grade: **0**
O&M Grade: **0**
Clock Start/From:
Clock To:
1st Value:
2nd Value:
Value Percent: **20.000**
Continuous Index:
Within 8" of Joint: **NO**
Remarks:

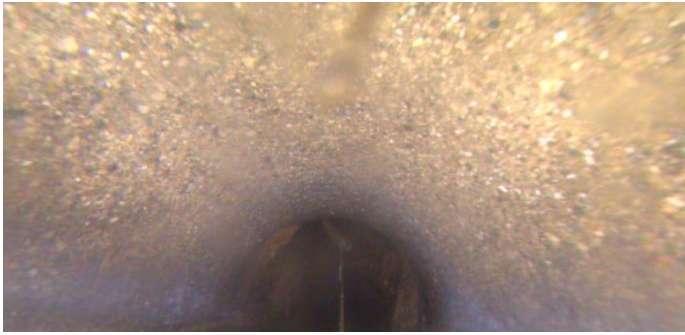
Code: **MGO**
Description: **General Observation**

Distance (ft): **1.2**
Structural Grade: **0**
O&M Grade: **0**
Clock Start/From:
Clock To:
1st Value:
2nd Value:
Value Percent:
Continuous Index:
Within 8" of Joint: **NO**
Remarks: **rear camera**

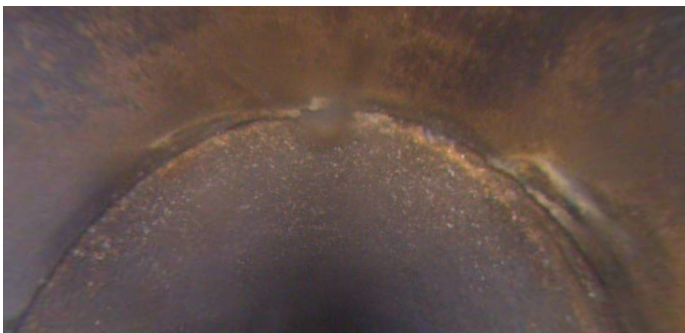
Code: **MMC**
Description: **Material Change**

Distance (ft): **19.9**
Structural Grade: **0**
O&M Grade: **0**
Clock Start/From:
Clock To:
1st Value:
2nd Value:
Value Percent:
Continuous Index:
Within 8" of Joint: **NO**
Remarks: **VCP**

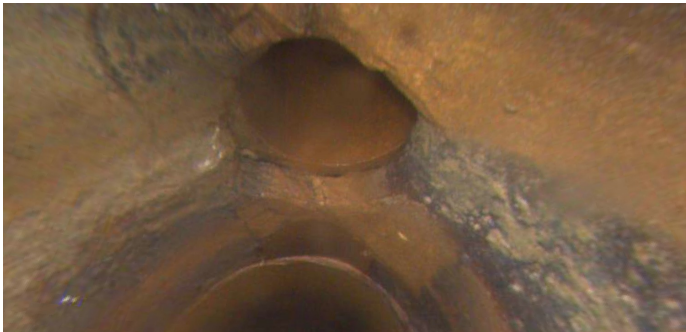
Code: **TB**
Description: **Tap Break-in**

Distance (ft): **83.5**
Structural Grade: **0**
O&M Grade: **0**
Clock Start/From: **12**
Clock To:
1st Value: **4.000**
2nd Value:
Value Percent:
Continuous Index:
Within 8" of Joint:
Remarks:

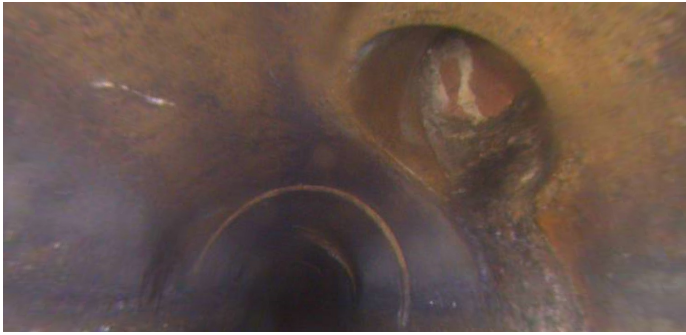
Code: **TFC**
Description: **Tap Factory Capped**

Distance (ft): **95.7**
Structural Grade: **0**
O&M Grade: **0**
Clock Start/From: **10**
Clock To:
1st Value: **4.000**
2nd Value:
Value Percent:
Continuous Index:
Within 8" of Joint:
Remarks:

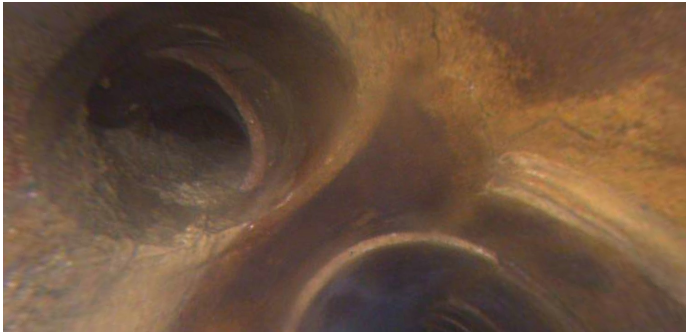
Code: **TF**
Description: **Tap Factory**

Distance (ft): **155.3**
Structural Grade: **0**
O&M Grade: **0**
Clock Start/From: **1**
Clock To:
1st Value: **4.000**
2nd Value:
Value Percent:
Continuous Index:
Within 8" of Joint:
Remarks:

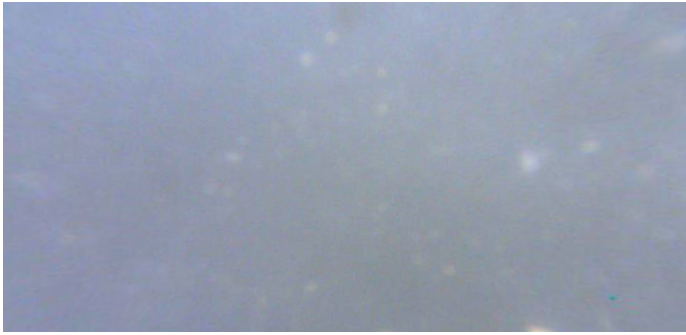
Code: **MCU**
Description: **Camera Underwater**

Distance (ft): **189.0**
Structural Grade: **0**
O&M Grade: **4**
Clock Start/From:
Clock To:
1st Value:
2nd Value:
Value Percent:
Continuous Index: **S06**
Within 8" of Joint: **NO**
Remarks:

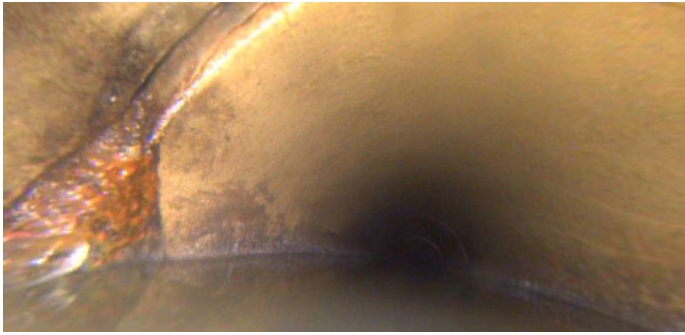
Code: **MCU**
Description: **Camera Underwater**

Distance (ft): **205.5**
Structural Grade: **0**
O&M Grade: **4**
Clock Start/From:
Clock To:
1st Value:
2nd Value:
Value Percent:
Continuous Index: **F06**
Within 8" of Joint: **NO**
Remarks:

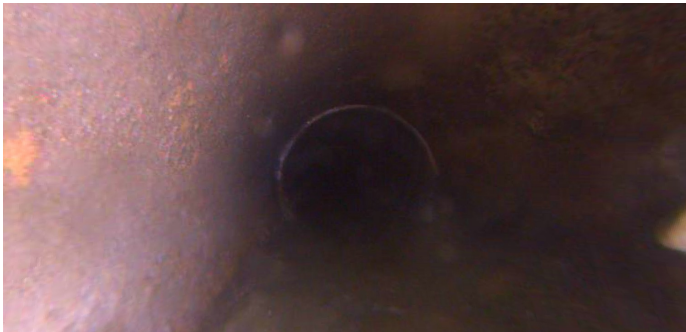
Code: **MSA**
Description: **Abandoned Survey**

Distance (ft): **249.0**
Structural Grade: **0**
O&M Grade: **0**
Clock Start/From:
Clock To:
1st Value:
2nd Value:
Value Percent:
Continuous Index:
Within 8" of Joint: **NO**
Remarks: **ROOTS**
