Profile/Photo Observation Report

Date:	04/20/2018	Weather:		Coding:	PACP 6.0
Pipe Length (ft):	273.0	Owner:	NA	Pre Clean:	No Pre-Cleaning
P.O.#:		Surveyor:	Byrd Fitzgerald	PSR:	P-405-026-025
Customer:		Clean Date:	01/01/1900	Shape:	C

Street:	DRIFTWOOD DR	Flow Control:	Not Controlled
City:	Hobart, IN	Year Renewed:	
Location:	Yard	Tape/Media #:	
Purpose:	Routine Assessment	Dia/Height:	10"
Use:	Sanitary	Material:	VCP
Drain Area:	NA	Lining:	
Category:	NA		
Comment:			
Location Details:		Direction of Survey:	Downstream
US MH:	M-405-026	DS MH:	M-405-025
		Total Length Surveyed (ft):	273.2

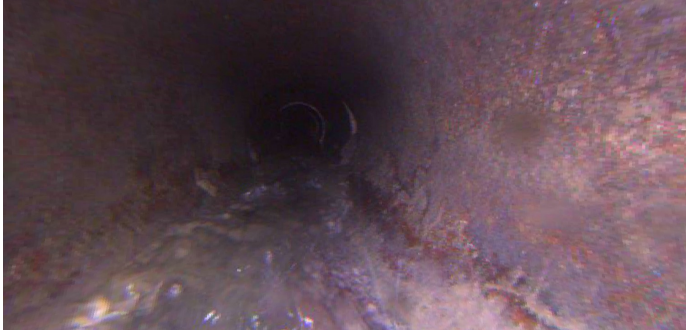
Code: **AMH**
Description: **Manhole**

Distance (ft): **.0**
Structural Grade: **0**
O&M Grade: **0**
Clock Start/From:
Clock To:
1st Value:
2nd Value:
Value Percent:
Continuous Index:
Within 8" of Joint: **NO**
Remarks: **M-405-026**

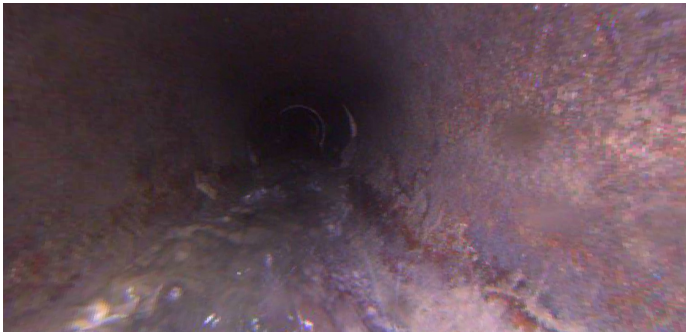
Code: **MWL**
Description: **Water Level**

Distance (ft): **.0**
Structural Grade: **0**
O&M Grade: **0**
Clock Start/From:
Clock To:
1st Value:
2nd Value:
Value Percent: **5.000**
Continuous Index:
Within 8" of Joint: **NO**
Remarks:

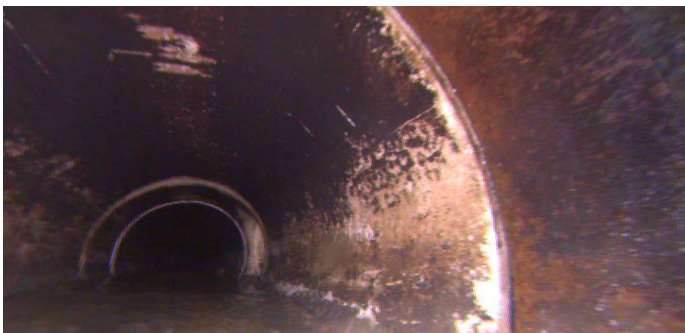
Code: **MMC**
Description: **Material Change**

Distance (ft): **6.7**
Structural Grade: **0**
O&M Grade: **0**
Clock Start/From:
Clock To:
1st Value:
2nd Value:
Value Percent:
Continuous Index:
Within 8" of Joint: **NO**
Remarks: **pvc**

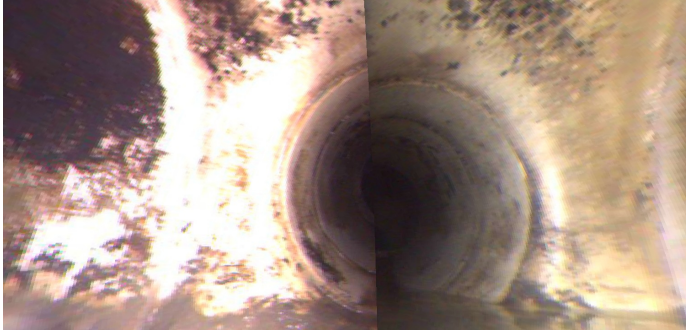
Code: **TF**
Description: **Tap Factory**

Distance (ft): **9.1**
Structural Grade: **0**
O&M Grade: **0**
Clock Start/From: **3**
Clock To:
1st Value: **4.000**
2nd Value:
Value Percent:
Continuous Index:
Within 8" of Joint: **YES**
Remarks:

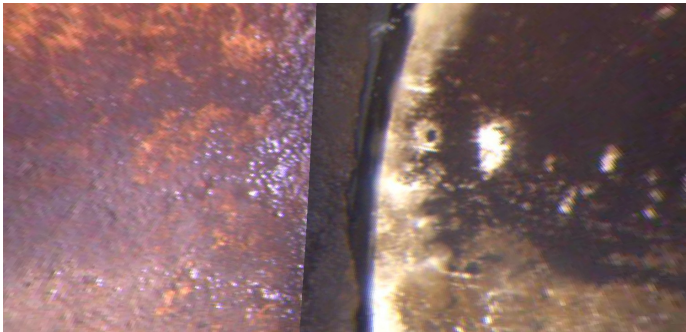
Code: **MMC**
Description: **Material Change**

Distance (ft): **13.4**
Structural Grade: **0**
O&M Grade: **0**
Clock Start/From:
Clock To:
1st Value:
2nd Value:
Value Percent:
Continuous Index:
Within 8" of Joint: **NO**
Remarks: **vcp**

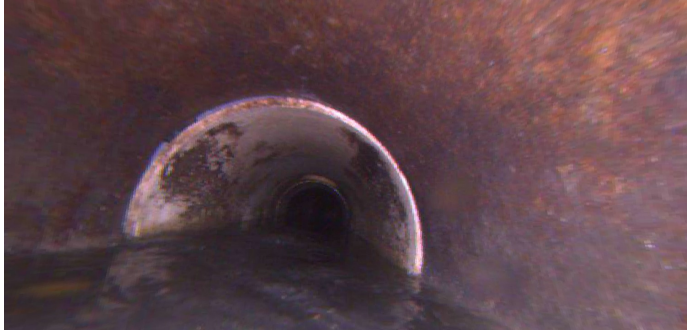
Code:	MWL
Description:	Water Level
Distance (ft):	35.7
Structural Grade:	0
O&M Grade:	0
Clock Start/From:	
Clock To:	
1st Value:	
2nd Value:	
Value Percent:	25.000
Continuous Index:	
Within 8" of Joint:	NO
Remarks:

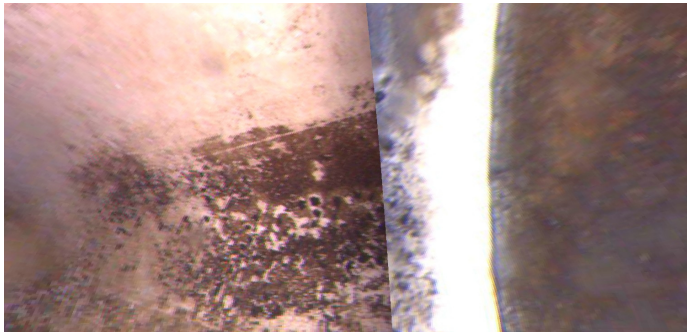
Code:	MMC
Description:	Material Change
Distance (ft):	37.0
Structural Grade:	0
O&M Grade:	0
Clock Start/From:	
Clock To:	
1st Value:	
2nd Value:	
Value Percent:	
Continuous Index:	
Within 8" of Joint:	NO
Remarks:	pvc

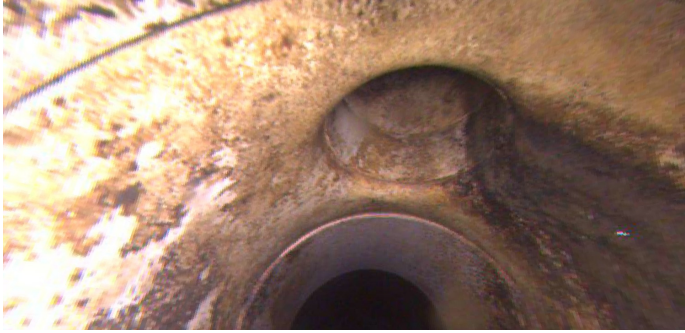
Code: **TF**
Description: **Tap Factory**

Distance (ft): **38.8**
Structural Grade: **0**
O&M Grade: **0**
Clock Start/From: **12**
Clock To:
1st Value: **4.000**
2nd Value:
Value Percent:
Continuous Index:
Within 8" of Joint: **YES**
Remarks:

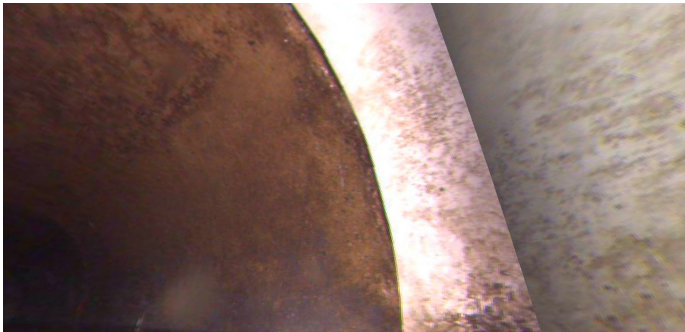
Code: **MMC**
Description: **Material Change**

Distance (ft): **40.6**
Structural Grade: **0**
O&M Grade: **0**
Clock Start/From:
Clock To:
1st Value:
2nd Value:
Value Percent:
Continuous Index:
Within 8" of Joint: **NO**
Remarks: **vcp**

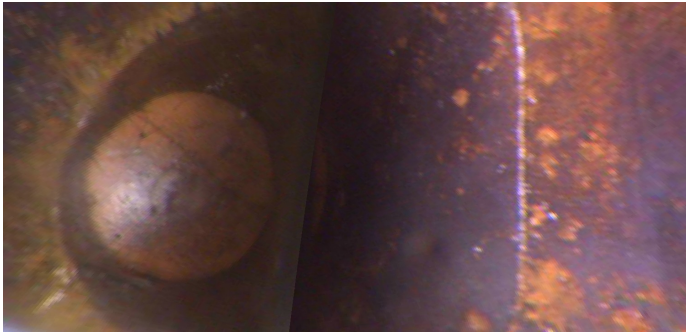
Code: **TFC**
Description: **Tap Factory Capped**

Distance (ft): **43.7**
Structural Grade: **0**
O&M Grade: **0**
Clock Start/From: **10**
Clock To:
1st Value: **4.000**
2nd Value:
Value Percent:
Continuous Index:
Within 8" of Joint: **YES**
Remarks:

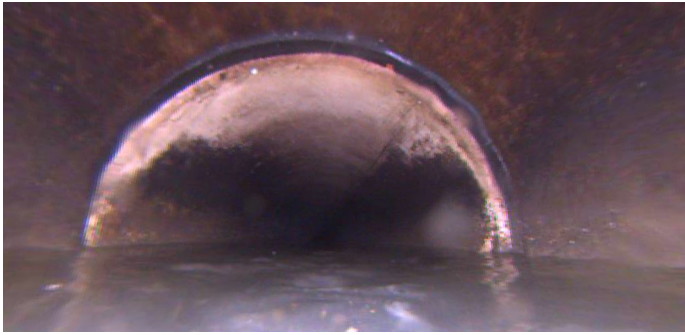
Code: **MMC**
Description: **Material Change**

Distance (ft): **84.1**
Structural Grade: **0**
O&M Grade: **0**
Clock Start/From:
Clock To:
1st Value:
2nd Value:
Value Percent:
Continuous Index:
Within 8" of Joint: **NO**
Remarks: **pvc**

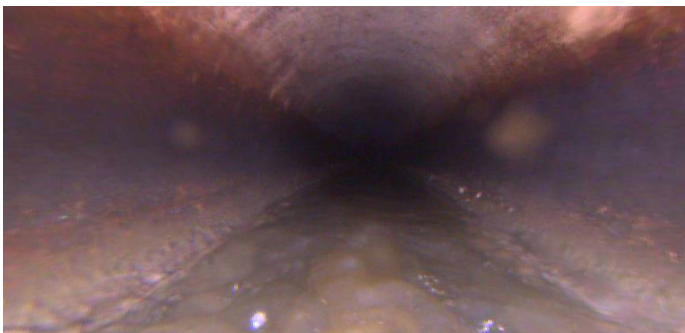
Code: **MWL**
Description: **Water Level**

Distance (ft): **98.2**
Structural Grade: **0**
O&M Grade: **0**
Clock Start/From:
Clock To:
1st Value:
2nd Value:
Value Percent: **5.000**
Continuous Index:
Within 8" of Joint: **NO**
Remarks:

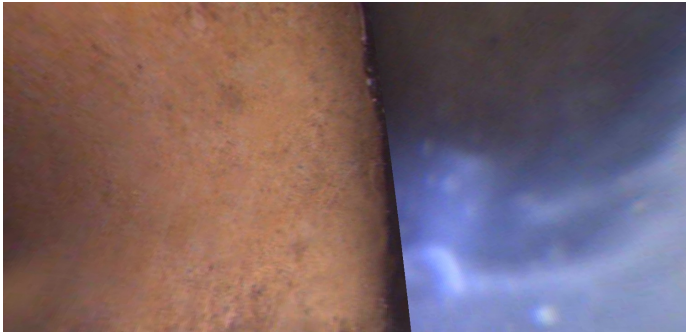
Code: **MMC**
Description: **Material Change**

Distance (ft): **121.2**
Structural Grade: **0**
O&M Grade: **0**
Clock Start/From:
Clock To:
1st Value:
2nd Value:
Value Percent:
Continuous Index:
Within 8" of Joint: **NO**
Remarks: **vcp**

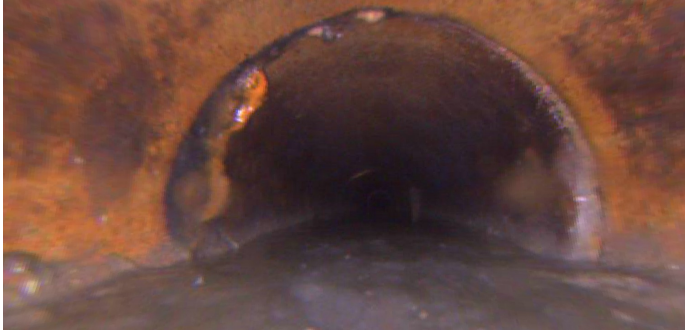
Code: **MWL**
Description: **Water Level**

Distance (ft): **162.4**
Structural Grade: **0**
O&M Grade: **0**
Clock Start/From:
Clock To:
1st Value:
2nd Value:
Value Percent: **25.000**
Continuous Index:
Within 8" of Joint: **NO**
Remarks:

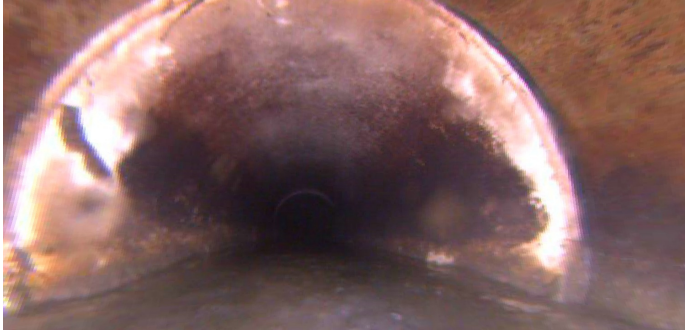
Code: **MMC**
Description: **Material Change**

Distance (ft): **174.6**
Structural Grade: **0**
O&M Grade: **0**
Clock Start/From:
Clock To:
1st Value:
2nd Value:
Value Percent:
Continuous Index:
Within 8" of Joint: **NO**
Remarks: **pvc**

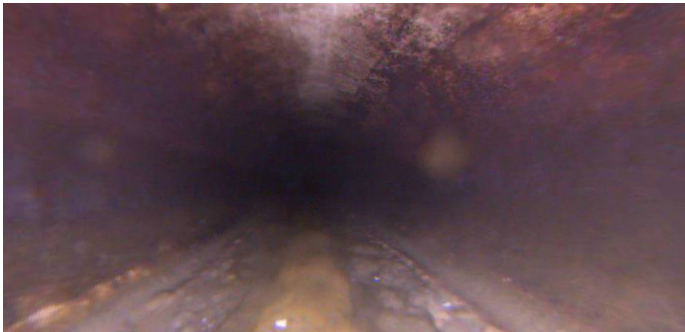
Code: **MWL**
Description: **Water Level**

Distance (ft): **192.8**
Structural Grade: **0**
O&M Grade: **0**
Clock Start/From:
Clock To:
1st Value:
2nd Value:
Value Percent: **5.000**
Continuous Index:
Within 8" of Joint: **NO**
Remarks:

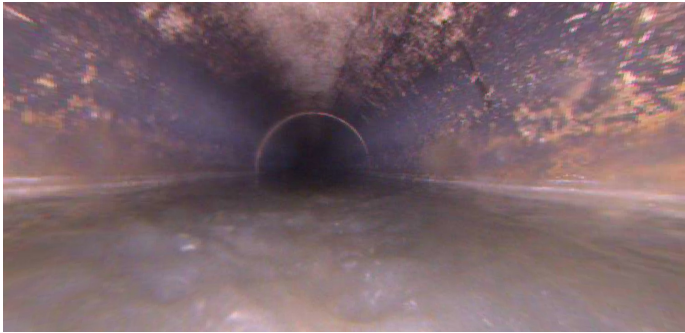
Code: **MWL**
Description: **Water Level**

Distance (ft): **254.8**
Structural Grade: **0**
O&M Grade: **0**
Clock Start/From:
Clock To:
1st Value:
2nd Value:
Value Percent: **25.000**
Continuous Index:
Within 8" of Joint: **NO**
Remarks:

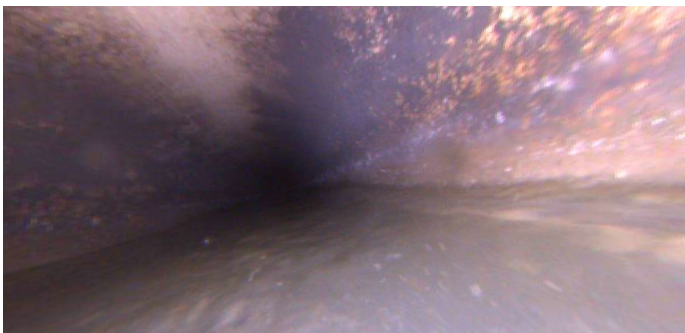
Code: **MWL**
Description: **Water Level**

Distance (ft): **261.7**
Structural Grade: **0**
O&M Grade: **0**
Clock Start/From:
Clock To:
1st Value:
2nd Value:
Value Percent: **50.000**
Continuous Index:
Within 8" of Joint: **NO**
Remarks:

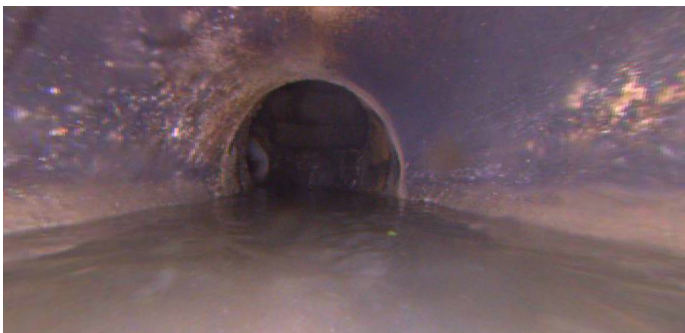
Code: **MWL**
Description: **Water Level**

Distance (ft): **269.6**
Structural Grade: **0**
O&M Grade: **0**
Clock Start/From:
Clock To:
1st Value:
2nd Value:
Value Percent: **25.000**
Continuous Index:
Within 8" of Joint: **NO**
Remarks:

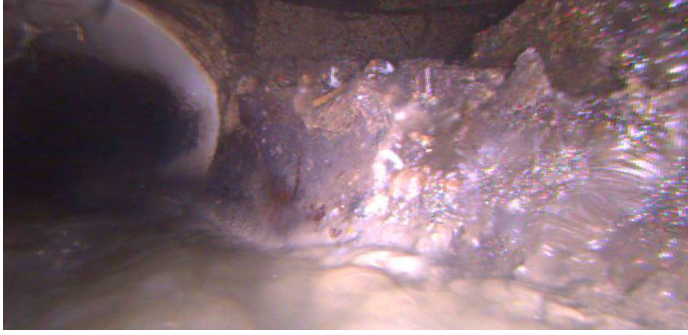
Code:	AMH
Description:	Manhole
Distance (ft):	273.2
Structural Grade:	0
O&M Grade:	0
Clock Start/From:	
Clock To:	
1st Value:	
2nd Value:	
Value Percent:	
Continuous Index:	
Within 8" of Joint:	NO
Remarks:	M-405-025
