## Profile/Photo Observation Report

Date:	<b>04/20/2018</b>	Weather:		Coding:	<b>PACP 6.0</b>
Pipe Length (ft):	<b>273.0</b>	Owner:	<b>NA</b>	Pre Clean:	<b>No Pre-Cleaning</b>
P.O.#:		Surveyor:	<b>Byrd Fitzgerald</b>	PSR:	<b>P-405-026-025</b>
Customer:		Clean Date:	<b>01/01/1900</b>	Shape:	<b>C</b>

Street:	<b>FOXCROFT STREET</b>	Flow Control:	<b>Not Controlled</b>
City:	<b>Hobart, IN</b>	Year Renewed:	
Location:	<b>Yard</b>	Tape/Media #:	
Purpose:	<b>Routine Assessment</b>	Dia/Height:	<b>10"</b>
Use:	<b>Sanitary</b>	Material:	<b>VCP</b>
Drain Area:	<b>NA</b>	Lining:	
Category:	<b>NA</b>		
Comment:

Location Details:		Direction of Survey:	<b>Downstream</b>
US MH:	<b>M-405-026</b>	DS MH:	<b>M-405-025</b>
		Total Length Surveyed (ft):	<b>273.2</b>

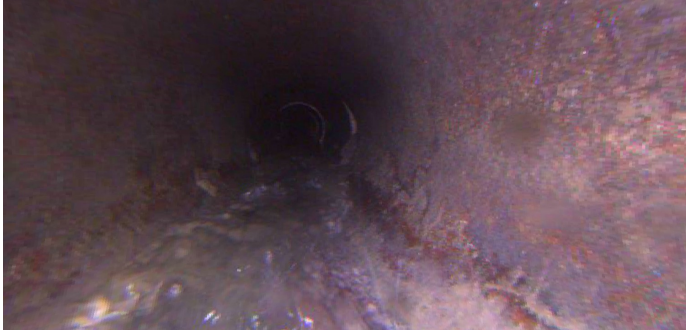
Code: **AMH**  
Description: **Manhole**

Distance (ft): **.0**  
Structural Grade: **0**  
O&M Grade: **0**  
Clock Start/From:  
Clock To:  
1st Value:  
2nd Value:  
Value Percent:  
Continuous Index:  
Within 8" of Joint: **NO**  
Remarks: **M-405-026**

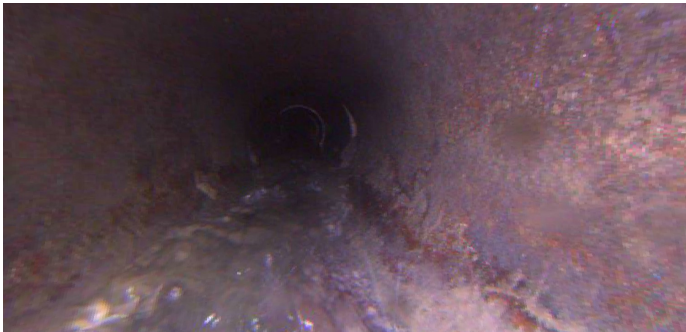
Code: **MWL**  
Description: **Water Level**

Distance (ft): **.0**  
Structural Grade: **0**  
O&M Grade: **0**  
Clock Start/From:  
Clock To:  
1st Value:  
2nd Value:  
Value Percent: **5.000**  
Continuous Index:  
Within 8" of Joint: **NO**  
Remarks:

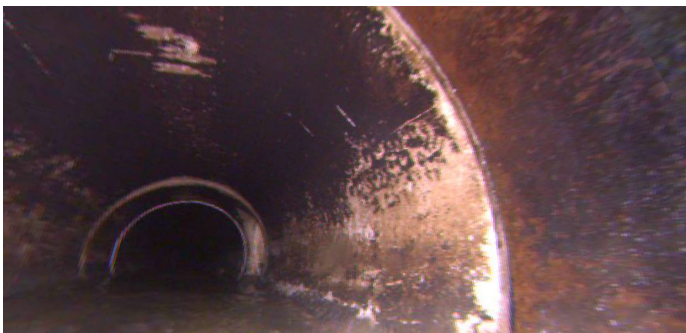
Code: **MMC**  
Description: **Material Change**

Distance (ft): **6.7**  
Structural Grade: **0**  
O&M Grade: **0**  
Clock Start/From:  
Clock To:  
1st Value:  
2nd Value:  
Value Percent:  
Continuous Index:  
Within 8" of Joint: **NO**  
Remarks: **pvc**

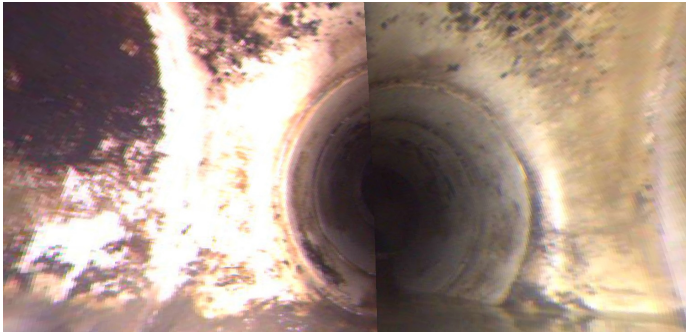
Code: **TF**  
Description: **Tap Factory**

Distance (ft): **9.1**  
Structural Grade: **0**  
O&M Grade: **0**  
Clock Start/From: **3**  
Clock To:  
1st Value: **4.000**  
2nd Value:  
Value Percent:  
Continuous Index:  
Within 8" of Joint: **YES**  
Remarks:

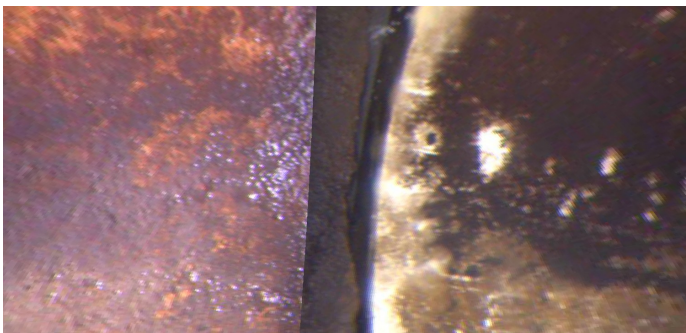
Code: **MMC**  
Description: **Material Change**

Distance (ft): **13.4**  
Structural Grade: **0**  
O&M Grade: **0**  
Clock Start/From:  
Clock To:  
1st Value:  
2nd Value:  
Value Percent:  
Continuous Index:  
Within 8" of Joint: **NO**  
Remarks: **vcp**

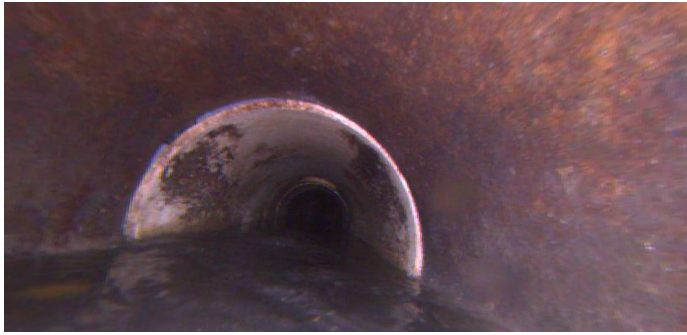
Code: **MWL**  
Description: **Water Level**

Distance (ft): **35.7**  
Structural Grade: **0**  
O&M Grade: **0**  
Clock Start/From:  
Clock To:  
1st Value:  
2nd Value:  
Value Percent: **25.000**  
Continuous Index:  
Within 8" of Joint: **NO**  
Remarks:

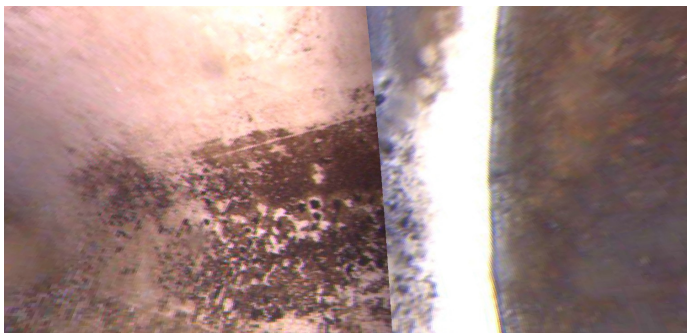
Code: **MMC**  
Description: **Material Change**

Distance (ft): **37.0**  
Structural Grade: **0**  
O&M Grade: **0**  
Clock Start/From:  
Clock To:  
1st Value:  
2nd Value:  
Value Percent:  
Continuous Index:  
Within 8" of Joint: **NO**  
Remarks: **pvc**

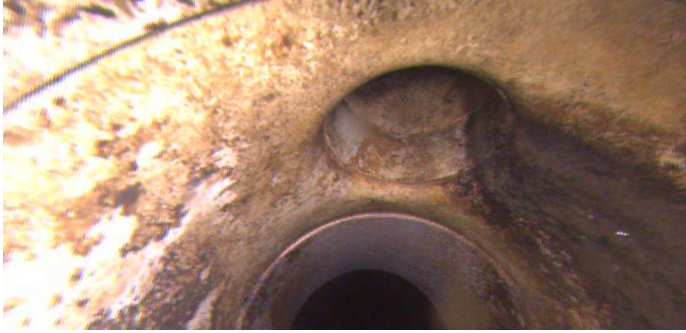
Code: **TF**  
Description: **Tap Factory**

Distance (ft): **38.8**  
Structural Grade: **0**  
O&M Grade: **0**  
Clock Start/From: **12**  
Clock To:  
1st Value: **4.000**  
2nd Value:  
Value Percent:  
Continuous Index:  
Within 8" of Joint: **YES**  
Remarks:

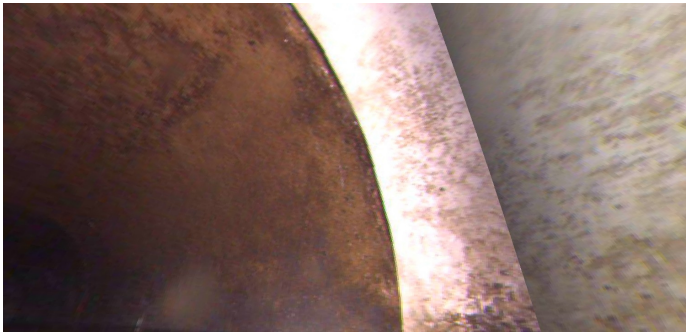
Code: **MMC**  
Description: **Material Change**

Distance (ft): **40.6**  
Structural Grade: **0**  
O&M Grade: **0**  
Clock Start/From:  
Clock To:  
1st Value:  
2nd Value:  
Value Percent:  
Continuous Index:  
Within 8" of Joint: **NO**  
Remarks: **vcp**

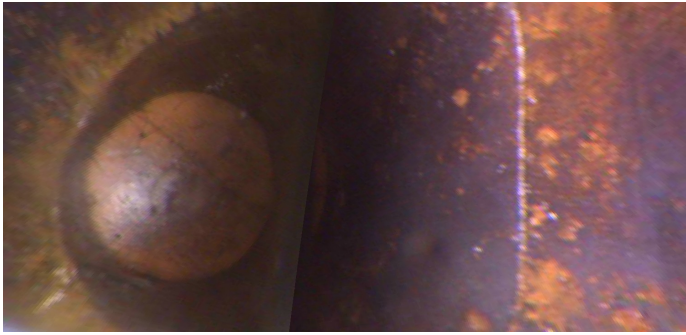
Code: **TFC**  
Description: **Tap Factory Capped**

Distance (ft): **43.7**  
Structural Grade: **0**  
O&M Grade: **0**  
Clock Start/From: **10**  
Clock To:  
1st Value: **4.000**  
2nd Value:  
Value Percent:  
Continuous Index:  
Within 8" of Joint: **YES**  
Remarks:

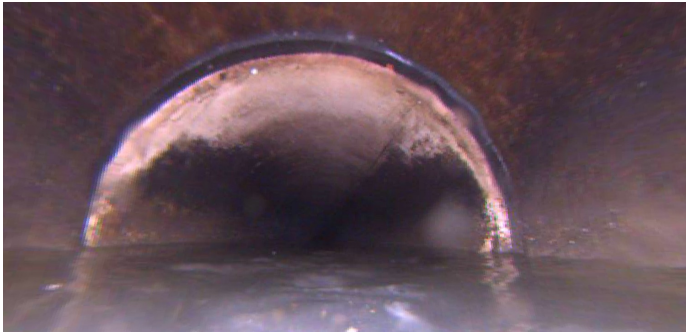
Code: **MMC**  
Description: **Material Change**

Distance (ft): **84.1**  
Structural Grade: **0**  
O&M Grade: **0**  
Clock Start/From:  
Clock To:  
1st Value:  
2nd Value:  
Value Percent:  
Continuous Index:  
Within 8" of Joint: **NO**  
Remarks: **pvc**

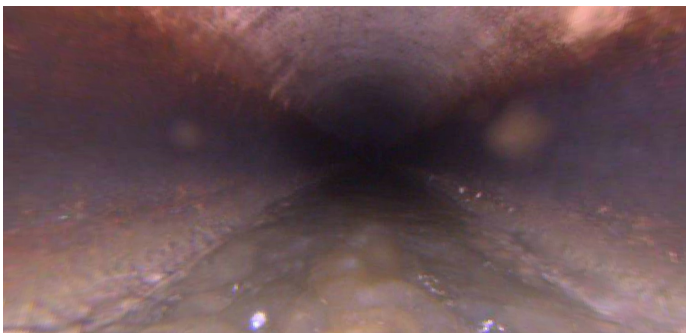
Code: **MWL**  
Description: **Water Level**

Distance (ft): **98.2**  
Structural Grade: **0**  
O&M Grade: **0**  
Clock Start/From:  
Clock To:  
1st Value:  
2nd Value:  
Value Percent: **5.000**  
Continuous Index:  
Within 8" of Joint: **NO**  
Remarks:

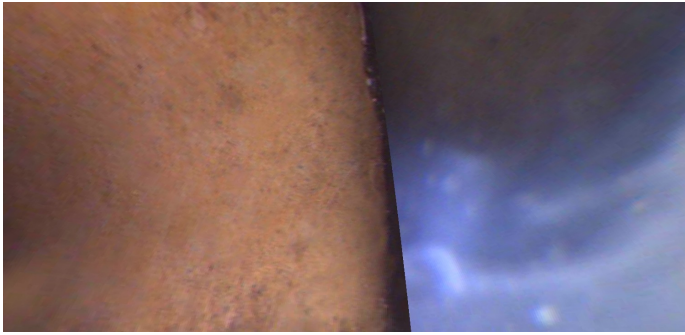
Code: **MMC**  
Description: **Material Change**

Distance (ft): **121.2**  
Structural Grade: **0**  
O&M Grade: **0**  
Clock Start/From:  
Clock To:  
1st Value:  
2nd Value:  
Value Percent:  
Continuous Index:  
Within 8" of Joint: **NO**  
Remarks: **vcp**

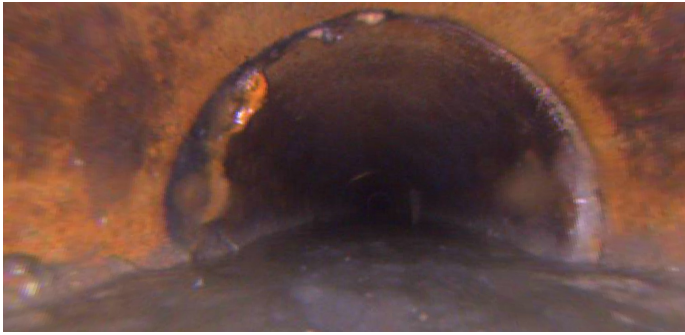
Code: **MWL**  
Description: **Water Level**

Distance (ft): **162.4**  
Structural Grade: **0**  
O&M Grade: **0**  
Clock Start/From:  
Clock To:  
1st Value:  
2nd Value:  
Value Percent: **25.000**  
Continuous Index:  
Within 8" of Joint: **NO**  
Remarks:

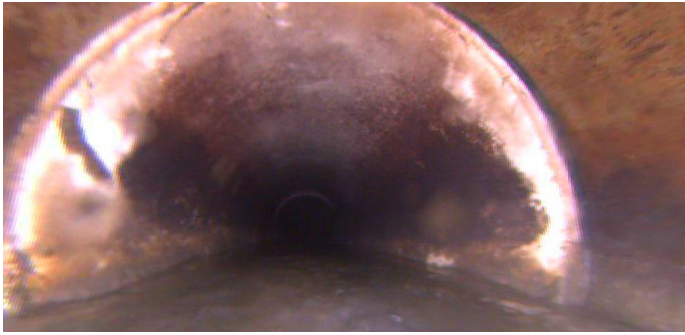
Code: **MMC**  
Description: **Material Change**

Distance (ft): **174.6**  
Structural Grade: **0**  
O&M Grade: **0**  
Clock Start/From:  
Clock To:  
1st Value:  
2nd Value:  
Value Percent:  
Continuous Index:  
Within 8" of Joint: **NO**  
Remarks: **pvc**

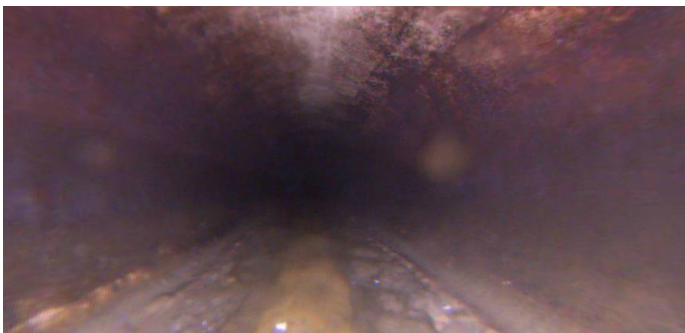
Code: **MWL**  
Description: **Water Level**

Distance (ft): **192.8**  
Structural Grade: **0**  
O&M Grade: **0**  
Clock Start/From:  
Clock To:  
1st Value:  
2nd Value:  
Value Percent: **5.000**  
Continuous Index:  
Within 8" of Joint: **NO**  
Remarks:

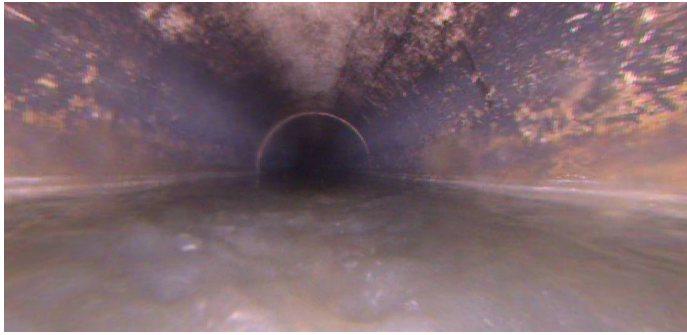
Code:	<b>MWL</b>
Description:	<b>Water Level</b>
Distance (ft):	<b>254.8</b>
Structural Grade:	<b>0</b>
O&M Grade:	<b>0</b>
Clock Start/From:	
Clock To:	
1st Value:	
2nd Value:	
Value Percent:	<b>25.000</b>
Continuous Index:	
Within 8" of Joint:	<b>NO</b>
Remarks:

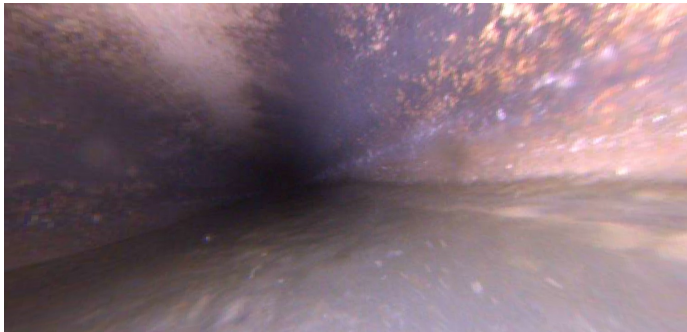
Code:	<b>MWL</b>
Description:	<b>Water Level</b>
Distance (ft):	<b>261.7</b>
Structural Grade:	<b>0</b>
O&M Grade:	<b>0</b>
Clock Start/From:	
Clock To:	
1st Value:	
2nd Value:	
Value Percent:	<b>50.000</b>
Continuous Index:	
Within 8" of Joint:	<b>NO</b>
Remarks:

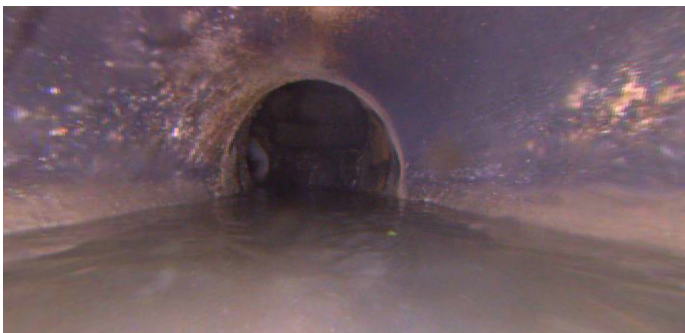
Code: **MWL**  
Description: **Water Level**

Distance (ft): **269.6**  
Structural Grade: **0**  
O&M Grade: **0**  
Clock Start/From:  
Clock To:  
1st Value:  
2nd Value:  
Value Percent: **25.000**  
Continuous Index:  
Within 8" of Joint: **NO**  
Remarks:

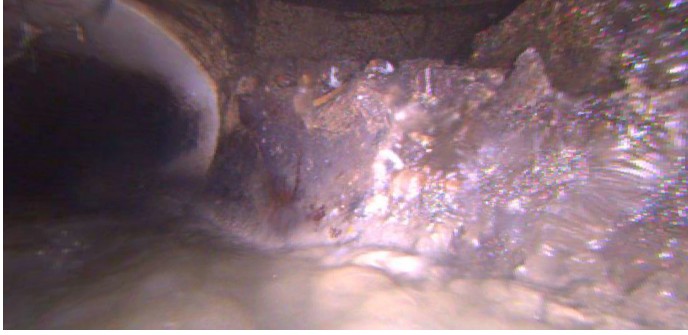
Code: **AMH**  
Description: **Manhole**

Distance (ft): **273.2**  
Structural Grade: **0**  
O&M Grade: **0**  
Clock Start/From:  
Clock To:  
1st Value:  
2nd Value:  
Value Percent:  
Continuous Index:  
Within 8" of Joint: **NO**  
Remarks: **M-405-025**
