Profile/Photo Observation Report

Date:	03/16/2024	Weather:		Coding:	PACP 7.0
Pipe Length (ft):	133.0	Owner:	City of Hobart	Pre Clean:	Heavy Cleaning
P.O.#:		Surveyor:	S. Bucklin	PSR:	P-405-028-027
Customer:	City of Hobart	Clean Date:	10/25/2023	Shape:	C

Street:	W 3RD PL	Flow Control:	Not Controlled
City:	Hobart, IN	Year Renewed:	
Location:	Easement/Right of Way	Tape/Media #:	
Purpose:	Sewer System Evaluation Survey (SS)	Dia/Height:	10"
Use:	Sanitary Sewage Pipe	Material:	VCP
Drain Area:		Lining:	Cured-In-Place Pipe
Category:	NA		
Comment:

Location Details:		Direction of Survey:	Downstream
US MH:	M-405-027	DS MH:	M-405-028
		Total Length Surveyed (ft):	104.7

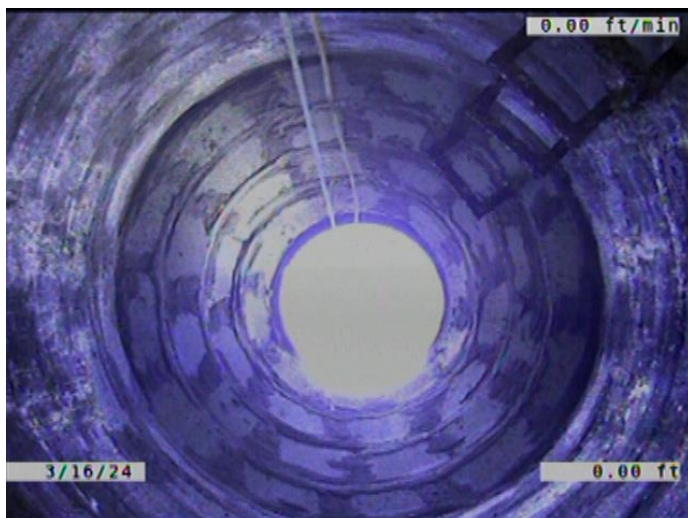
Code:	AMH
Description:	Manhole
Distance (ft):	.0
Structural Grade:	0
O&M Grade:	0
Clock Start/From:	
Clock To:	
1st Value:	
2nd Value:	
Value Percent:	
Continuous Index:	
Within 8" of Joint:	NO
Remarks:	M-405-027

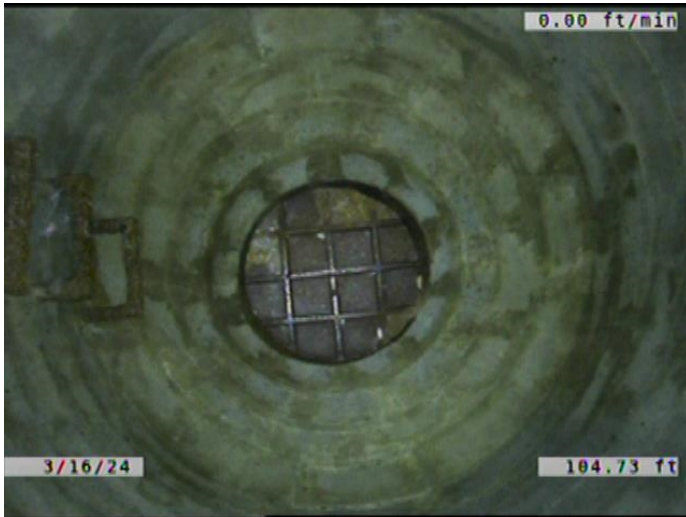
Code:	AMH
Description:	Manhole
Distance (ft):	104.7
Structural Grade:	0
O&M Grade:	0
Clock Start/From:	
Clock To:	
1st Value:	
2nd Value:	
Value Percent:	
Continuous Index:	
Within 8" of Joint:	NO
Remarks:	M-405-028
