Profile/Photo Observation Report

Date:	04/24/2018	Weather:		Coding:	PACP 6.0
Pipe Length (ft):	257.7	Owner:	NA	Pre Clean:	No Pre-Cleaning
P.O.#:		Surveyor:	Jen Costello	PSR:	P-405-030-029
Customer:		Clean Date:	01/01/1900	Shape:	C

Street:	FOXCROFT STREET	Flow Control:	Not Controlled
City:	Hobart, IN	Year Renewed:	
Location:	Yard	Tape/Media #:	
Purpose:	Routine Assessment	Dia/Height:	8"
Use:	Sanitary	Material:	VCP
Drain Area:	NA	Lining:	
Category:	NA		
Comment:	P_C at 36 ft nothing visible. Flow direction wrong		
Location Details:		Direction of Survey:	Downstream
US MH:	M-405-029	DS MH:	M-405-030
		Total Length Surveyed (ft):	37.5

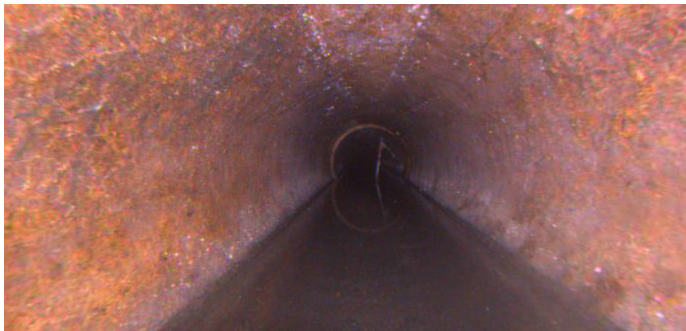
Code: **AMH**
Description: **Manhole**

Distance (ft): **.0**
Structural Grade: **0**
O&M Grade: **0**
Clock Start/From:
Clock To:
1st Value:
2nd Value:
Value Percent:
Continuous Index:
Within 8" of Joint: **NO**
Remarks: **M-405-029**

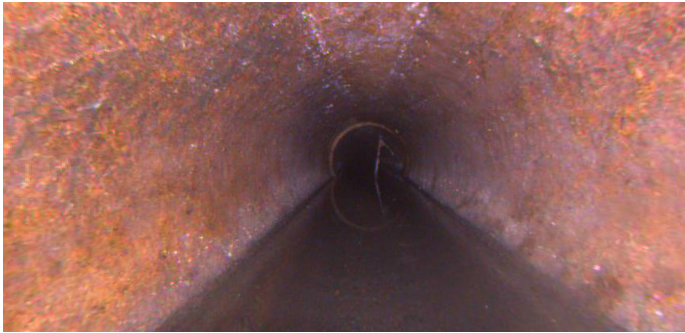
Code:	MWL
Description:	Water Level

Distance (ft):	.0
Structural Grade:	0
O&M Grade:	0
Clock Start/From:	
Clock To:	
1st Value:	
2nd Value:	
Value Percent:	10.000
Continuous Index:	
Within 8" of Joint:	NO
Remarks:
