Profile/Photo Observation Report

Date:	03/16/2024	Weather:		Coding:	PACP 7.0
Pipe Length (ft):	258.0	Owner:	City of Hobart	Pre Clean:	Heavy Cleaning
P.O.#:		Surveyor:	S. Bucklin	PSR:	P-405-030-029
Customer:	City of Hobart	Clean Date:	10/27/2023	Shape:	C

Street:	W 3RD ST	Flow Control:	Not Controlled
City:	Hobart, IN	Year Renewed:	
Location:	Easement/Right of Way	Tape/Media #:	
Purpose:	Sewer System Evaluation Survey (SS)	Dia/Height:	8"
Use:	Sanitary Sewage Pipe	Material:	VCP
Drain Area:		Lining:	None
Category:	NA		
Comment:			
Location Details:		Direction of Survey:	Upstream
US MH:	M-405-029	DS MH:	M-405-030
		Total Length Surveyed (ft):	255.7

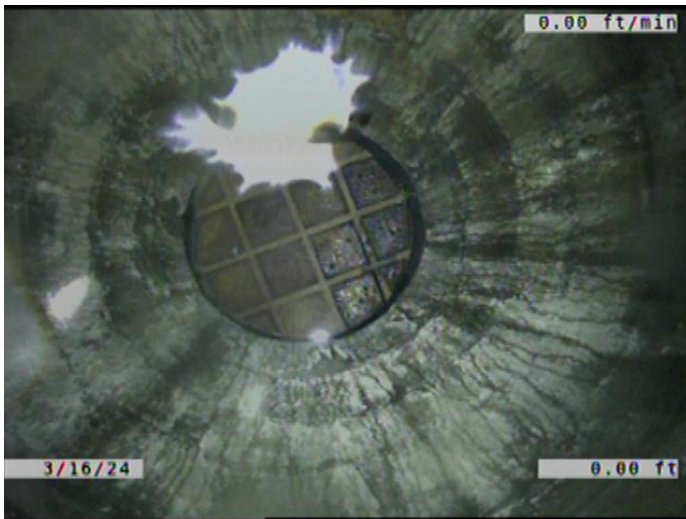
Code: **AMH**
Description: **Manhole**

Distance (ft): **.0**
Structural Grade: **0**
O&M Grade: **0**
Clock Start/From:
Clock To:
1st Value:
2nd Value:
Value Percent:
Continuous Index:
Within 8" of Joint: **NO**
Remarks: **M-405-030**

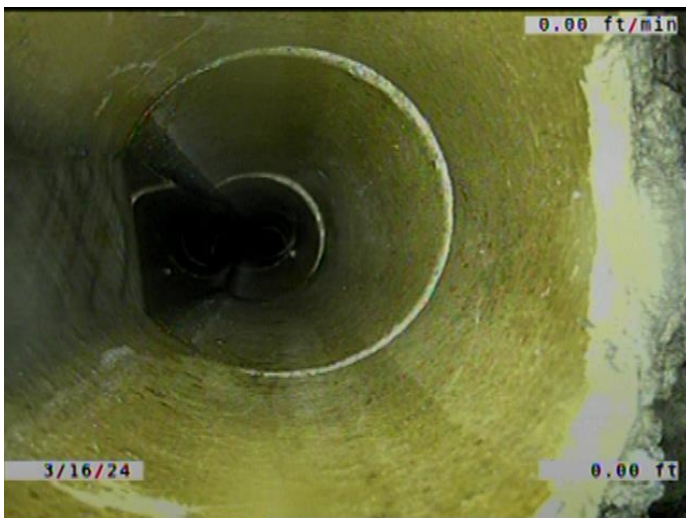
Code: **MWL**
Description: **Miscellaneous Water Level**

Distance (ft): **.0**
Structural Grade: **0**
O&M Grade: **0**
Clock Start/From:
Clock To:
1st Value:
2nd Value:
Value Percent: **5.000**
Continuous Index:
Within 8" of Joint: **NO**
Remarks:

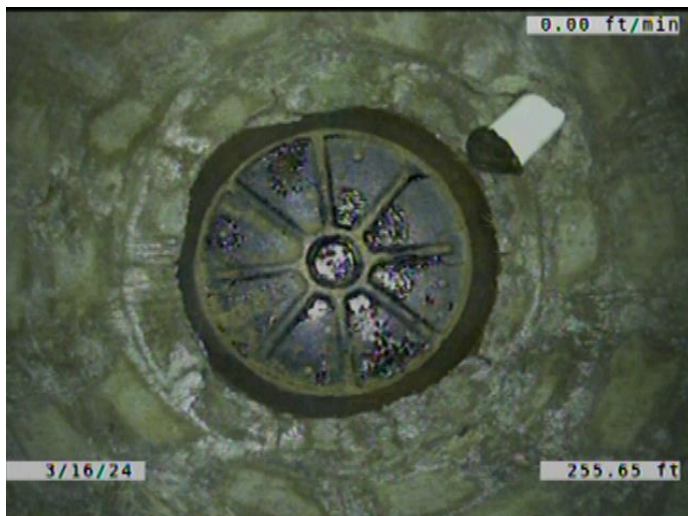
Code: **AMH**
 Description: **Manhole**

Distance (ft): **255.7**
 Structural Grade: **0**
 O&M Grade: **0**
 Clock Start/From:
 Clock To:
 1st Value:
 2nd Value:
 Value Percent:
 Continuous Index:
 Within 8" of Joint: **NO**
 Remarks: **M-405-029**
