Profile/Photo Observation Report

Date:	04/19/2018	Weather:		Coding:	PACP 6.0
Pipe Length (ft):	332.8	Owner:	NA	Pre Clean:	No Pre-Cleaning
P.O.#:		Surveyor:	Byrd Fitzgerald	PSR:	P-405-035-031
Customer:		Clean Date:	01/01/1900	Shape:	C

Street:	FOXCROFT STREET	Flow Control:	Not Controlled
City:	Hobart, IN	Year Renewed:	
Location:	Yard	Tape/Media #:	
Purpose:	Routine Assessment	Dia/Height:	8"
Use:	Sanitary	Material:	PVC
Drain Area:	NA	Lining:	
Category:	NA		
Comment:	P_C at 168 ft roots		
Location Details:		Direction of Survey:	Downstream
US MH:	M-405-031	DS MH:	M-405-035
		Total Length Surveyed (ft):	169.7

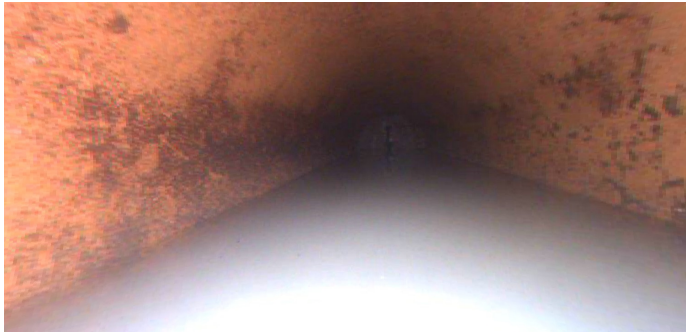
Code: **AMH**
Description: **Manhole**

Distance (ft): **.0**
Structural Grade: **0**
O&M Grade: **0**
Clock Start/From:
Clock To:
1st Value:
2nd Value:
Value Percent:
Continuous Index:
Within 8" of Joint: **NO**
Remarks: **M-405-031**

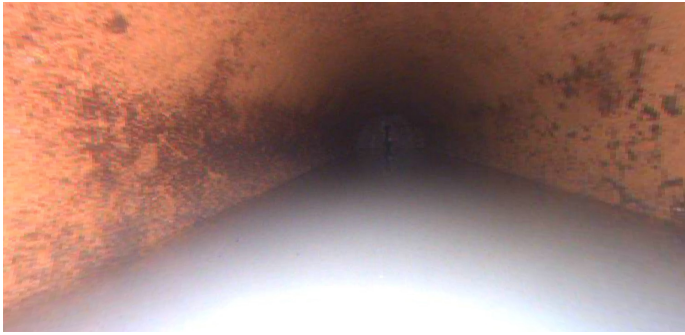
Code: **MWL**
Description: **Water Level**

Distance (ft): **.0**
Structural Grade: **0**
O&M Grade: **0**
Clock Start/From:
Clock To:
1st Value:
2nd Value:
Value Percent: **25.000**
Continuous Index:
Within 8" of Joint: **NO**
Remarks:

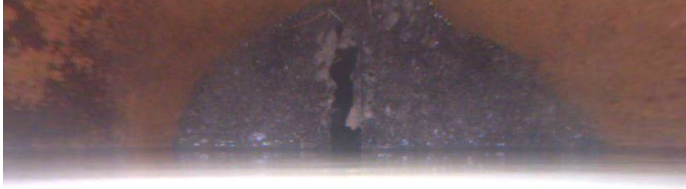
Code: **MWL**
Description: **Water Level**

Distance (ft): **3.7**
Structural Grade: **0**
O&M Grade: **0**
Clock Start/From:
Clock To:
1st Value:
2nd Value:
Value Percent: **50.000**
Continuous Index:
Within 8" of Joint: **NO**
Remarks:

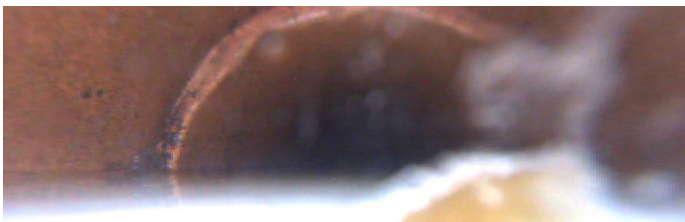
Code: **MWL**
Description: **Water Level**

Distance (ft): **52.0**
Structural Grade: **0**
O&M Grade: **0**
Clock Start/From:
Clock To:
1st Value:
2nd Value:
Value Percent: **50.000**
Continuous Index:
Within 8" of Joint: **NO**
Remarks:

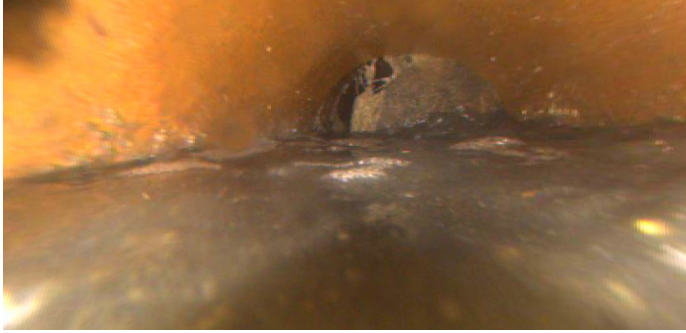
Code: **MGO**
Description: **General Observation**

Distance (ft): **65.4**
Structural Grade: **0**
O&M Grade: **0**
Clock Start/From:
Clock To:
1st Value:
2nd Value:
Value Percent:
Continuous Index:
Within 8" of Joint: **NO**
Remarks: **rear camera/mcu**

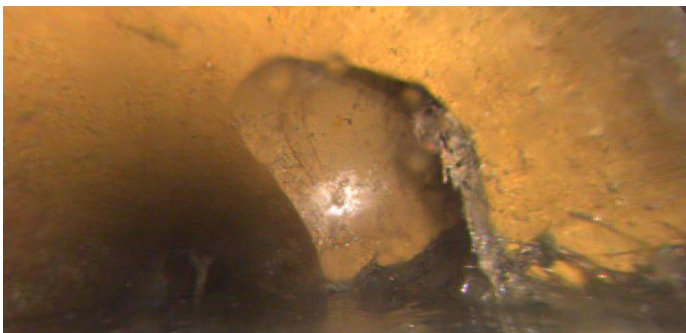
Code: **TF**
Description: **Tap Factory**

Distance (ft): **76.2**
Structural Grade: **0**
O&M Grade: **0**
Clock Start/From: **10**
Clock To:
1st Value: **4.000**
2nd Value:
Value Percent:
Continuous Index:
Within 8" of Joint:
Remarks:

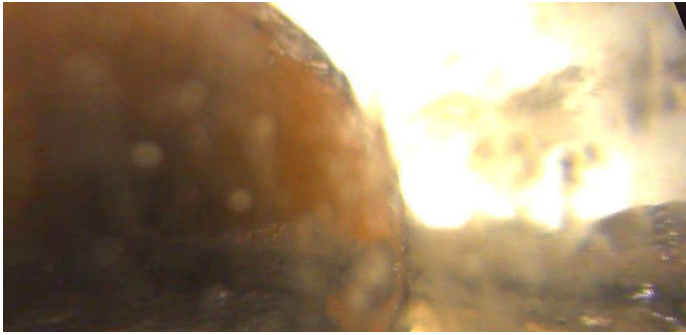
Code: **MMC**
Description: **Material Change**

Distance (ft): **112.7**
Structural Grade: **0**
O&M Grade: **0**
Clock Start/From:
Clock To:
1st Value:
2nd Value:
Value Percent:
Continuous Index:
Within 8" of Joint: **NO**
Remarks: **pvc**

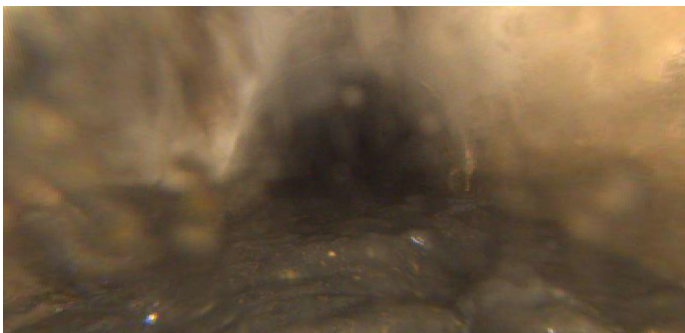
Code: **TF**
Description: **Tap Factory**

Distance (ft): **114.7**
Structural Grade: **0**
O&M Grade: **0**
Clock Start/From: **3**
Clock To:
1st Value: **6.000**
2nd Value:
Value Percent:
Continuous Index:
Within 8" of Joint: **YES**
Remarks:

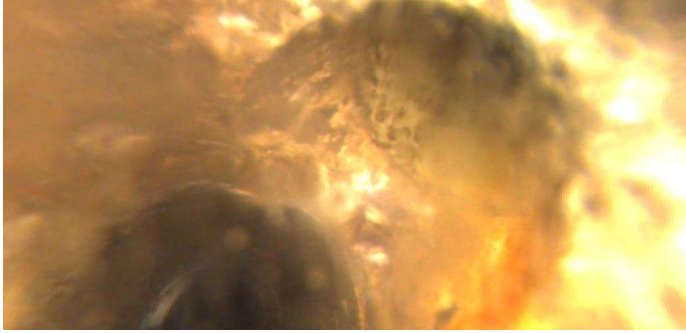
Code: **TF**
Description: **Tap Factory**

Distance (ft): **116.7**
Structural Grade: **0**
O&M Grade: **0**
Clock Start/From: **11**
Clock To:
1st Value: **4.000**
2nd Value:
Value Percent:
Continuous Index:
Within 8" of Joint: **YES**
Remarks:

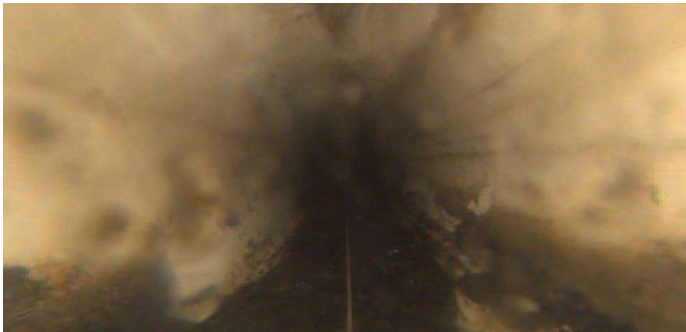
Code: **MWL**
Description: **Water Level**

Distance (ft): **120.0**
Structural Grade: **0**
O&M Grade: **0**
Clock Start/From:
Clock To:
1st Value:
2nd Value:
Value Percent: **5.000**
Continuous Index:
Within 8" of Joint: **NO**
Remarks:

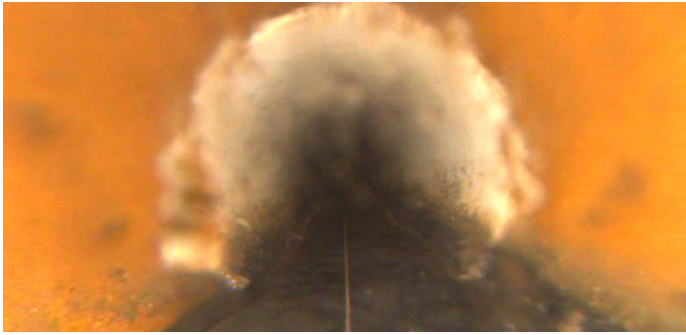
Code: **MMC**
Description: **Material Change**

Distance (ft): **122.0**
Structural Grade: **0**
O&M Grade: **0**
Clock Start/From:
Clock To:
1st Value:
2nd Value:
Value Percent:
Continuous Index:
Within 8" of Joint: **NO**
Remarks: **vcp**

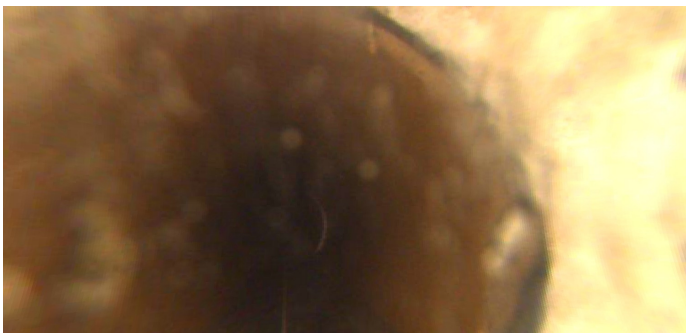
Code: **MMC**
Description: **Material Change**

Distance (ft): **151.1**
Structural Grade: **0**
O&M Grade: **0**
Clock Start/From:
Clock To:
1st Value:
2nd Value:
Value Percent:
Continuous Index:
Within 8" of Joint: **NO**
Remarks: **pvc**

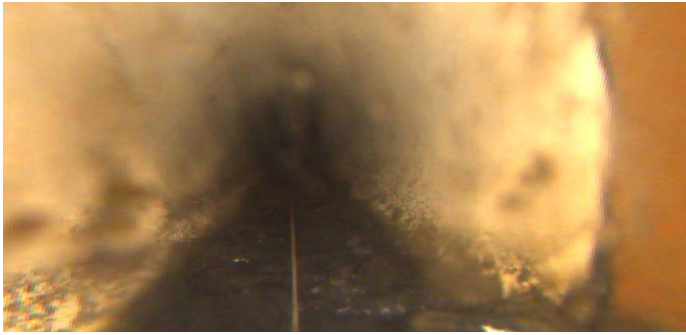
Code: **MMC**
Description: **Material Change**

Distance (ft): **157.7**
Structural Grade: **0**
O&M Grade: **0**
Clock Start/From:
Clock To:
1st Value:
2nd Value:
Value Percent:
Continuous Index:
Within 8" of Joint: **NO**
Remarks: **vcp**
