# Profile/Photo Observation Report

Date: **02/17/2024**      Weather:      Coding: **PACP 7.0**  
 Pipe Length (ft): **333.0**      Owner: **City of Hobart**      Pre Clean: **Heavy Cleaning**  
 P.O.#: **YES502259**      Surveyor: **S. Bucklin**      PSR: **P-405-035-031**  
 Customer: **City of Hobart**      Clean Date: **10/13/2023**      Shape: **C**

Street: **SOFTWOOD DR**      Flow Control: **Not Controlled**  
 City: **Hobart, IN**      Year Renewed:  
 Location: **Easement/Right of Way**      Tape/Media #:  
 Purpose: **Routine Assessment**      Dia/Height: **8"**  
 Use: **Sanitary Sewage Pipe**      Material: **VCP**  
 Drain Area:      Lining: **None**  
 Category: **NA**  
 Comment:  
 Location Details:      Direction of Survey: **Downstream**  
 US MH: **M-405-031**      DS MH: **M-405-035**      Total Length Surveyed (ft): **327.9**

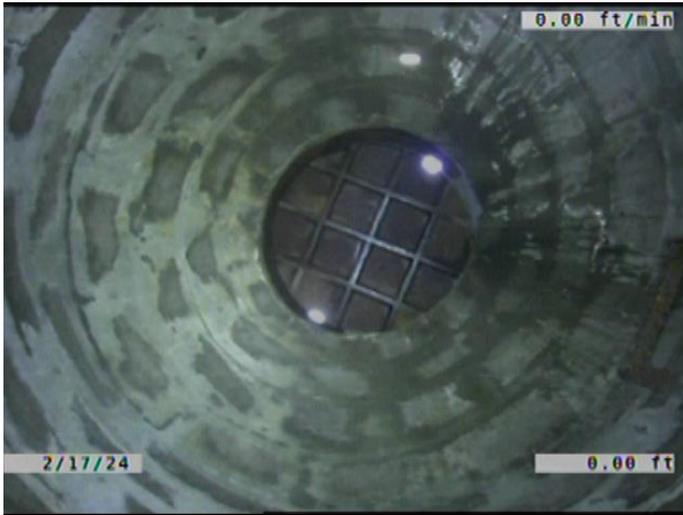
Code: **AMH**  
Description: **Manhole**

Distance (ft): **.0**  
Structural Grade: **0**  
O&M Grade: **0**  
Clock Start/From:  
Clock To:  
1st Value:  
2nd Value:  
Value Percent:  
Continuous Index:  
Within 8" of Joint: **NO**  
Remarks: **M-405-031**

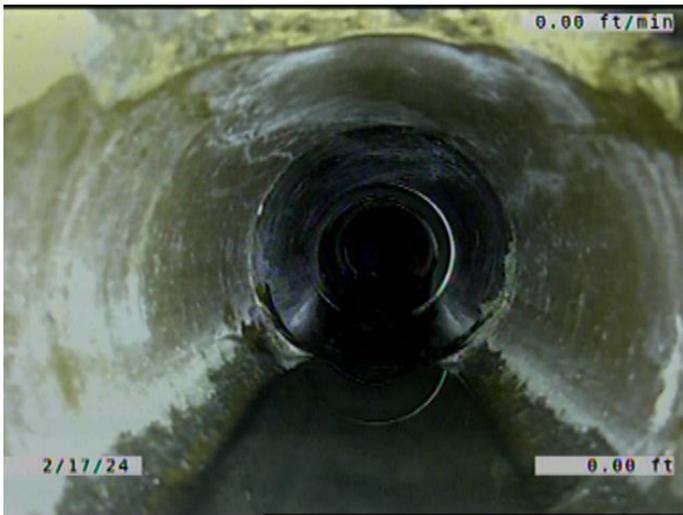
Code: **MWL**  
Description: **Miscellaneous Water Level**

Distance (ft): **.0**  
Structural Grade: **0**  
O&M Grade: **0**  
Clock Start/From:  
Clock To:  
1st Value:  
2nd Value:  
Value Percent: **5.000**  
Continuous Index:  
Within 8" of Joint: **NO**  
Remarks:

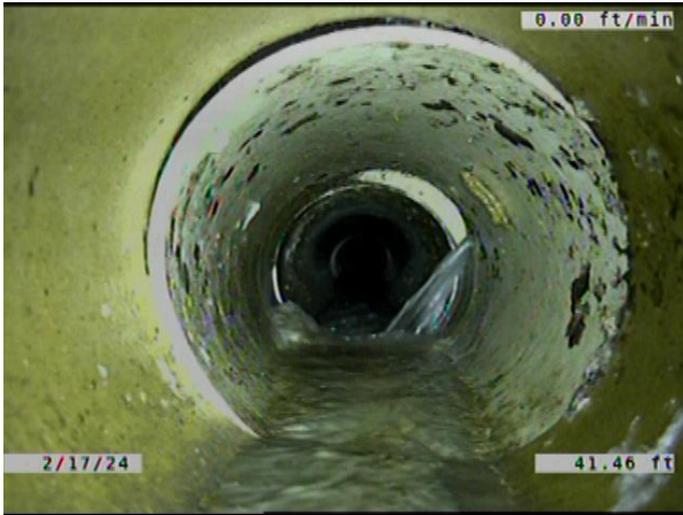
Code: **JOM**  
Description: **Joint Offset Medium**

Distance (ft): **41.5**  
Structural Grade: **3**  
O&M Grade: **0**  
Clock Start/From:  
Clock To:  
1st Value:  
2nd Value:  
Value Percent:  
Continuous Index:  
Within 8" of Joint: **NO**  
Remarks:

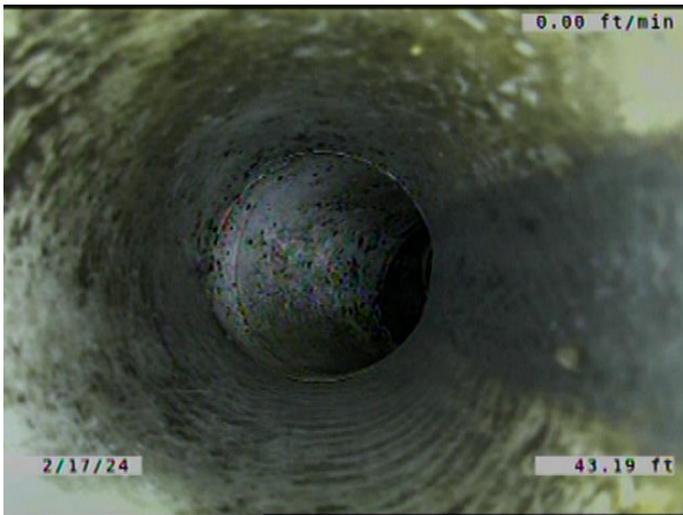
Code: **TFA**  
Description: **Tap Factory Activity**

Distance (ft): **43.2**  
Structural Grade: **0**  
O&M Grade: **0**  
Clock Start/From: **1**  
Clock To:  
1st Value: **6.000**  
2nd Value:  
Value Percent:  
Continuous Index:  
Within 8" of Joint: **YES**  
Remarks:

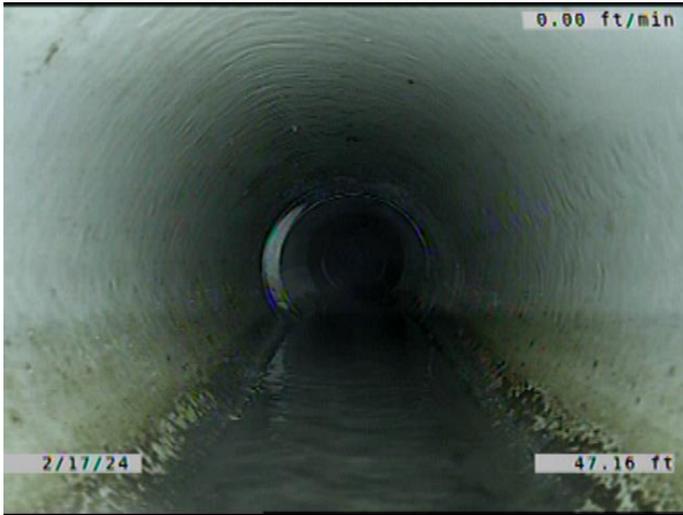
Code: **MWLS**  
 Description: **Miscellaneous Water Level Sag**

Distance (ft): **47.2**  
 Structural Grade: **2**  
 O&M Grade: **0**  
 Clock Start/From:  
 Clock To:  
 1st Value:  
 2nd Value:  
 Value Percent: **10.000**  
 Continuous Index: **S05**  
 Within 8" of Joint: **NO**  
 Remarks:

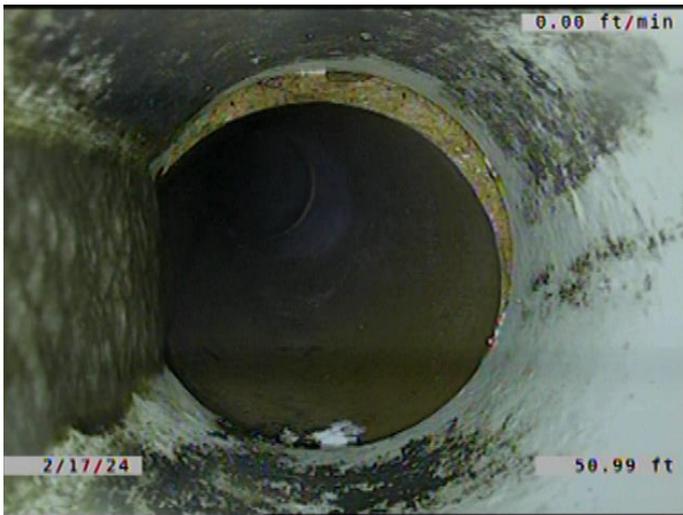
Code: **TF**  
 Description: **Tap Factory**

Distance (ft): **51.0**  
 Structural Grade: **0**  
 O&M Grade: **0**  
 Clock Start/From: **9**  
 Clock To:  
 1st Value: **6.000**  
 2nd Value:  
 Value Percent:  
 Continuous Index:  
 Within 8" of Joint: **YES**  
 Remarks: **PVC T. SERVICE IS VCP. CONSTANTLY RUNNING WATER.**

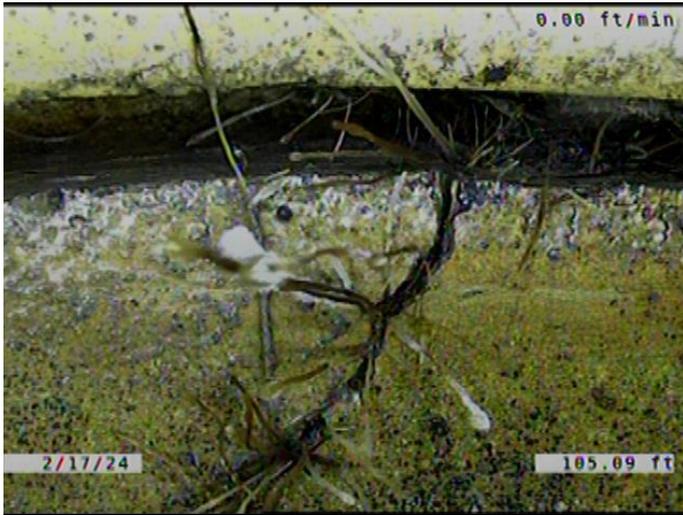
Code: **RFJ**  
 Description: **Roots Fine Joint**

Distance (ft): **105.1**  
 Structural Grade: **0**  
 O&M Grade: **1**  
 Clock Start/From: **7**  
 Clock To: **5**  
 1st Value:  
 2nd Value:  
 Value Percent:  
 Continuous Index: **S09**  
 Within 8" of Joint: **YES**  
 Remarks:

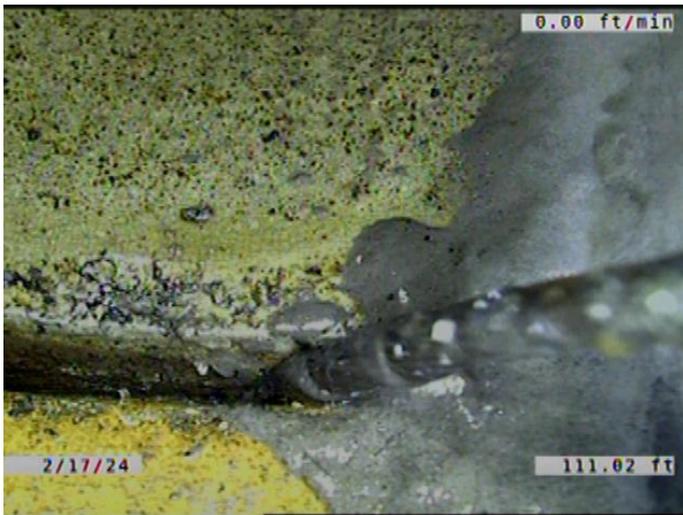
Code: **OBJ**  
 Description: **Obstruction Wedged In The Joint**

Distance (ft): **111.0**  
 Structural Grade: **0**  
 O&M Grade: **2**  
 Clock Start/From: **8**  
 Clock To: **3**  
 1st Value:  
 2nd Value:  
 Value Percent: **5.000**  
 Continuous Index:  
 Within 8" of Joint: **YES**  
 Remarks: **STICK**

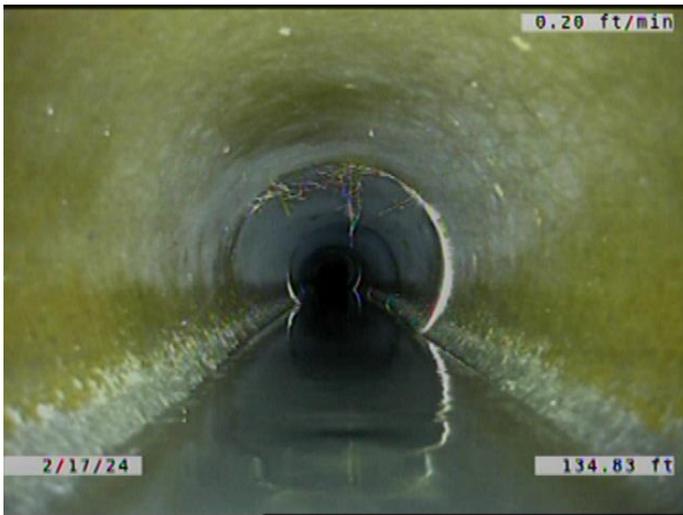
Code: **MWLS**  
Description: **Miscellaneous Water Level Sag**

Distance (ft): **134.8**  
Structural Grade: **2**  
O&M Grade: **0**  
Clock Start/From:  
Clock To:  
1st Value:  
2nd Value:  
Value Percent: **10.000**  
Continuous Index: **S11**  
Within 8" of Joint: **NO**  
Remarks:

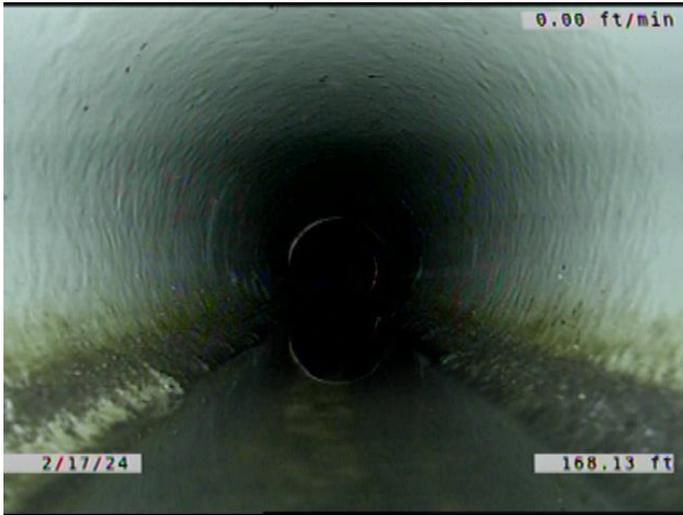
Code: **RFJ**  
Description: **Roots Fine Joint**

Distance (ft): **168.1**  
Structural Grade: **0**  
O&M Grade: **1**  
Clock Start/From: **7**  
Clock To: **5**  
1st Value:  
2nd Value:  
Value Percent:  
Continuous Index: **F09**  
Within 8" of Joint: **YES**  
Remarks:

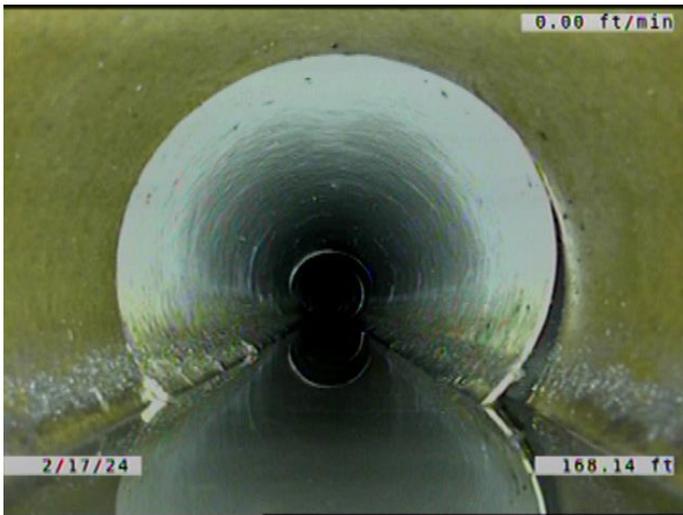
Code: **JOM**  
Description: **Joint Offset Medium**

Distance (ft): **168.1**  
Structural Grade: **3**  
O&M Grade: **0**  
Clock Start/From:  
Clock To:  
1st Value:  
2nd Value:  
Value Percent:  
Continuous Index:  
Within 8" of Joint: **NO**  
Remarks:

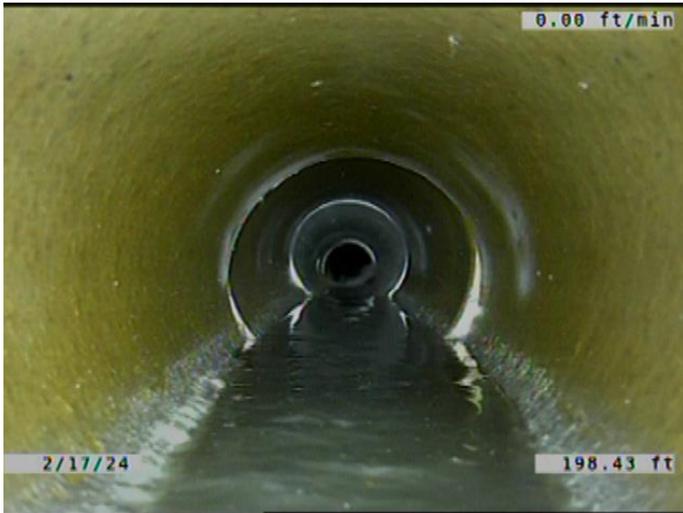
Code: **MWLS**  
 Description: **Miscellaneous Water Level Sag**

Distance (ft): **198.4**  
 Structural Grade: **2**  
 O&M Grade: **0**  
 Clock Start/From:  
 Clock To:  
 1st Value:  
 2nd Value:  
 Value Percent: **10.000**  
 Continuous Index: **S15**  
 Within 8" of Joint: **NO**  
 Remarks:

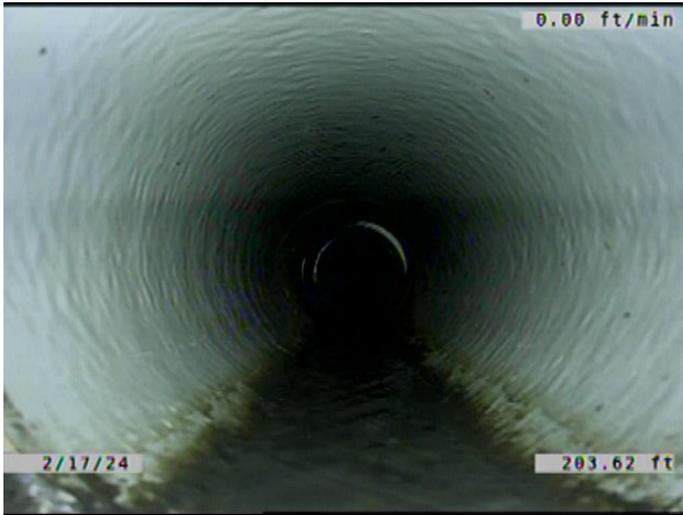
Code: **MWLS**  
Description: **Miscellaneous Water Level Sag**

Distance (ft): **203.6**  
Structural Grade: **2**  
O&M Grade: **0**  
Clock Start/From:  
Clock To:  
1st Value:  
2nd Value:  
Value Percent: **10.000**  
Continuous Index: **F15**  
Within 8" of Joint: **NO**  
Remarks:

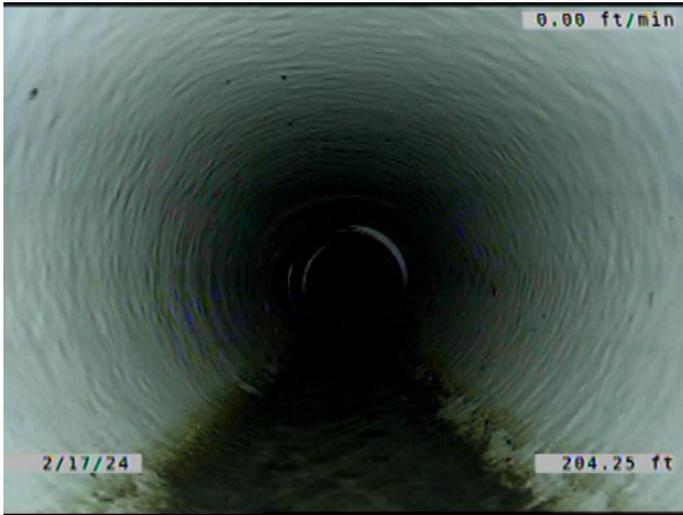
Code: **DAE**  
Description: **Deposits Attached Encrustation**

Distance (ft): **204.2**  
Structural Grade: **0**  
O&M Grade: **2**  
Clock Start/From: **7**  
Clock To: **5**  
1st Value:  
2nd Value:  
Value Percent: **5.000**  
Continuous Index: **F14**  
Within 8" of Joint: **NO**  
Remarks:

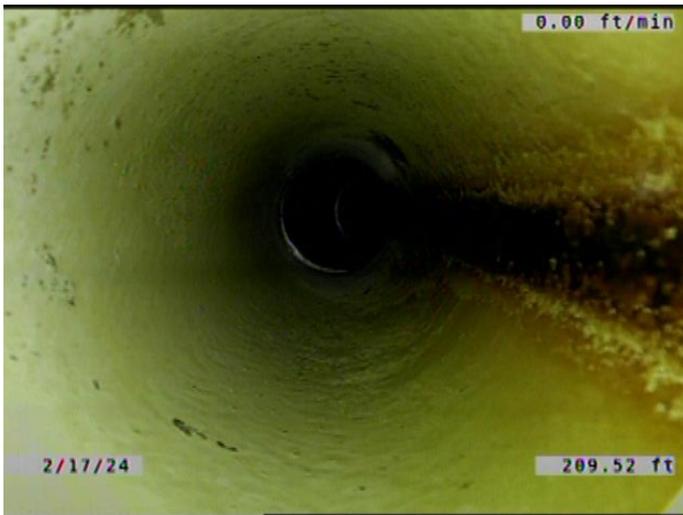
Code: **TFA**  
Description: **Tap Factory Activity**

Distance (ft): **209.5**  
Structural Grade: **0**  
O&M Grade: **0**  
Clock Start/From: **2**  
Clock To:  
1st Value: **6.000**  
2nd Value:  
Value Percent:  
Continuous Index:  
Within 8" of Joint: **YES**  
Remarks:

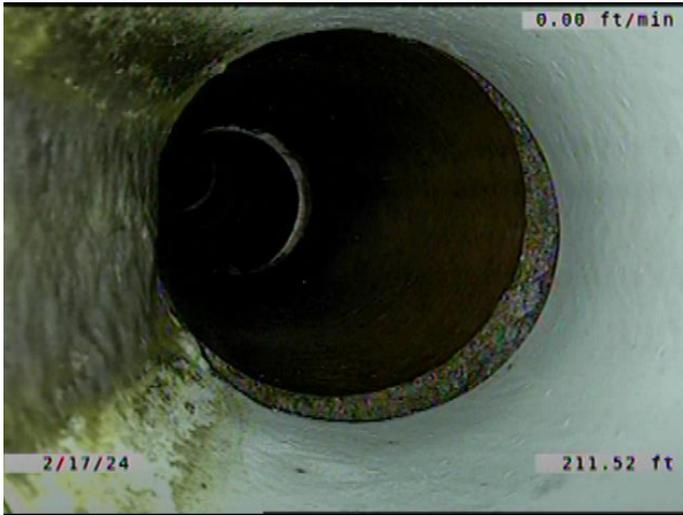
Code: **TF**  
 Description: **Tap Factory**

Distance (ft): **211.5**  
 Structural Grade: **0**  
 O&M Grade: **0**  
 Clock Start/From: **10**  
 Clock To:  
 1st Value: **6.000**  
 2nd Value:  
 Value Percent:  
 Continuous Index:

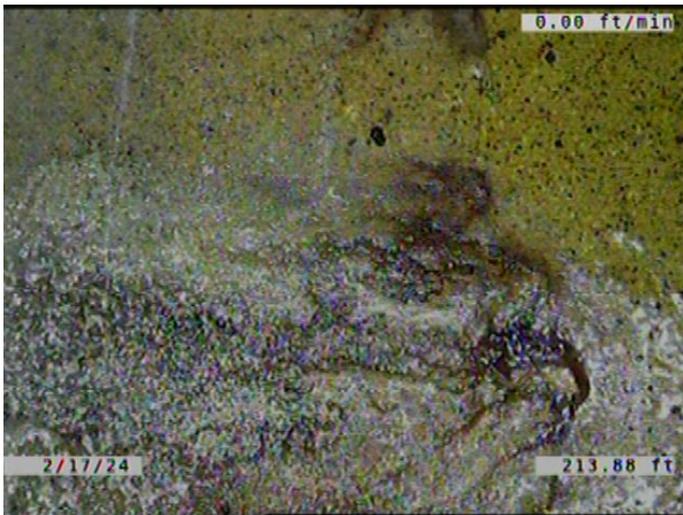
Code: **DAE**  
Description: **Deposits Attached Encrustation**

Distance (ft): **213.9**  
Structural Grade: **0**  
O&M Grade: **2**  
Clock Start/From: **3**  
Clock To: **5**  
1st Value:  
2nd Value:  
Value Percent: **5.000**  
Continuous Index:  
Within 8" of Joint: **YES**  
Remarks:

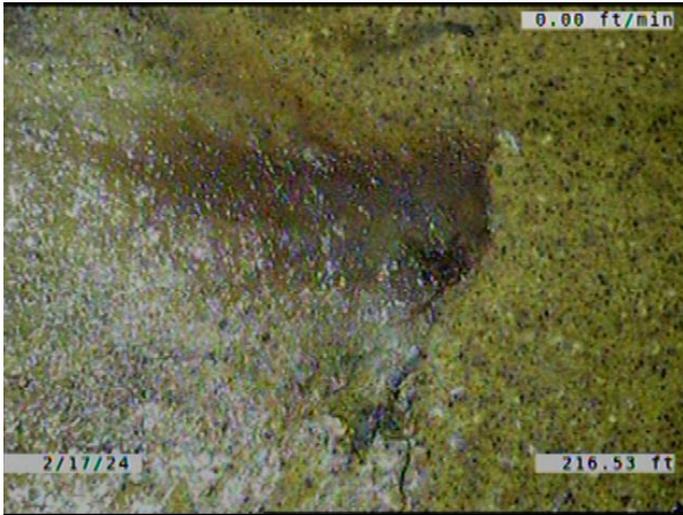
Code: **DAE**  
Description: **Deposits Attached Encrustation**

Distance (ft): **216.5**  
Structural Grade: **0**  
O&M Grade: **2**  
Clock Start/From: **3**  
Clock To: **5**  
1st Value:  
2nd Value:  
Value Percent: **5.000**  
Continuous Index:  
Within 8" of Joint: **YES**  
Remarks:

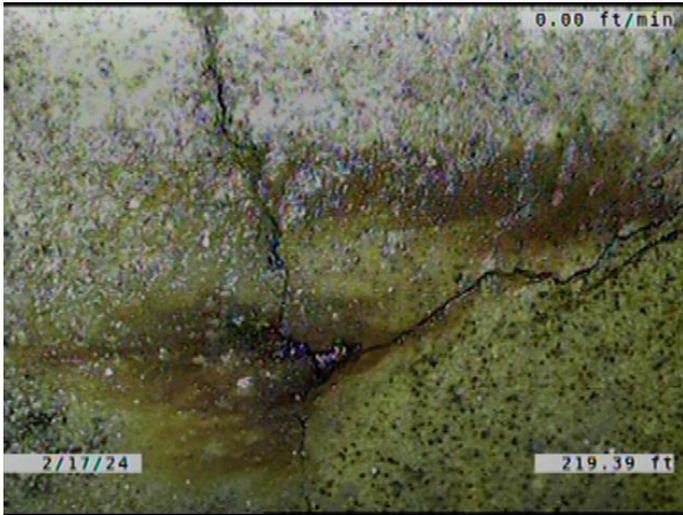
Code: **DAE**  
Description: **Deposits Attached Encrustation**

Distance (ft): **219.4**  
Structural Grade: **0**  
O&M Grade: **2**  
Clock Start/From: **7**  
Clock To: **9**  
1st Value:  
2nd Value:  
Value Percent: **5.000**  
Continuous Index:  
Within 8" of Joint: **YES**  
Remarks:

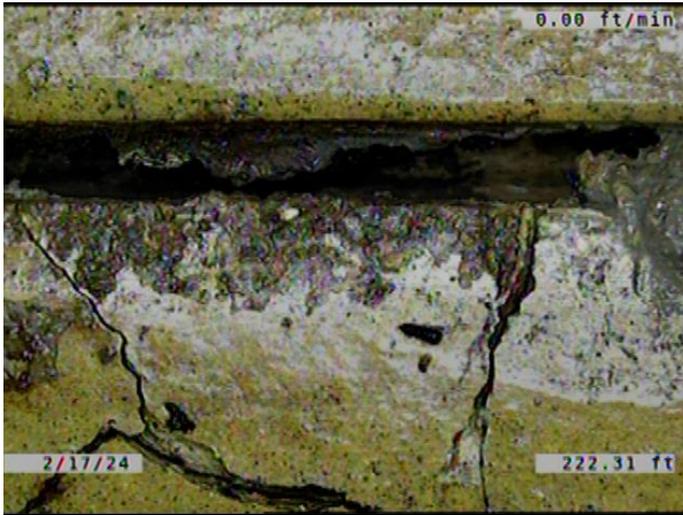
Code: **DAE**  
 Description: **Deposits Attached Encrustation**

Distance (ft): **222.3**  
 Structural Grade: **0**  
 O&M Grade: **2**  
 Clock Start/From: **7**  
 Clock To: **5**  
 1st Value:  
 2nd Value:  
 Value Percent: **5.000**  
 Continuous Index: **S17**  
 Within 8" of Joint: **NO**  
 Remarks:

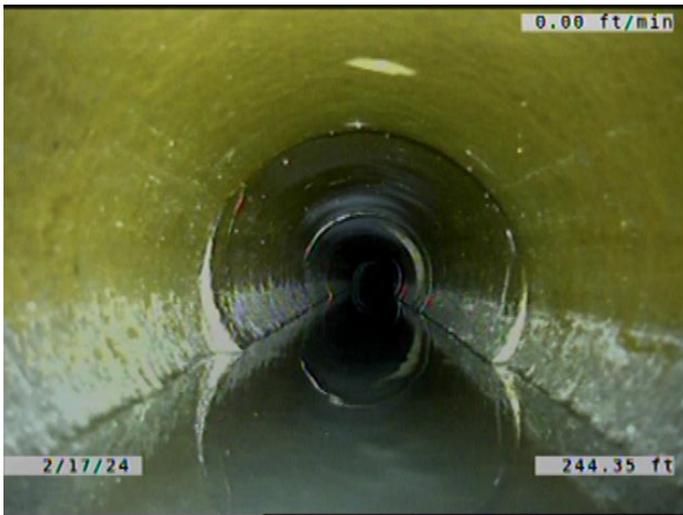
Code: **MWLS**  
Description: **Miscellaneous Water Level Sag**

Distance (ft): **244.3**  
Structural Grade: **2**  
O&M Grade: **0**  
Clock Start/From:  
Clock To:  
1st Value:  
2nd Value:  
Value Percent: **15.000**  
Continuous Index: **S19**  
Within 8" of Joint: **NO**  
Remarks:

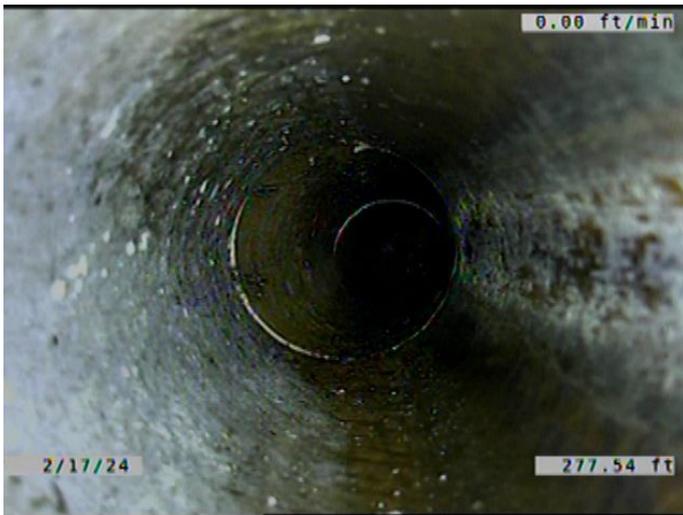
Code: **TBI**  
 Description: **Tap Break-in Intruding**

Distance (ft): **277.5**  
 Structural Grade: **0**  
 O&M Grade: **2**  
 Clock Start/From: **2**  
 Clock To:  
 1st Value: **6.000**  
 2nd Value: **3.000**  
 Value Percent:  
 Continuous Index:  
 Within 8" of Joint: **YES**  
 Remarks: **ROOTS GROWING IN THE JOINTS.  
 AND AT THE SERVICE TO MAIN CON**

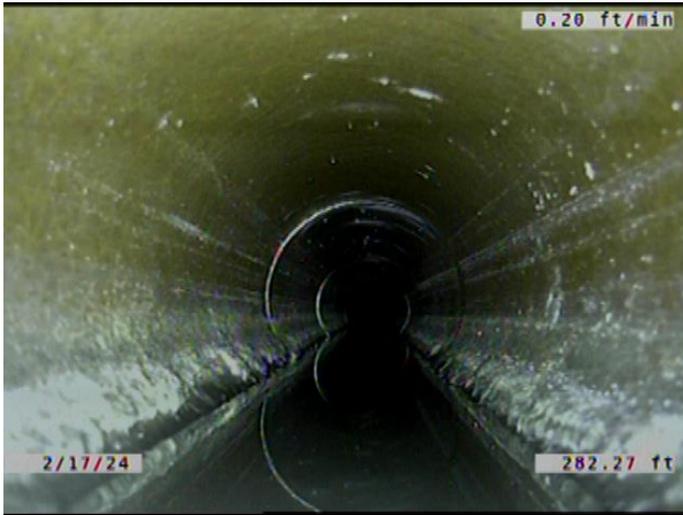
Code: **DAGS**  
Description: **Deposits Attached Grease**

Distance (ft): **282.3**  
Structural Grade: **0**  
O&M Grade: **2**  
Clock Start/From: **4**  
Clock To: **8**  
1st Value:  
2nd Value:  
Value Percent: **5.000**  
Continuous Index: **S20**  
Within 8" of Joint: **YES**  
Remarks:

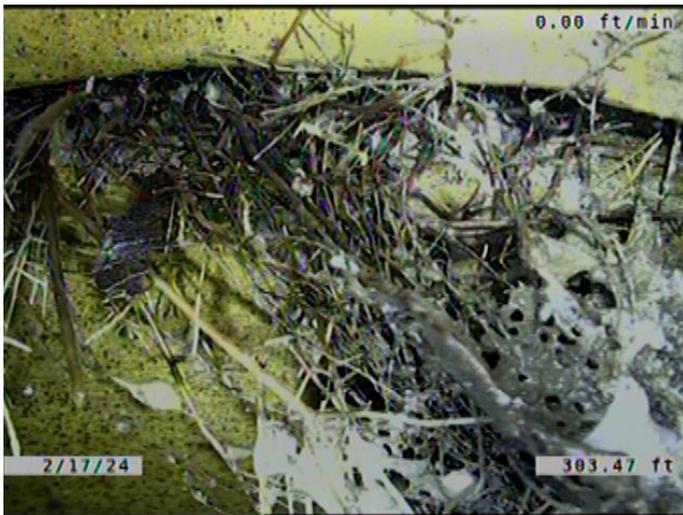
Code: **RMJ**  
Description: **Roots Medium Joint**

Distance (ft): **303.5**  
Structural Grade: **0**  
O&M Grade: **3**  
Clock Start/From: **8**  
Clock To: **4**  
1st Value:  
2nd Value:  
Value Percent: **5.000**  
Continuous Index:  
Within 8" of Joint: **YES**  
Remarks:

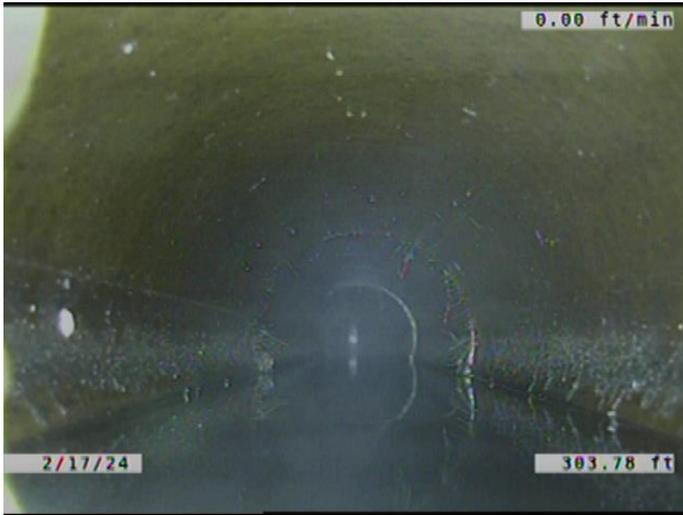
Code: **DAGS**  
Description: **Deposits Attached Grease**

Distance (ft): **303.8**  
Structural Grade: **0**  
O&M Grade: **2**  
Clock Start/From: **4**  
Clock To: **8**  
1st Value:  
2nd Value:  
Value Percent: **5.000**  
Continuous Index: **F20**  
Within 8" of Joint: **YES**  
Remarks:

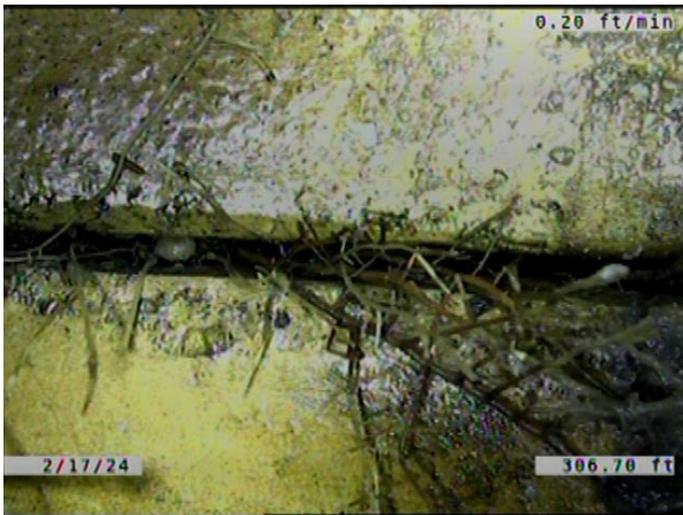
Code: **RFJ**  
Description: **Roots Fine Joint**

Distance (ft): **306.7**  
Structural Grade: **0**  
O&M Grade: **1**  
Clock Start/From: **8**  
Clock To: **4**  
1st Value:  
2nd Value:  
Value Percent:  
Continuous Index: **S21**  
Within 8" of Joint: **YES**  
Remarks:

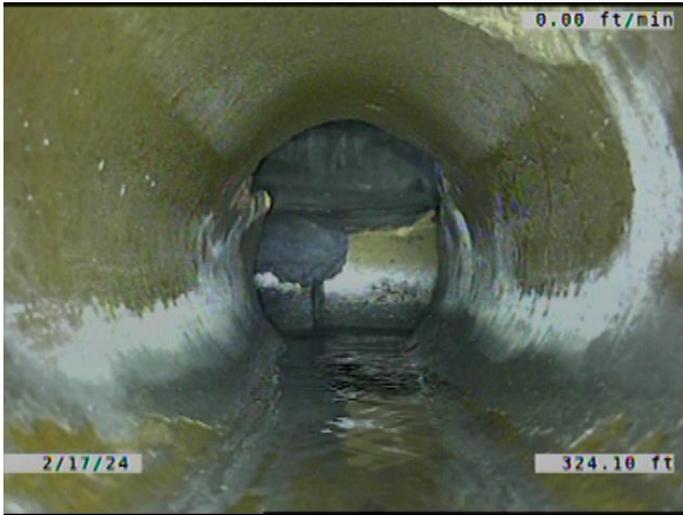
Code: **MWLS**  
 Description: **Miscellaneous Water Level Sag**

Distance (ft): **324.1**  
 Structural Grade: **2**  
 O&M Grade: **0**  
 Clock Start/From:  
 Clock To:  
 1st Value:  
 2nd Value:  
 Value Percent: **15.000**  
 Continuous Index: **F19**  
 Within 8" of Joint: **NO**  
 Remarks:

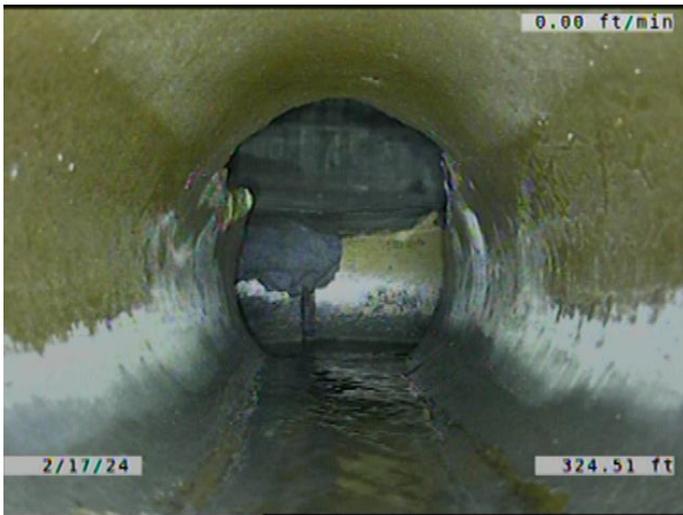
Code: **RFJ**  
 Description: **Roots Fine Joint**

Distance (ft): **324.4**  
 Structural Grade: **0**  
 O&M Grade: **1**  
 Clock Start/From: **8**  
 Clock To: **4**  
 1st Value:  
 2nd Value:  
 Value Percent:  
 Continuous Index: **F21**  
 Within 8" of Joint: **YES**  
 Remarks:

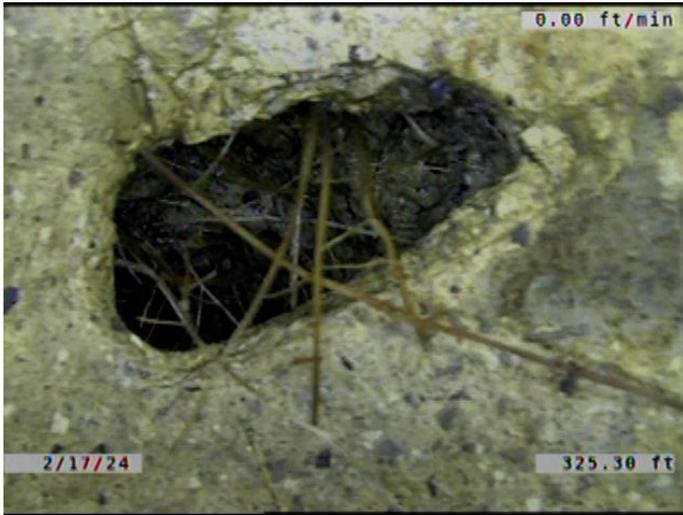
Code: **HSV**  
 Description: **Hole Soil Visible**

Distance (ft): **325.3**  
 Structural Grade: **5**  
 O&M Grade: **0**  
 Clock Start/From: **1**  
 Clock To:  
 1st Value:  
 2nd Value:  
 Value Percent:  
 Continuous Index:  
 Within 8" of Joint: **YES**

Remarks: **ROOTS GROWING IN THE HOLE.**

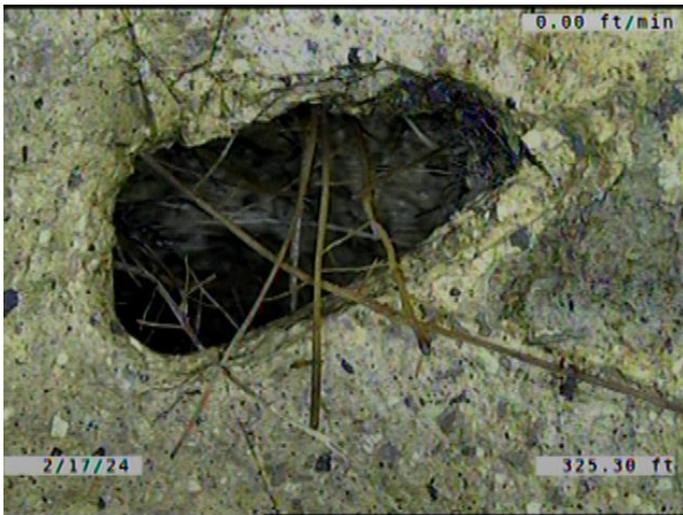
Code: **RFB**  
 Description: **Roots Fine Barrel**

Distance (ft): **325.3**  
 Structural Grade: **0**  
 O&M Grade: **2**  
 Clock Start/From: **1**  
 Clock To:  
 1st Value:  
 2nd Value:  
 Value Percent:  
 Continuous Index:  
 Within 8" of Joint: **NO**

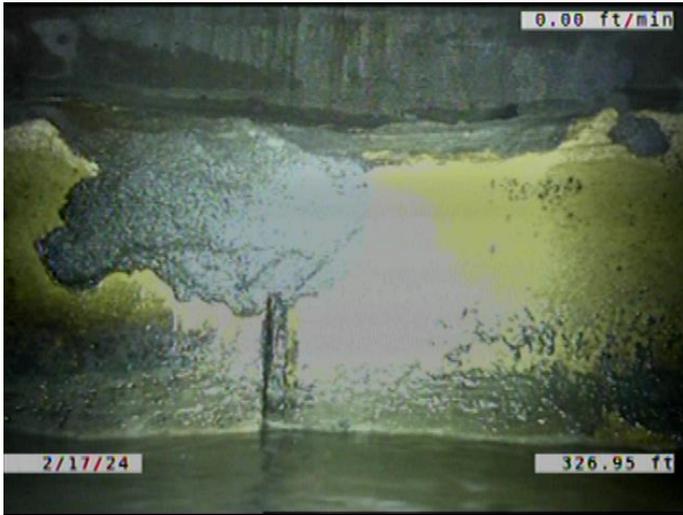
Code: **DAE**  
 Description: **Deposits Attached Encrustation**

Distance (ft): **326.9**  
 Structural Grade: **0**  
 O&M Grade: **2**  
 Clock Start/From: **7**  
 Clock To: **5**  
 1st Value:  
 2nd Value:  
 Value Percent: **5.000**  
 Continuous Index: **F17**  
 Within 8" of Joint: **NO**  
 Remarks:

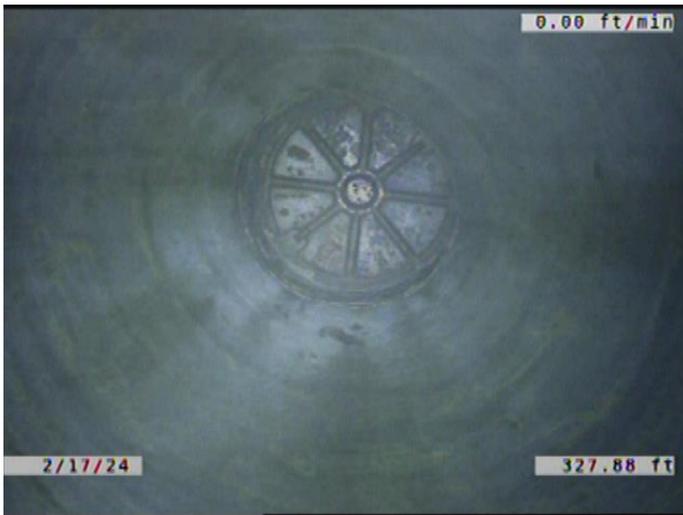
Code: **AMH**  
 Description: **Manhole**

Distance (ft): **327.9**  
 Structural Grade: **0**  
 O&M Grade: **0**  
 Clock Start/From:  
 Clock To:  
 1st Value:  
 2nd Value:  
 Value Percent:  
 Continuous Index:  
 Within 8" of Joint: **NO**  
 Remarks: **M-405-035**
