Profile/Photo Observation Report

Date:	02/17/2024	Weather:		Coding:	PACP 7.0
Pipe Length (ft):	319.0	Owner:	City of Hobart	Pre Clean:	Heavy Cleaning
P.O.#:	YES502259	Surveyor:	S. Bucklin	PSR:	P-405-036-035
Customer:	City of Hobart	Clean Date:	10/06/2023	Shape:	C

Street:	SOFTWOOD DR	Flow Control:	Not Controlled
City:	Hobart, IN	Year Renewed:	
Location:	Easement/Right of Way	Tape/Media #:	
Purpose:	Routine Assessment	Dia/Height:	8"
Use:	Sanitary Sewage Pipe	Material:	VCP
Drain Area:		Lining:	None
Category:	NA		
Comment:			
Location Details:		Direction of Survey:	Downstream
US MH:	M-405-035	DS MH:	M-405-036
		Total Length Surveyed (ft):	318.5

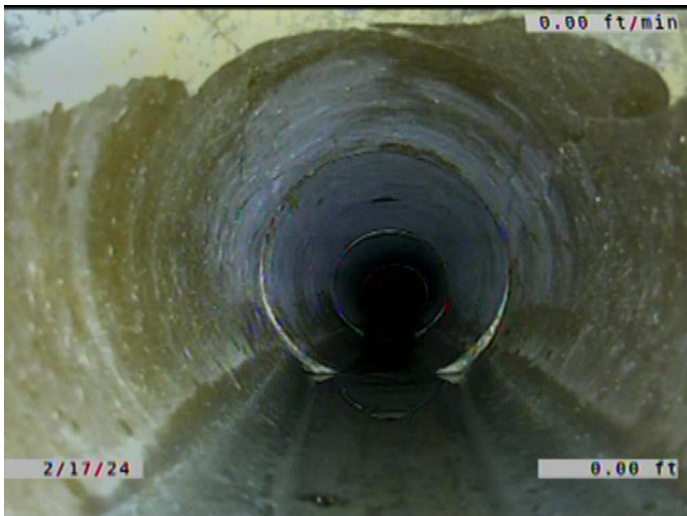
Code: **AMH**
Description: **Manhole**

Distance (ft): **.0**
Structural Grade: **0**
O&M Grade: **0**
Clock Start/From:
Clock To:
1st Value:
2nd Value:
Value Percent:
Continuous Index:
Within 8" of Joint: **NO**
Remarks: **M-405-035**

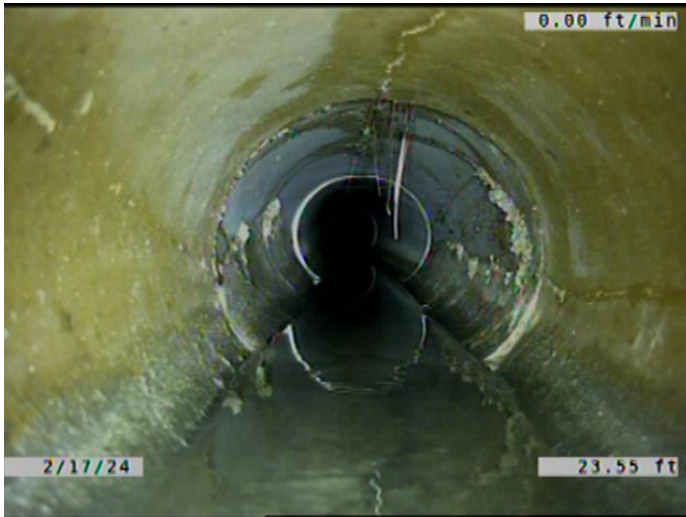
Code: **MWLS**
Description: **Miscellaneous Water Level Sag**

Distance (ft): **23.6**
Structural Grade: **2**
O&M Grade: **0**
Clock Start/From:
Clock To:
1st Value:
2nd Value:
Value Percent: **10.000**
Continuous Index: **S06**
Within 8" of Joint: **NO**
Remarks:

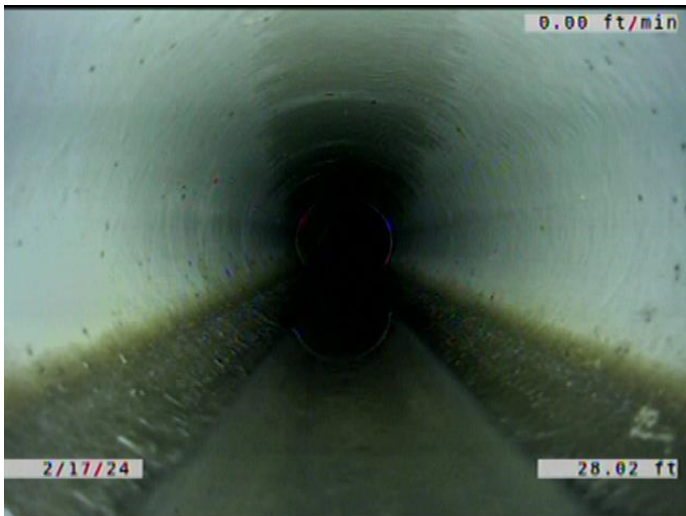
Code: **RFB**
Description: **Roots Fine Barrel**

Distance (ft): **28.0**
Structural Grade: **0**
O&M Grade: **2**
Clock Start/From: **8**
Clock To: **4**
1st Value:
2nd Value:
Value Percent:
Continuous Index: **F05**
Within 8" of Joint: **NO**
Remarks:

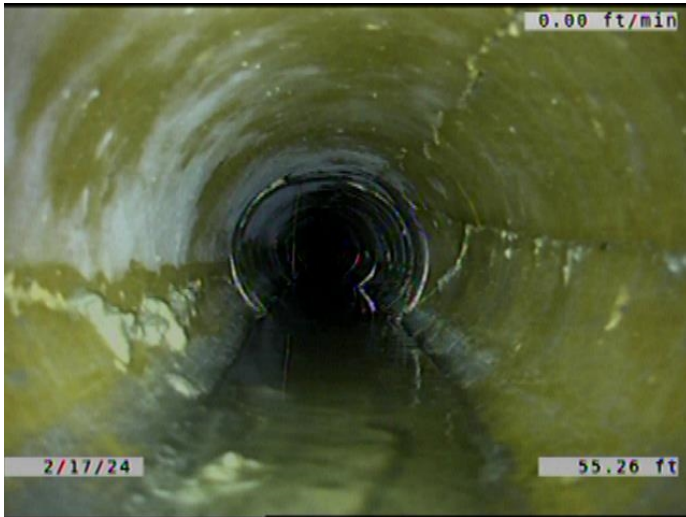
Code: **MWLS**
Description: **Miscellaneous Water Level Sag**

Distance (ft): **55.3**
Structural Grade: **2**
O&M Grade: **0**
Clock Start/From:
Clock To:
1st Value:
2nd Value:
Value Percent: **10.000**
Continuous Index: **S10**
Within 8" of Joint: **NO**
Remarks:

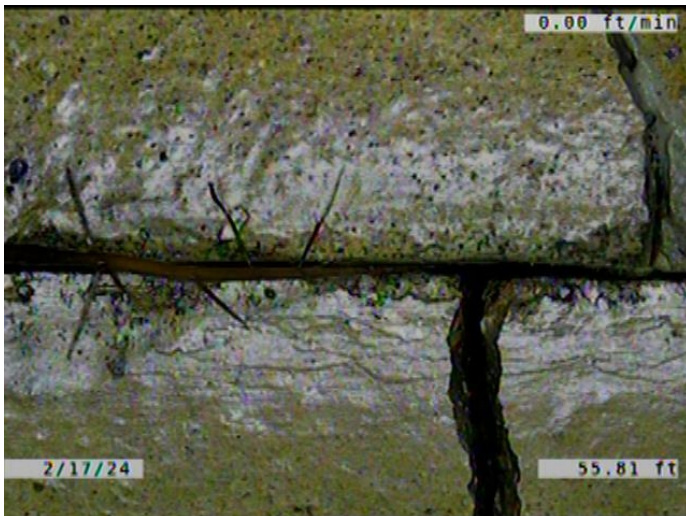
Code: **RFJ**
Description: **Roots Fine Joint**

Distance (ft): **55.8**
Structural Grade: **0**
O&M Grade: **1**
Clock Start/From: **12**
Clock To: **3**
1st Value:
2nd Value:
Value Percent:
Continuous Index:
Within 8" of Joint: **YES**
Remarks:

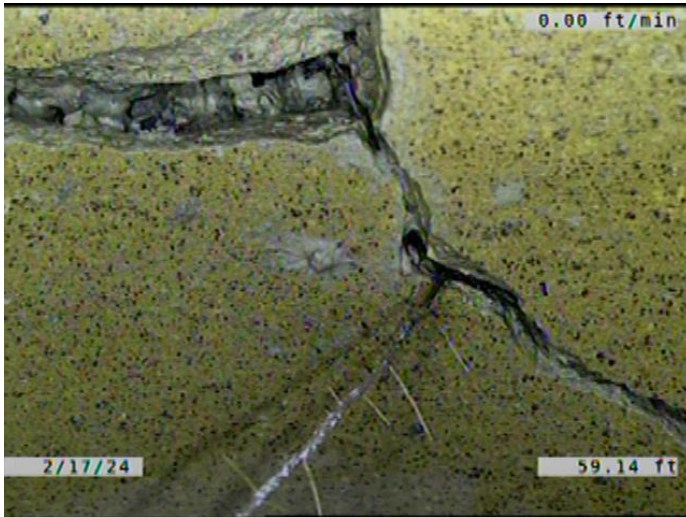
Code: **RFB**
 Description: **Roots Fine Barrel**

Distance (ft): **59.1**
 Structural Grade: **0**
 O&M Grade: **2**
 Clock Start/From: **11**
 Clock To: **12**
 1st Value:
 2nd Value:
 Value Percent:
 Continuous Index:
 Within 8" of Joint: **NO**
 Remarks:

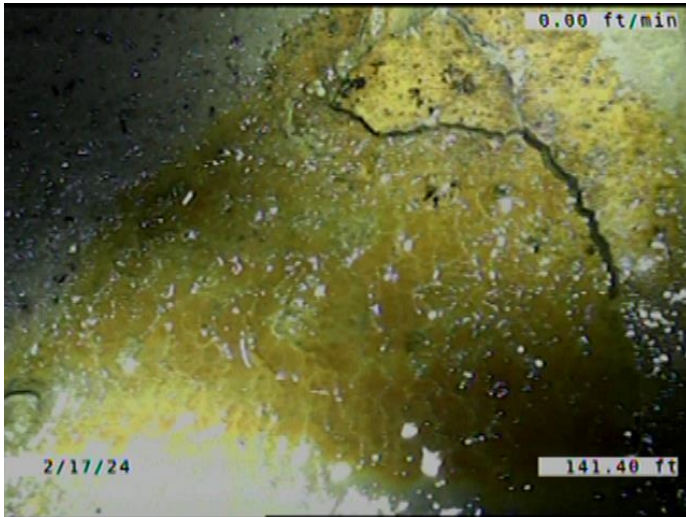
Code: **DAE**
Description: **Deposits Attached Encrustation**

Distance (ft): **141.4**
Structural Grade: **0**
O&M Grade: **2**
Clock Start/From: **7**
Clock To: **10**
1st Value:
2nd Value:
Value Percent: **5.000**
Continuous Index:
Within 8" of Joint: **YES**
Remarks:

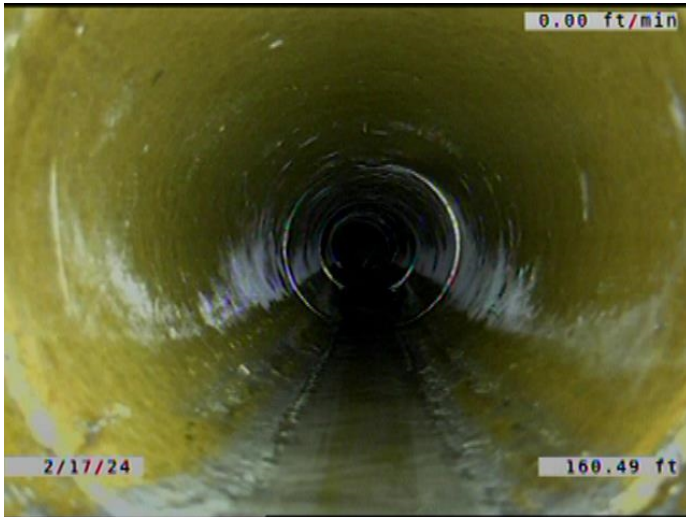
Code: **MWLS**
Description: **Miscellaneous Water Level Sag**

Distance (ft): **160.5**
Structural Grade: **2**
O&M Grade: **0**
Clock Start/From:
Clock To:
1st Value:
2nd Value:
Value Percent: **5.000**
Continuous Index: **F16**
Within 8" of Joint: **NO**
Remarks:

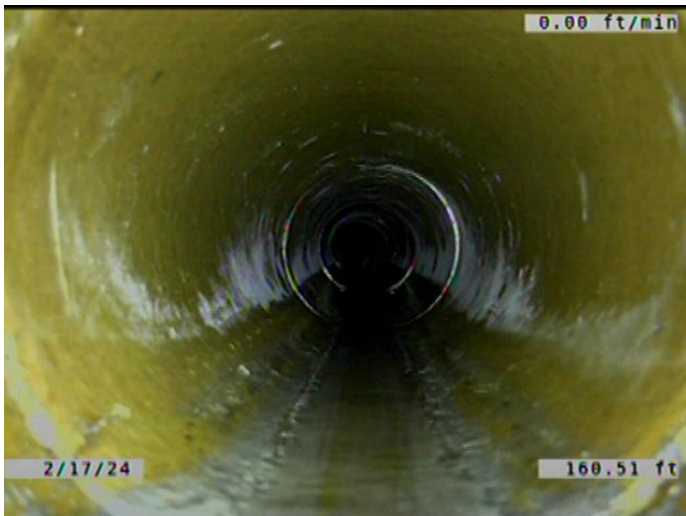
Code: **RFJ**
Description: **Roots Fine Joint**

Distance (ft): **160.5**
Structural Grade: **0**
O&M Grade: **1**
Clock Start/From: **7**
Clock To: **5**
1st Value:
2nd Value:
Value Percent:
Continuous Index: **F14**
Within 8" of Joint: **YES**
Remarks:

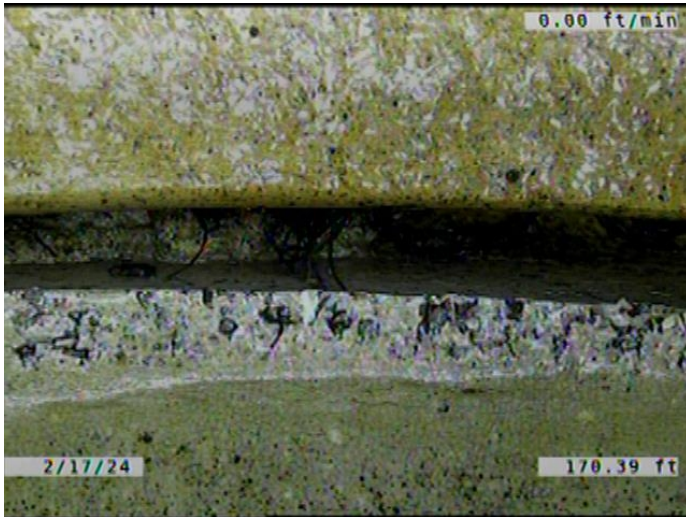
Code: **RFJ**
Description: **Roots Fine Joint**

Distance (ft): **170.4**
Structural Grade: **0**
O&M Grade: **1**
Clock Start/From: **7**
Clock To: **5**
1st Value:
2nd Value:
Value Percent:
Continuous Index: **S17**
Within 8" of Joint: **YES**
Remarks:

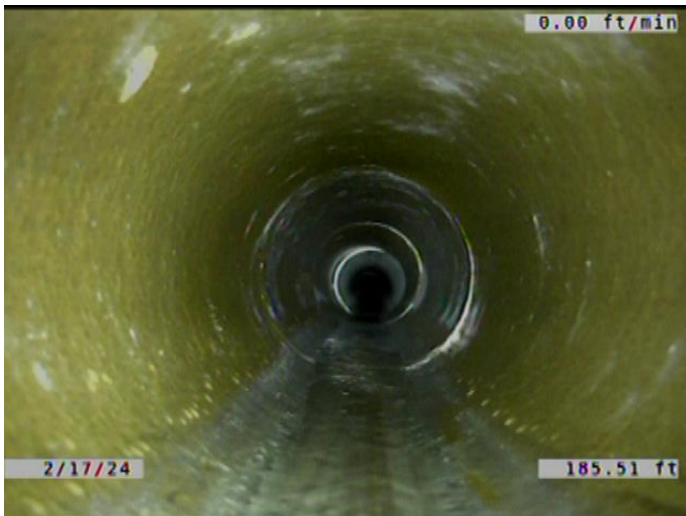
Code: **MWLS**
Description: **Miscellaneous Water Level Sag**

Distance (ft): **185.5**
Structural Grade: **2**
O&M Grade: **0**
Clock Start/From:
Clock To:
1st Value:
2nd Value:
Value Percent: **5.000**
Continuous Index: **F18**
Within 8" of Joint: **NO**
Remarks:

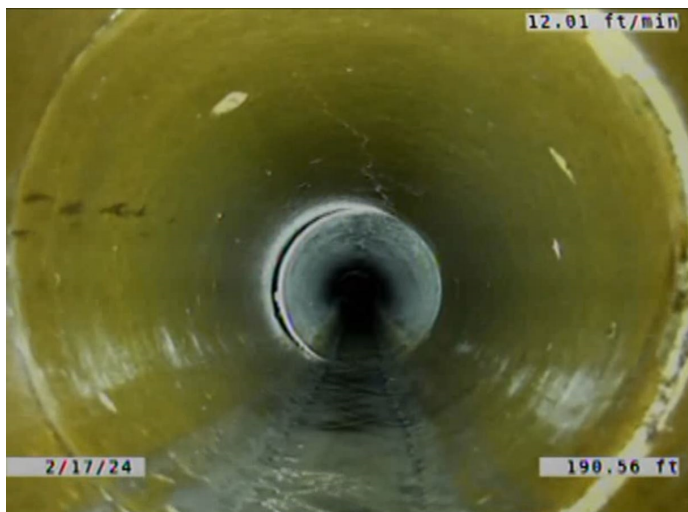
Code: **CM**
 Description: **Crack Multiple**

Distance (ft): **190.6**
 Structural Grade: **3**
 O&M Grade: **0**
 Clock Start/From: **8**
 Clock To: **4**
 1st Value:
 2nd Value:
 Value Percent:
 Continuous Index:
 Within 8" of Joint: **YES**
 Remarks:

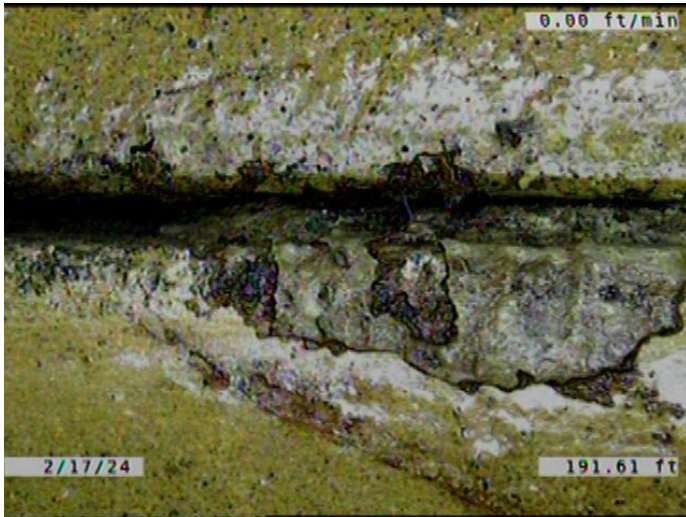
Code: **DAE**
Description: **Deposits Attached Encrustation**

Distance (ft): **191.6**
Structural Grade: **0**
O&M Grade: **2**
Clock Start/From: **1**
Clock To: **5**
1st Value:
2nd Value:
Value Percent: **5.000**
Continuous Index:
Within 8" of Joint: **YES**
Remarks:

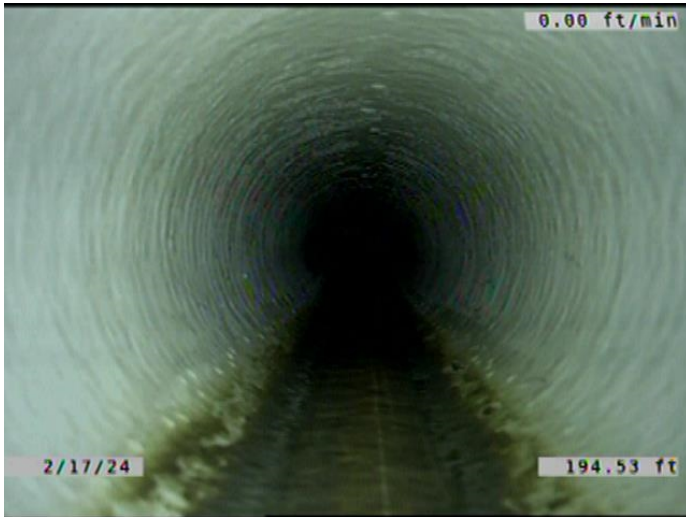
Code: **RFJ**
Description: **Roots Fine Joint**

Distance (ft): **194.5**
Structural Grade: **0**
O&M Grade: **1**
Clock Start/From: **7**
Clock To: **5**
1st Value:
2nd Value:
Value Percent:
Continuous Index: **F17**
Within 8" of Joint: **YES**
Remarks:

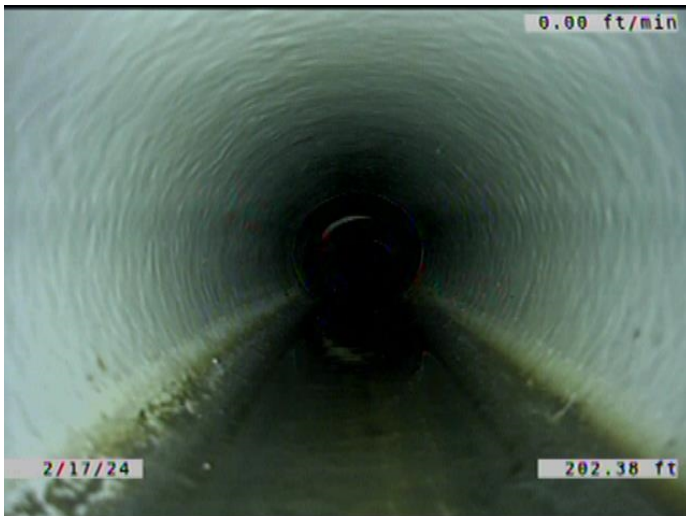
Code: **MWLS**
Description: **Miscellaneous Water Level Sag**

Distance (ft): **202.4**
Structural Grade: **2**
O&M Grade: **0**
Clock Start/From:
Clock To:
1st Value:
2nd Value:
Value Percent: **5.000**
Continuous Index:
Within 8" of Joint: **NO**
Remarks:

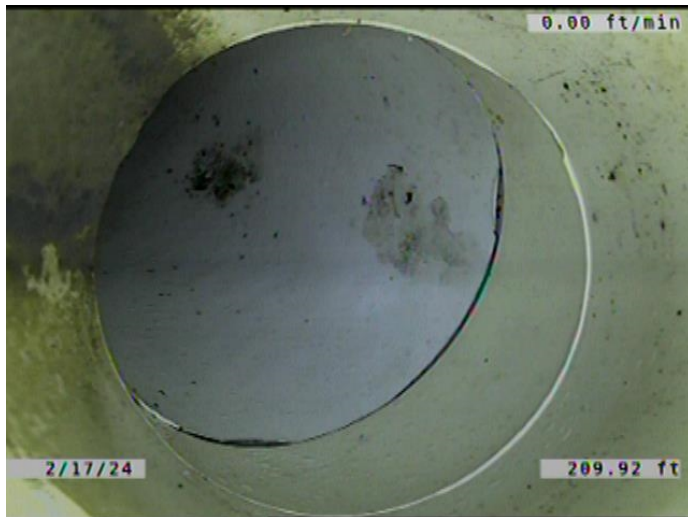
Code: **TF**
Description: **Tap Factory**

Distance (ft): **209.9**
Structural Grade: **0**
O&M Grade: **0**
Clock Start/From: **11**
Clock To:
1st Value: **6.000**
2nd Value:
Value Percent:
Continuous Index:
Within 8" of Joint: **YES**
Remarks: **CONSTANTLY RUNNING WATER.**

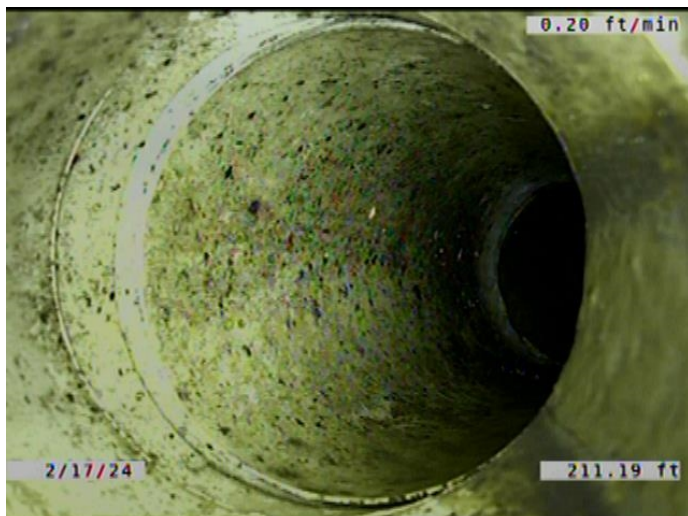
Code: **TF**
Description: **Tap Factory**

Distance (ft): **211.2**
Structural Grade: **0**
O&M Grade: **0**
Clock Start/From: **1**
Clock To:
1st Value: **6.000**
2nd Value:
Value Percent:
Continuous Index:
Within 8" of Joint: **YES**
Remarks: **PVC T. SERVICE IS VCP. CONSTANTLY RUNNING WATER.**

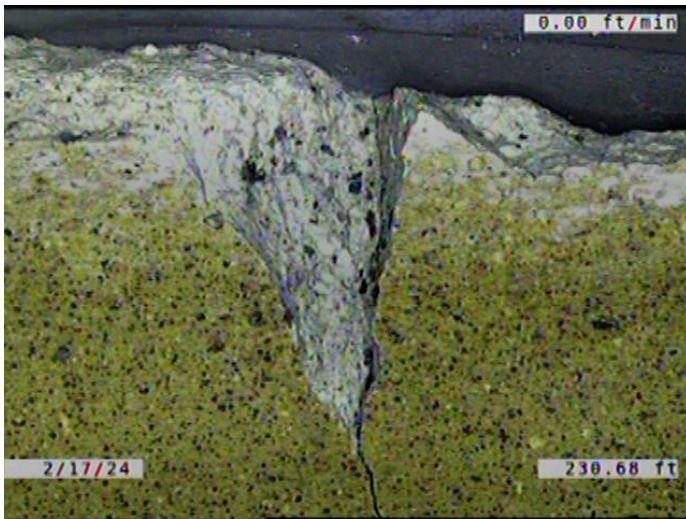
Code: **FM**
Description: **Fracture Multiple**

Distance (ft): **230.7**
Structural Grade: **4**
O&M Grade: **0**
Clock Start/From: **10**
Clock To: **3**
1st Value:
2nd Value:
Value Percent:
Continuous Index: **S20**
Within 8" of Joint: **YES**
Remarks:

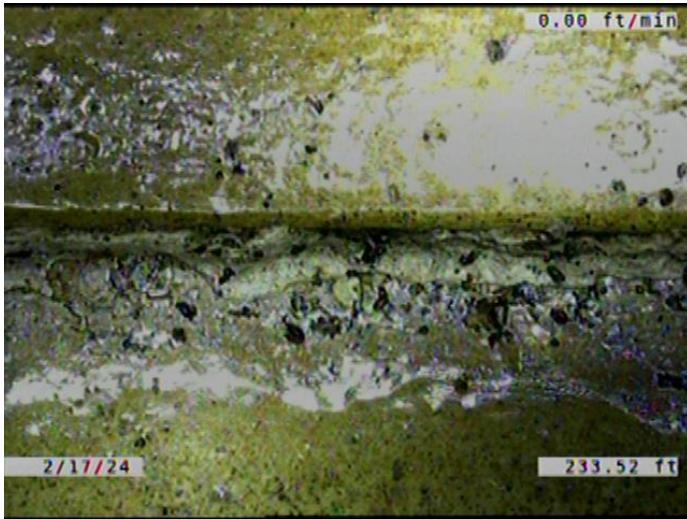
Code: **DAE**
Description: **Deposits Attached Encrustation**

Distance (ft): **233.5**
Structural Grade: **0**
O&M Grade: **2**
Clock Start/From: **7**
Clock To: **5**
1st Value:
2nd Value:
Value Percent: **5.000**
Continuous Index:
Within 8" of Joint: **YES**
Remarks:

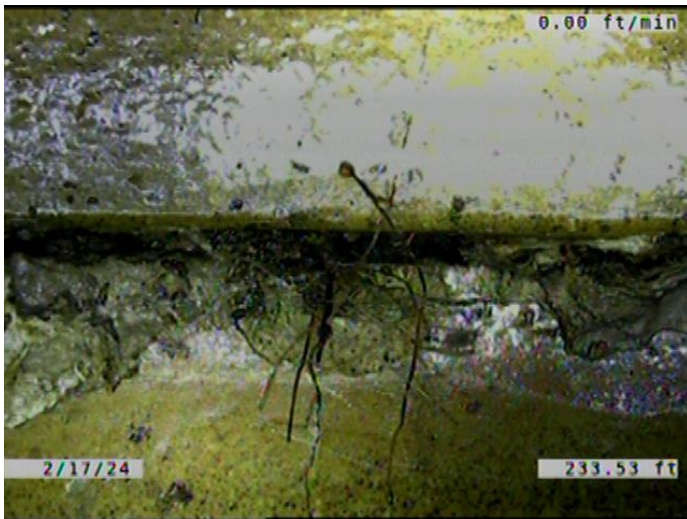
Code: **RFJ**
Description: **Roots Fine Joint**

Distance (ft): **233.5**
Structural Grade: **0**
O&M Grade: **1**
Clock Start/From: **10**
Clock To: **11**
1st Value:
2nd Value:
Value Percent:
Continuous Index:
Within 8" of Joint: **YES**
Remarks:

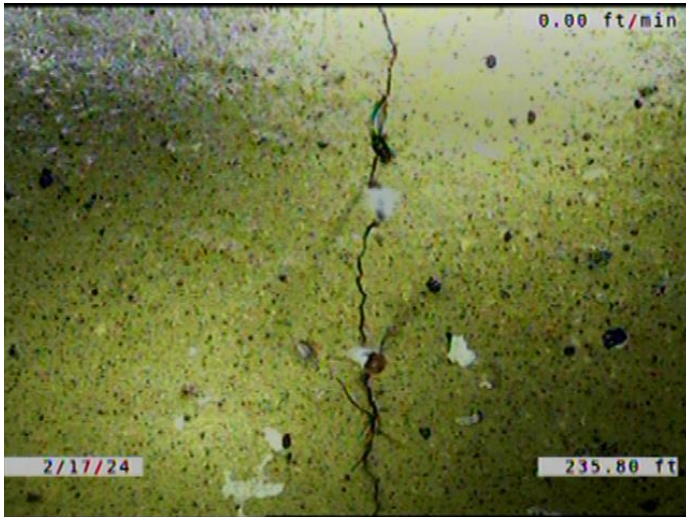
Code: **RFB**
Description: **Roots Fine Barrel**

Distance (ft): **235.8**
Structural Grade: **0**
O&M Grade: **2**
Clock Start/From: **12**
Clock To:
1st Value:
2nd Value:
Value Percent:
Continuous Index:
Within 8" of Joint: **NO**
Remarks:

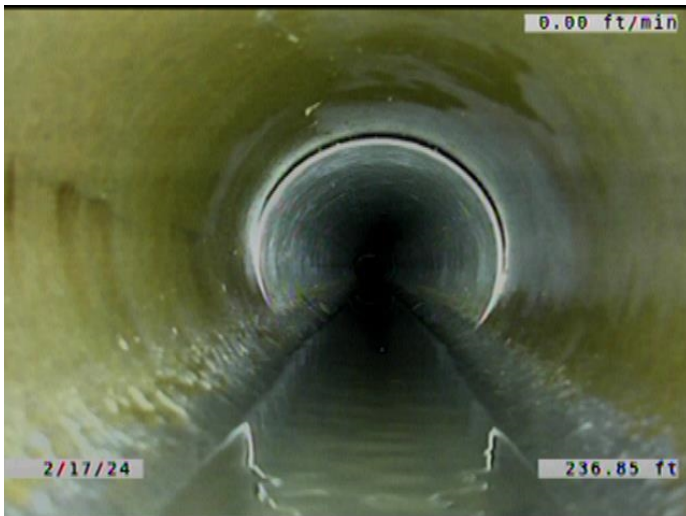
Code: **MWLS**
Description: **Miscellaneous Water Level Sag**

Distance (ft): **236.8**
Structural Grade: **2**
O&M Grade: **0**
Clock Start/From:
Clock To:
1st Value:
2nd Value:
Value Percent: **5.000**
Continuous Index: **S21**
Within 8" of Joint: **NO**
Remarks:

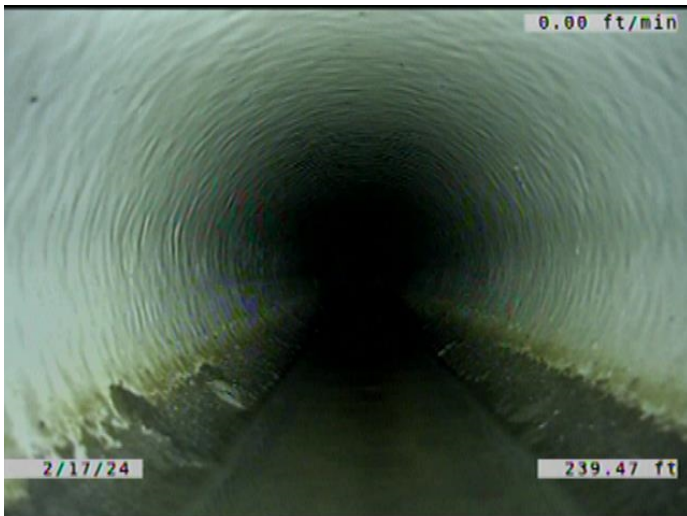
Code: **FM**
Description: **Fracture Multiple**

Distance (ft): **239.5**
Structural Grade: **4**
O&M Grade: **0**
Clock Start/From: **10**
Clock To: **3**
1st Value:
2nd Value:
Value Percent:
Continuous Index: **F20**
Within 8" of Joint: **YES**
Remarks:

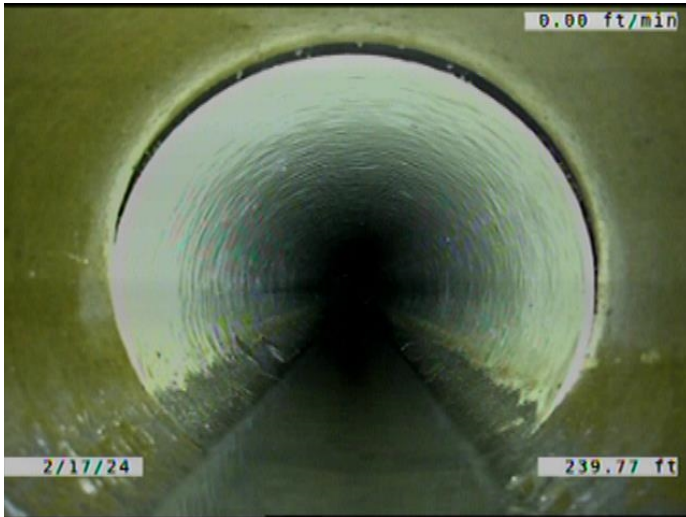
Code: **JOM**
Description: **Joint Offset Medium**

Distance (ft): **239.8**
Structural Grade: **3**
O&M Grade: **0**
Clock Start/From:
Clock To:
1st Value:
2nd Value:
Value Percent:
Continuous Index:
Within 8" of Joint: **NO**
Remarks:

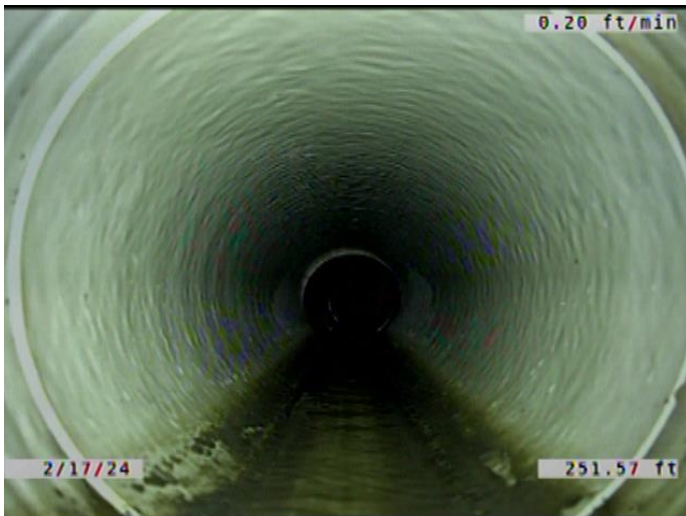
Code: **MWLS**
Description: **Miscellaneous Water Level Sag**

Distance (ft): **251.6**
Structural Grade: **2**
O&M Grade: **0**
Clock Start/From:
Clock To:
1st Value:
2nd Value:
Value Percent: **5.000**
Continuous Index: **F21**
Within 8" of Joint: **NO**
Remarks:

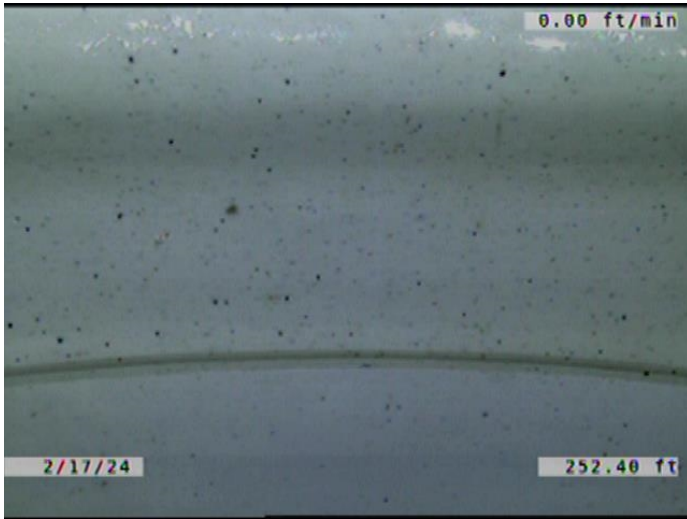
Code: **MGO**
Description: **Miscellaneous General Observation**

Distance (ft): **252.4**
Structural Grade: **0**
O&M Grade: **0**
Clock Start/From:
Clock To:
1st Value:
2nd Value:
Value Percent:
Continuous Index:
Within 8" of Joint: **NO**
Remarks: **JOINT/ PIPES NOT PUSHED ALL THE WAY TOGETHER WHEN INSTALLED**

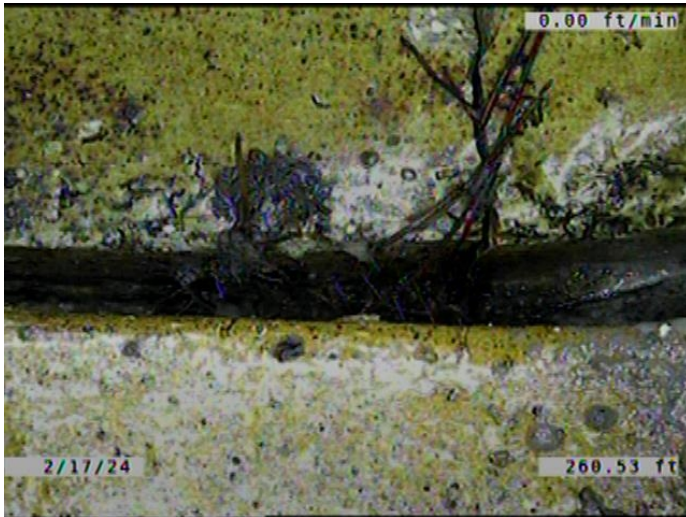
Code: **RFJ**
Description: **Roots Fine Joint**

Distance (ft): **260.5**
Structural Grade: **0**
O&M Grade: **1**
Clock Start/From: **8**
Clock To: **4**
1st Value:
2nd Value:
Value Percent:
Continuous Index:
Within 8" of Joint: **YES**
Remarks:

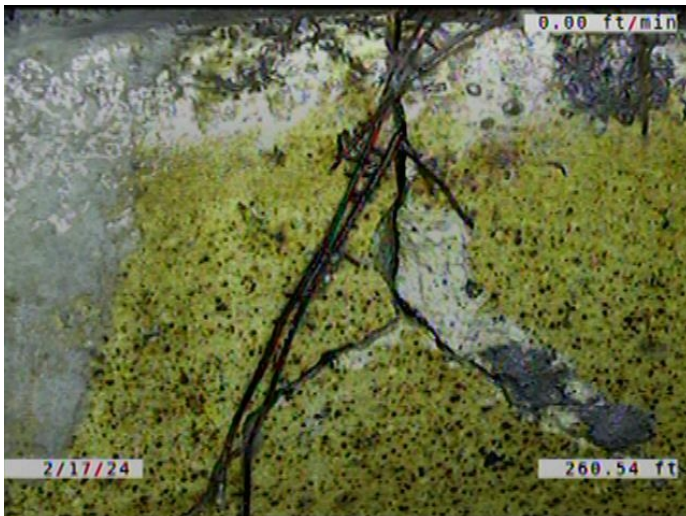
Code: **FM**
Description: **Fracture Multiple**

Distance (ft): **260.5**
Structural Grade: **4**
O&M Grade: **0**
Clock Start/From: **12**
Clock To: **12**
1st Value:
2nd Value:
Value Percent:
Continuous Index: **S23**
Within 8" of Joint: **YES**
Remarks:

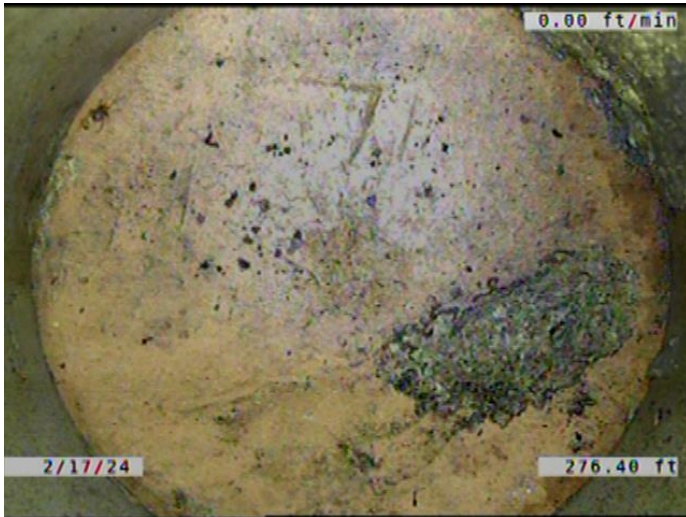
Code: **TFD**
Description: **Tap Factory Defective**

Distance (ft): **276.4**
Structural Grade: **0**
O&M Grade: **3**
Clock Start/From: **2**
Clock To:
1st Value: **6.000**
2nd Value:
Value Percent:
Continuous Index:
Within 8" of Joint: **YES**
Remarks: **CAPPED. TAP BOKEN.
ENCrustation COMING AROUND T**

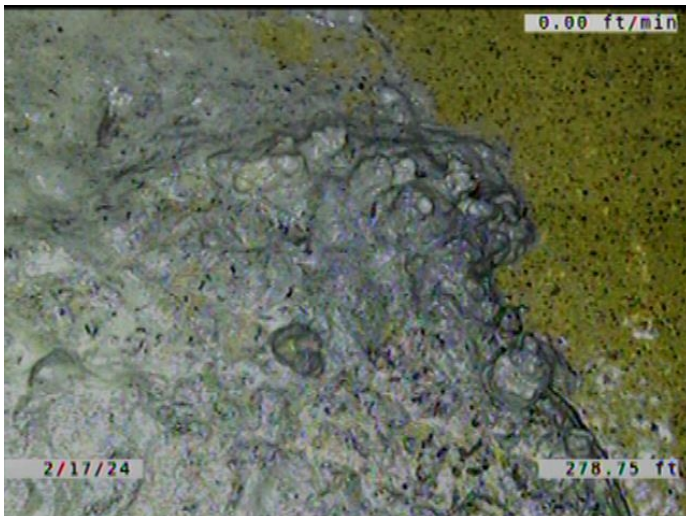
Code: **DAE**
Description: **Deposits Attached Encrustation**

Distance (ft): **278.8**
Structural Grade: **0**
O&M Grade: **2**
Clock Start/From: **3**
Clock To: **5**
1st Value:
2nd Value:
Value Percent: **5.000**
Continuous Index:
Within 8" of Joint: **YES**
Remarks:

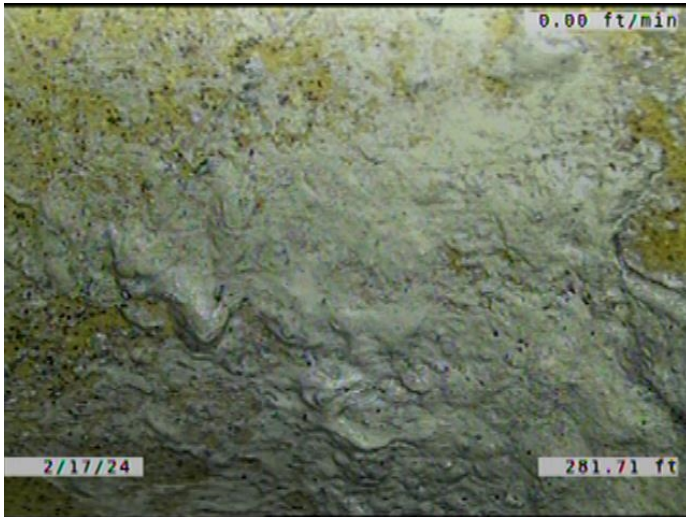
Code: **DAE**
Description: **Deposits Attached Encrustation**

Distance (ft): **281.7**
Structural Grade: **0**
O&M Grade: **2**
Clock Start/From: **7**
Clock To: **5**
1st Value:
2nd Value:
Value Percent: **5.000**
Continuous Index: **S24**
Within 8" of Joint: **YES**
Remarks:

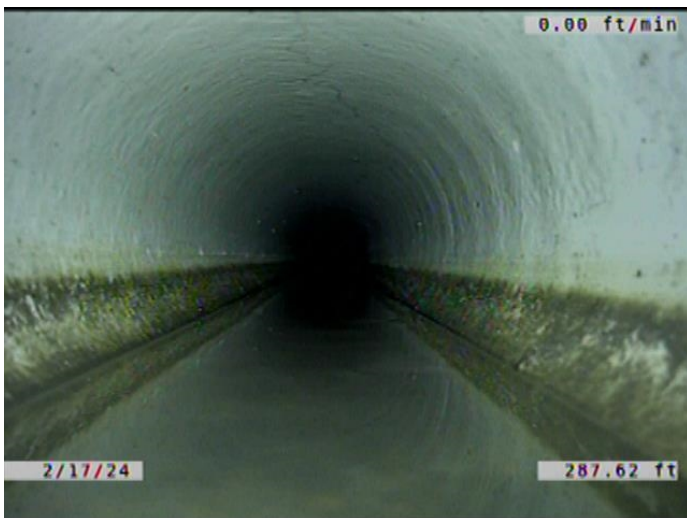
Code: **FM**
Description: **Fracture Multiple**

Distance (ft): **287.6**
Structural Grade: **4**
O&M Grade: **0**
Clock Start/From: **12**
Clock To: **12**
1st Value:
2nd Value:
Value Percent:
Continuous Index: **F23**
Within 8" of Joint: **YES**
Remarks:

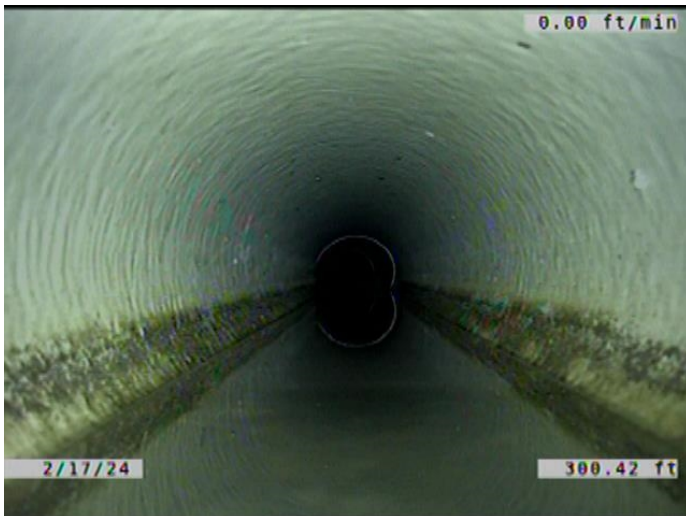
Code:	MWLS
Description:	Miscellaneous Water Level Sag
Distance (ft):	300.4
Structural Grade:	2
O&M Grade:	0
Clock Start/From:	
Clock To:	
1st Value:	
2nd Value:	
Value Percent:	15.000
Continuous Index:	S26
Within 8" of Joint:	NO
Remarks:

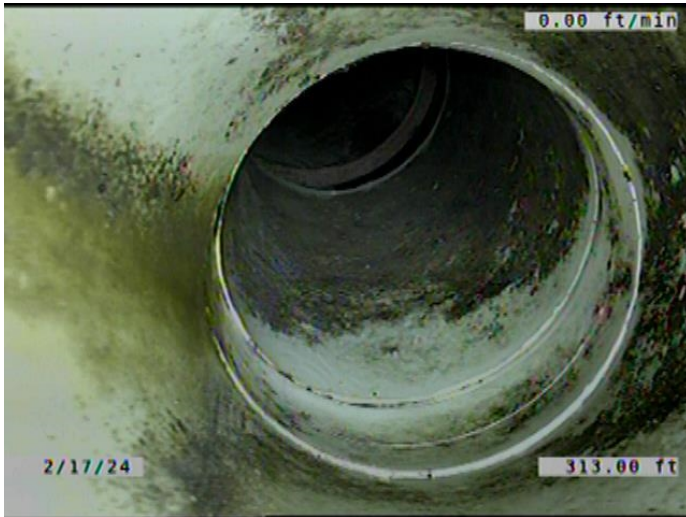
Code: **TF**
Description: **Tap Factory**

Distance (ft): **313.0**
Structural Grade: **0**
O&M Grade: **0**
Clock Start/From: **9**
Clock To:
1st Value: **6.000**
2nd Value:
Value Percent:
Continuous Index:
Within 8" of Joint: **YES**
Remarks: **PVC T. SERVICE IS VCP.**

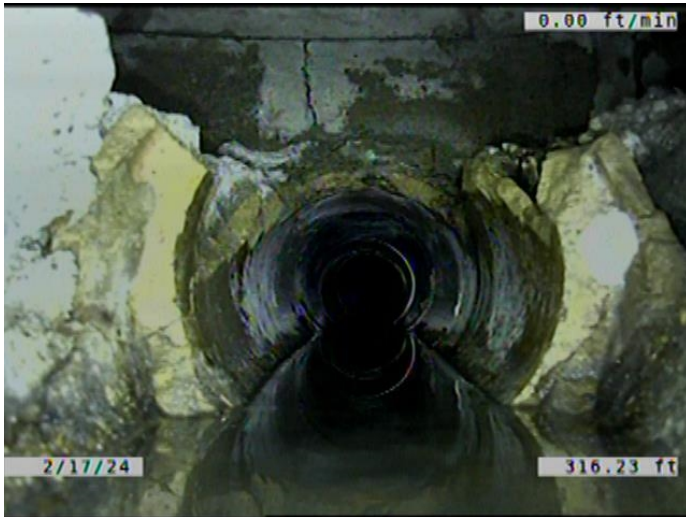
Code: **MWLS**
 Description: **Miscellaneous Water Level Sag**

Distance (ft): **316.2**
 Structural Grade: **2**
 O&M Grade: **0**
 Clock Start/From:
 Clock To:
 1st Value:
 2nd Value:
 Value Percent: **15.000**
 Continuous Index: **F26**
 Within 8" of Joint: **NO**
 Remarks:

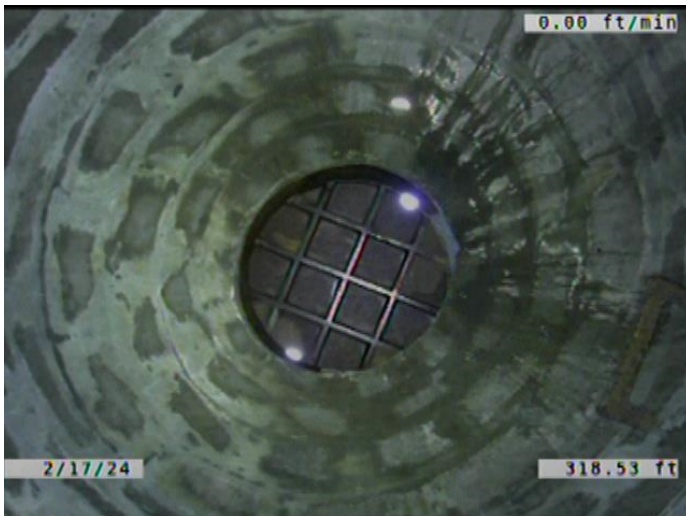
Code: **AMH**
 Description: **Manhole**

Distance (ft): **318.5**
 Structural Grade: **0**
 O&M Grade: **0**
 Clock Start/From:
 Clock To:
 1st Value:
 2nd Value:
 Value Percent:
 Continuous Index:
 Within 8" of Joint: **NO**
 Remarks: **M-405-036**
