Profile/Photo Observation Report

Date:	04/20/2018	Weather:		Coding:	PACP 6.0
Pipe Length (ft):	294.3	Owner:	NA	Pre Clean:	No Pre-Cleaning
P.O.#:		Surveyor:	Byrd Fitzgerald	PSR:	P-405-037-036
Customer:		Clean Date:	01/01/1900	Shape:	C

Street:	FOXCROFT STREET	Flow Control:	Not Controlled
City:	Hobart, IN	Year Renewed:	
Location:	Yard	Tape/Media #:	
Purpose:	Routine Assessment	Dia/Height:	8"
Use:	Sanitary	Material:	PVC
Drain Area:	NA	Lining:	
Category:	NA		
Comment:	P_C at 75 ft build up at the joint . Flow direction wrong		
Location Details:		Direction of Survey:	Downstream
US MH:	M-405-036	DS MH:	M-405-037
		Total Length Surveyed (ft):	76.4

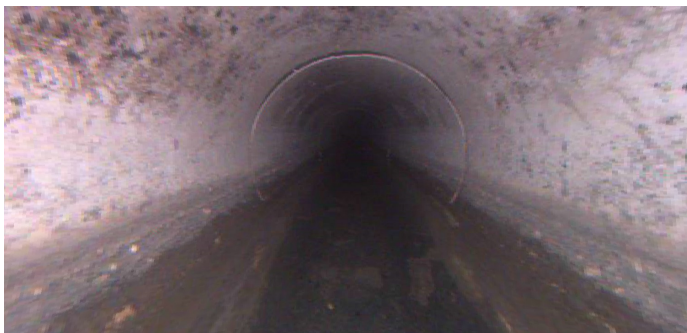
Code: **AMH**
 Description: **Manhole**
 Distance (ft): **.0**
 Structural Grade: **0**
 O&M Grade: **0**
 Clock Start/From:
 Clock To:
 1st Value:
 2nd Value:
 Value Percent:
 Continuous Index:
 Within 8" of Joint: **NO**
 Remarks: **M-405-036**

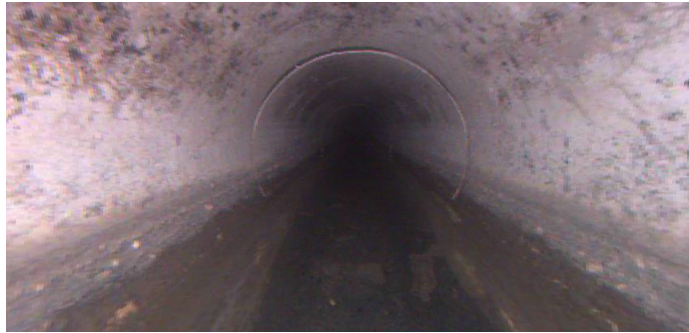
Code: **MWL**
Description: **Water Level**

Distance (ft): **.0**
Structural Grade: **0**
O&M Grade: **0**
Clock Start/From:
Clock To:
1st Value:
2nd Value:
Value Percent: **5.000**
Continuous Index:
Within 8" of Joint: **NO**
Remarks:

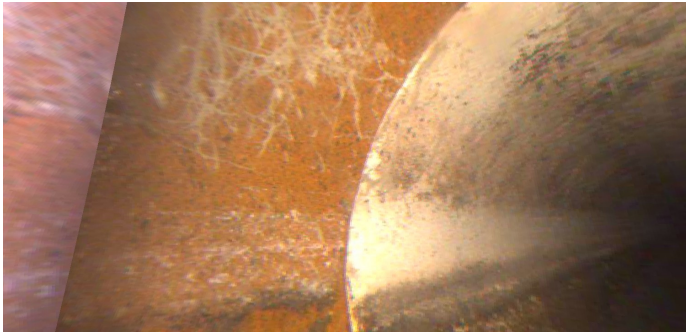
Code: **MMC**
Description: **Material Change**

Distance (ft): **7.5**
Structural Grade: **0**
O&M Grade: **0**
Clock Start/From:
Clock To:
1st Value:
2nd Value:
Value Percent:
Continuous Index:
Within 8" of Joint: **NO**
Remarks: **vcp**

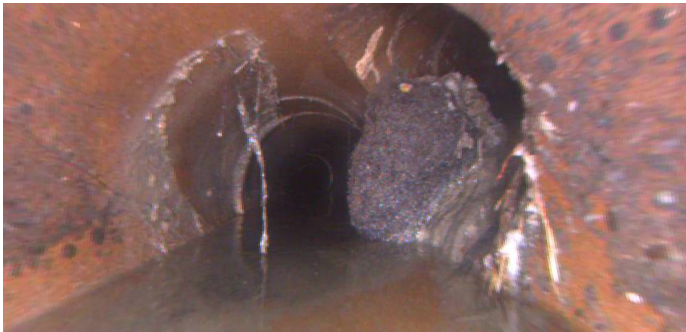
Code: **TF**
Description: **Tap Factory**

Distance (ft): **32.8**
Structural Grade: **0**
O&M Grade: **0**
Clock Start/From: **2**
Clock To:
1st Value: **4.000**
2nd Value:
Value Percent:
Continuous Index:
Within 8" of Joint:
Remarks:

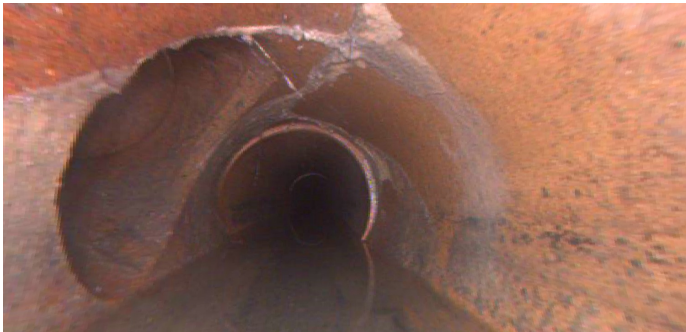
Code: **TF**
Description: **Tap Factory**

Distance (ft): **35.9**
Structural Grade: **0**
O&M Grade: **0**
Clock Start/From: **10**
Clock To:
1st Value: **4.000**
2nd Value:
Value Percent:
Continuous Index:
Within 8" of Joint: **YES**
Remarks:

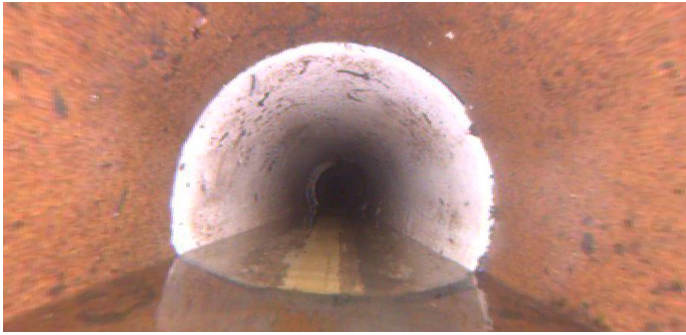
Code: **MMC**
Description: **Material Change**

Distance (ft): **57.3**
Structural Grade: **0**
O&M Grade: **0**
Clock Start/From:
Clock To:
1st Value:
2nd Value:
Value Percent:
Continuous Index:
Within 8" of Joint: **NO**
Remarks: **pvc**

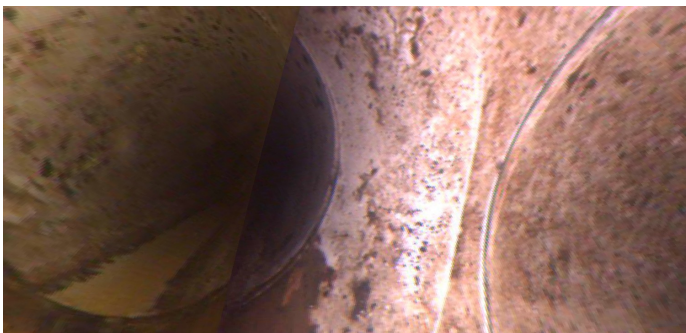
Code: **TF**
Description: **Tap Factory**

Distance (ft): **60.6**
Structural Grade: **0**
O&M Grade: **0**
Clock Start/From: **10**
Clock To:
1st Value: **4.000**
2nd Value:
Value Percent:
Continuous Index:
Within 8" of Joint: **YES**
Remarks:

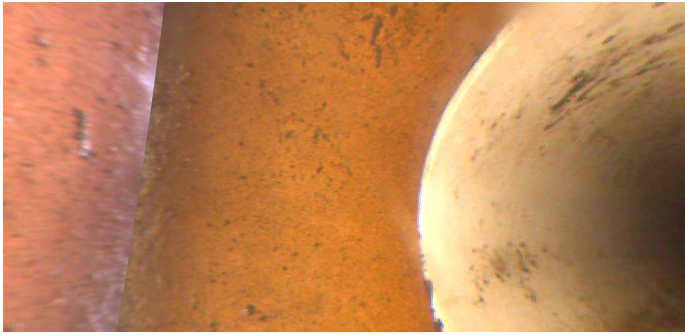
Code: **MMC**
Description: **Material Change**

Distance (ft): **64.7**
Structural Grade: **0**
O&M Grade: **0**
Clock Start/From:
Clock To:
1st Value:
2nd Value:
Value Percent:
Continuous Index:
Within 8" of Joint: **NO**
Remarks: **vcp**
