Profile/Photo Observation Report

Date:	02/17/2024	Weather:		Coding:	PACP 7.0
Pipe Length (ft):	294.0	Owner:	City of Hobart	Pre Clean:	Heavy Cleaning
P.O.#:	YES502259	Surveyor:	S. Bucklin	PSR:	P-405-037-036
Customer:	City of Hobart	Clean Date:	10/03/2023	Shape:	C

Street:	SOFTWOOD DR	Flow Control:	Not Controlled
City:	Hobart, IN	Year Renewed:	
Location:	Easement/Right of Way	Tape/Media #:	
Purpose:	Routine Assessment	Dia/Height:	8"
Use:	Sanitary Sewage Pipe	Material:	VCP
Drain Area:		Lining:	None
Category:	NA		
Comment:			
Location Details:		Direction of Survey:	Upstream
US MH:	M-405-036	DS MH:	M-405-037
		Total Length Surveyed (ft):	312.0

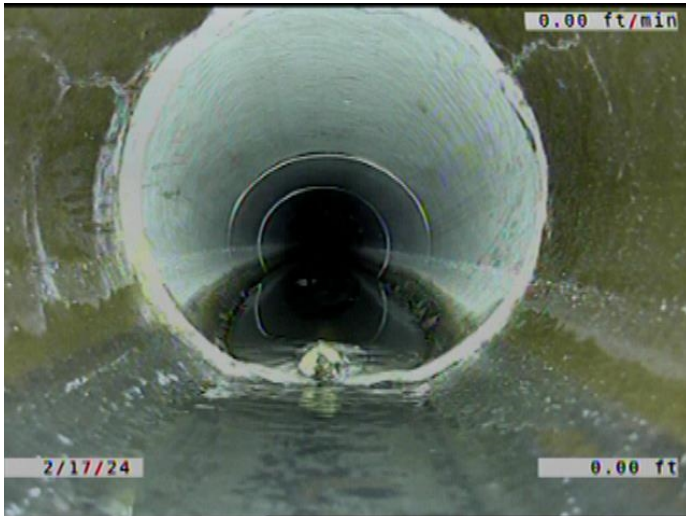
Code: **AMH**
Description: **Manhole**

Distance (ft): **.0**
Structural Grade: **0**
O&M Grade: **0**
Clock Start/From:
Clock To:
1st Value:
2nd Value:
Value Percent:
Continuous Index:
Within 8" of Joint: **NO**
Remarks: **M-405-037**

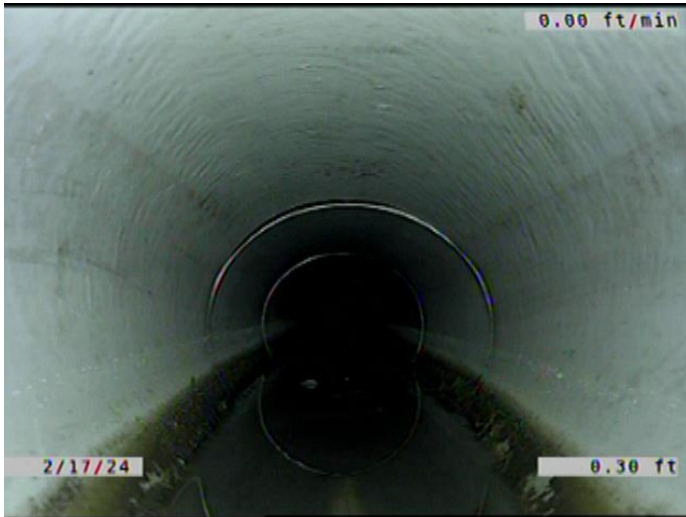
Code: **MWL**
Description: **Miscellaneous Water Level**

Distance (ft): **.0**
Structural Grade: **0**
O&M Grade: **0**
Clock Start/From:
Clock To:
1st Value:
2nd Value:
Value Percent: **5.000**
Continuous Index:
Within 8" of Joint: **NO**
Remarks:

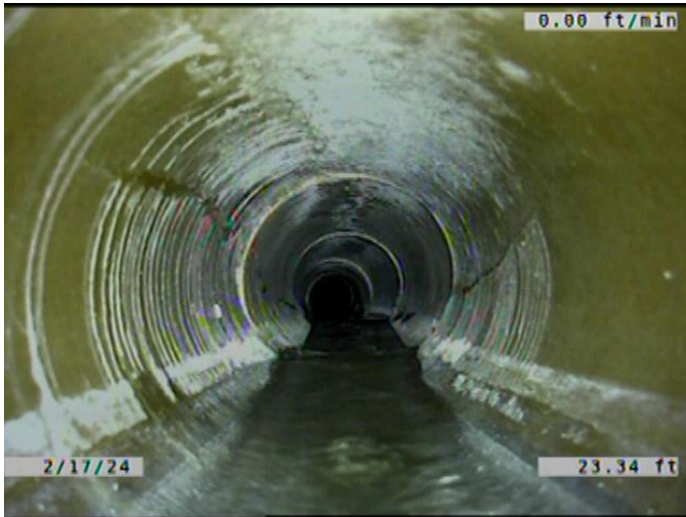
Code: **DAE**
Description: **Deposits Attached Encrustation**

Distance (ft): **12.6**
Structural Grade: **0**
O&M Grade: **2**
Clock Start/From: **7**
Clock To: **5**
1st Value:
2nd Value:
Value Percent: **5.000**
Continuous Index: **S04**
Within 8" of Joint: **YES**
Remarks:

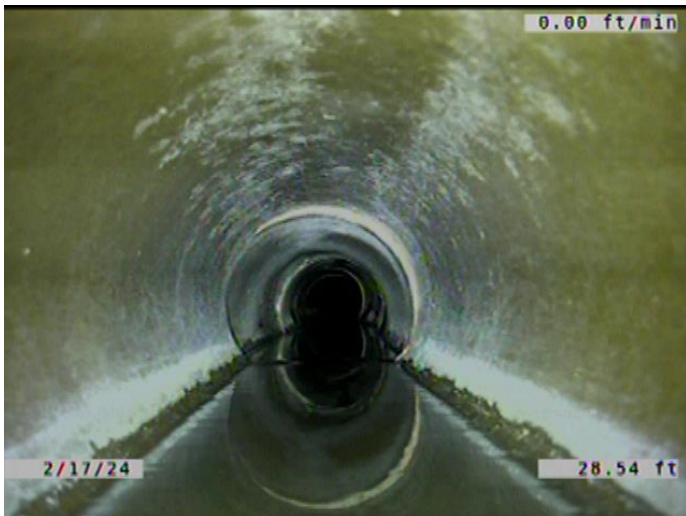
Code: **MWLS**
Description: **Miscellaneous Water Level Sag**

Distance (ft): **23.3**
Structural Grade: **2**
O&M Grade: **0**
Clock Start/From:
Clock To:
1st Value:
2nd Value:
Value Percent: **10.000**
Continuous Index: **F01**
Within 8" of Joint: **NO**
Remarks:

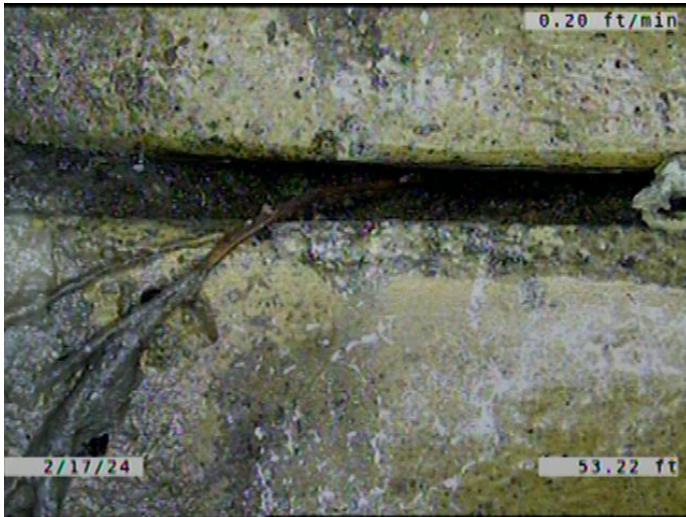
Code: **RFJ**
Description: **Roots Fine Joint**

Distance (ft): **43.3**
Structural Grade: **0**
O&M Grade: **1**
Clock Start/From: **4**
Clock To: **8**
1st Value:
2nd Value:
Value Percent:
Continuous Index:
Within 8" of Joint: **YES**
Remarks:

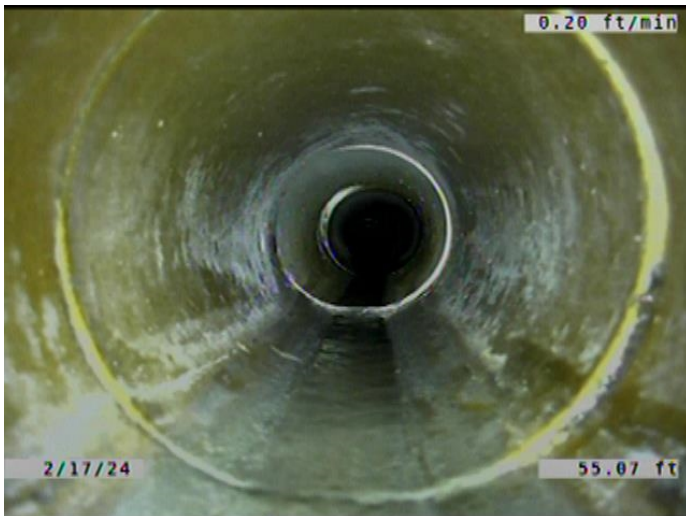
Code: **RFJ**
Description: **Roots Fine Joint**

Distance (ft): **53.2**
Structural Grade: **0**
O&M Grade: **1**
Clock Start/From: **4**
Clock To: **5**
1st Value:
2nd Value:
Value Percent:
Continuous Index:
Within 8" of Joint: **YES**
Remarks:

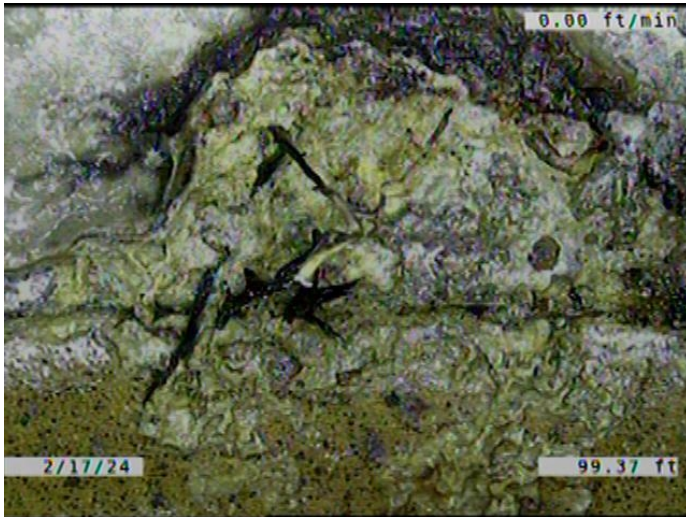
Code: **RFJ**
Description: **Roots Fine Joint**

Distance (ft): **99.4**
Structural Grade: **0**
O&M Grade: **1**
Clock Start/From: **3**
Clock To: **5**
1st Value:
2nd Value:
Value Percent:
Continuous Index:
Within 8" of Joint: **YES**
Remarks:

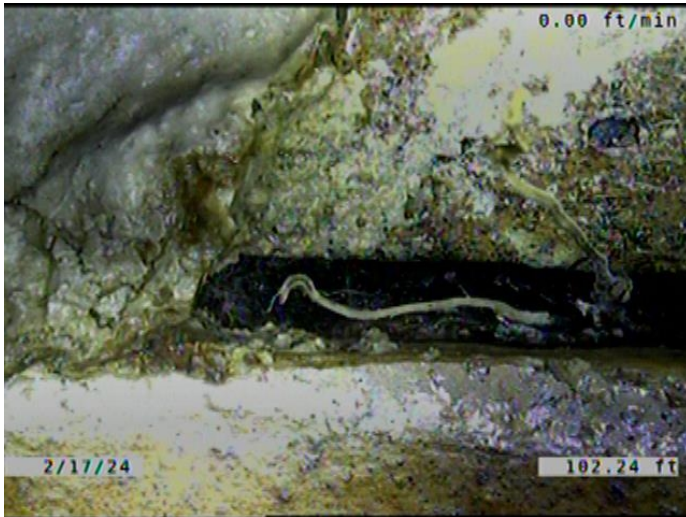
Code: **RFJ**
Description: **Roots Fine Joint**

Distance (ft): **102.2**
Structural Grade: **0**
O&M Grade: **1**
Clock Start/From: **7**
Clock To: **9**
1st Value:
2nd Value:
Value Percent:
Continuous Index:
Within 8" of Joint: **YES**
Remarks:

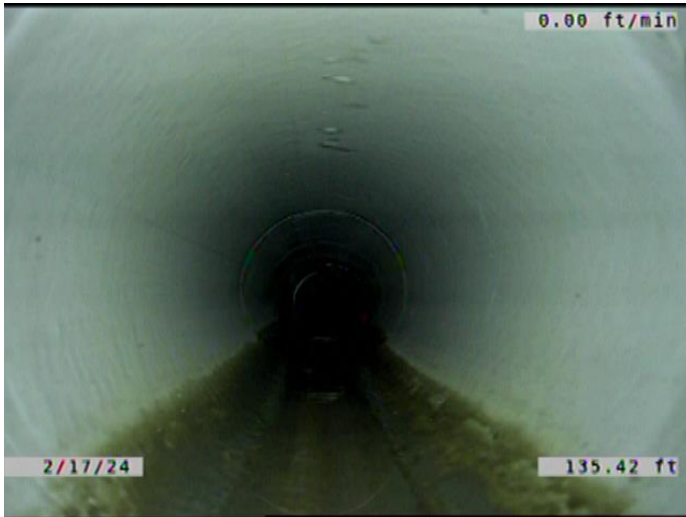
Code: **DAE**
Description: **Deposits Attached Encrustation**

Distance (ft): **135.4**
Structural Grade: **0**
O&M Grade: **2**
Clock Start/From: **7**
Clock To: **5**
1st Value:
2nd Value:
Value Percent: **5.000**
Continuous Index: **F08**
Within 8" of Joint: **YES**
Remarks:

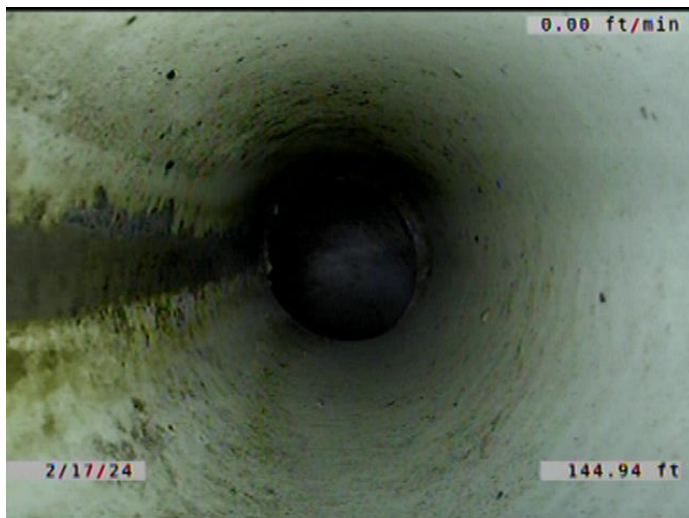
Code:	TF
Description:	Tap Factory
Distance (ft):	143.5
Structural Grade:	0
O&M Grade:	0
Clock Start/From:	2
Clock To:	
1st Value:	6.000
2nd Value:	
Value Percent:	
Continuous Index:	
Within 8" of Joint:	YES
Remarks:	PVC T. SERVICE IS VCP. CONSTANTLY RUNNING WATER.

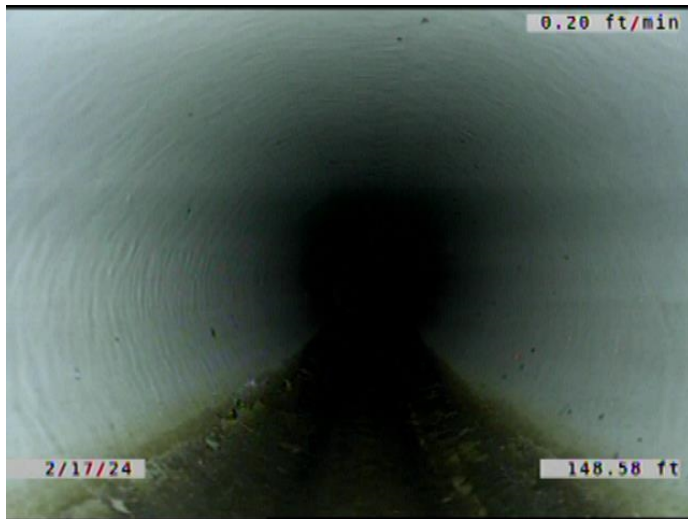
Code:	TF
Description:	Tap Factory
Distance (ft):	144.9
Structural Grade:	0
O&M Grade:	0
Clock Start/From:	10
Clock To:	
1st Value:	6.000
2nd Value:	
Value Percent:	
Continuous Index:	
Within 8" of Joint:	YES
Remarks:	PVC T. SERVICE IS VCP. CONSTANTLY RUNING WATER.

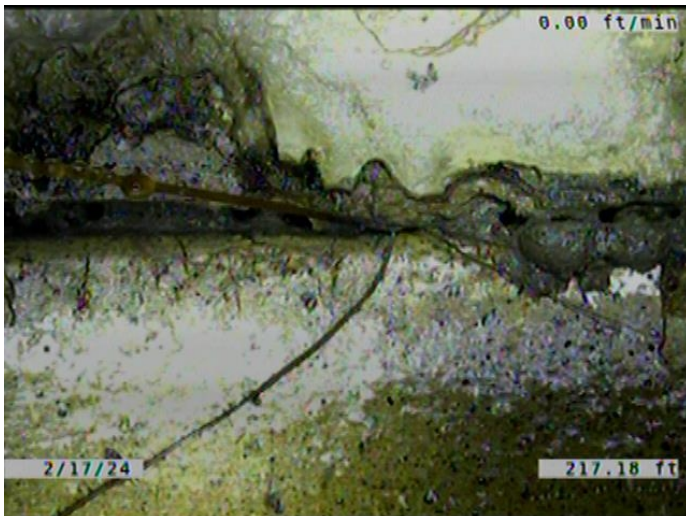
Code: **RFB**
 Description: **Roots Fine Barrel**

Distance (ft): **216.9**
 Structural Grade: **0**
 O&M Grade: **2**
 Clock Start/From: **10**
 Clock To: **11**
 1st Value:
 2nd Value:
 Value Percent:
 Continuous Index:
 Within 8" of Joint: **NO**
 Remarks:

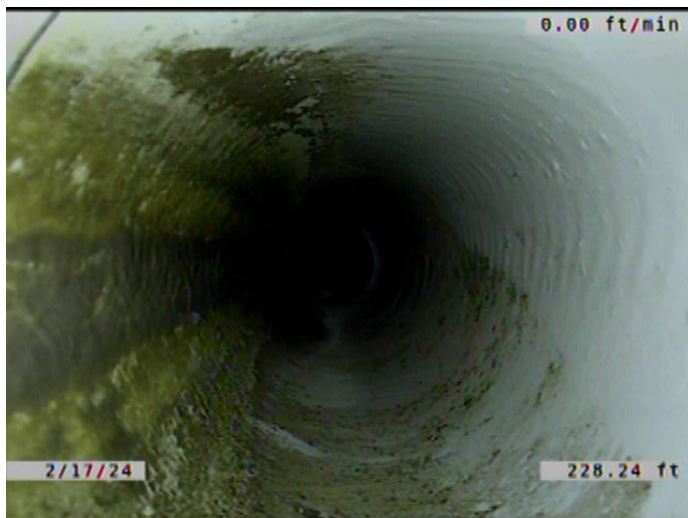
Code: **DAE**
Description: **Deposits Attached Encrustation**

Distance (ft): **226.5**
Structural Grade: **0**
O&M Grade: **2**
Clock Start/From: **7**
Clock To: **5**
1st Value:
2nd Value:
Value Percent: **5.000**
Continuous Index: **F18**
Within 8" of Joint: **YES**
Remarks:

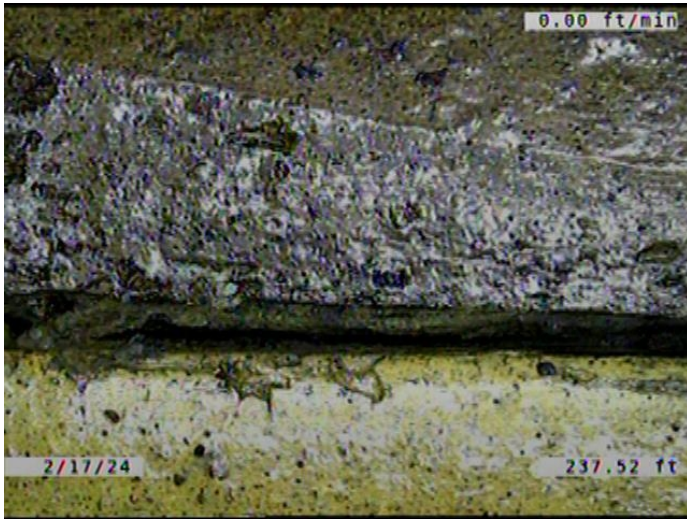
Code: **MWLS**
Description: **Miscellaneous Water Level Sag**

Distance (ft): **236.9**
Structural Grade: **2**
O&M Grade: **0**
Clock Start/From:
Clock To:
1st Value:
2nd Value:
Value Percent: **5.000**
Continuous Index: **S20**
Within 8" of Joint: **NO**
Remarks:

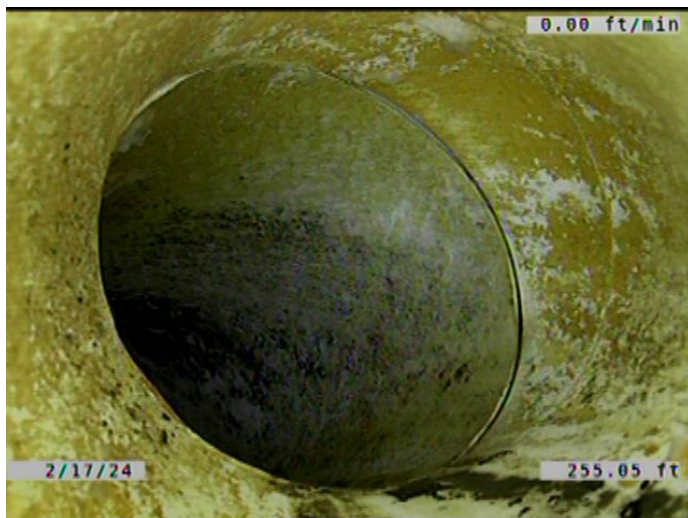
Code: **DAE**
Description: **Deposits Attached Encrustation**

Distance (ft): **252.1**
Structural Grade: **0**
O&M Grade: **2**
Clock Start/From: **7**
Clock To: **5**
1st Value:
2nd Value:
Value Percent: **5.000**
Continuous Index: **F21**
Within 8" of Joint: **YES**
Remarks:

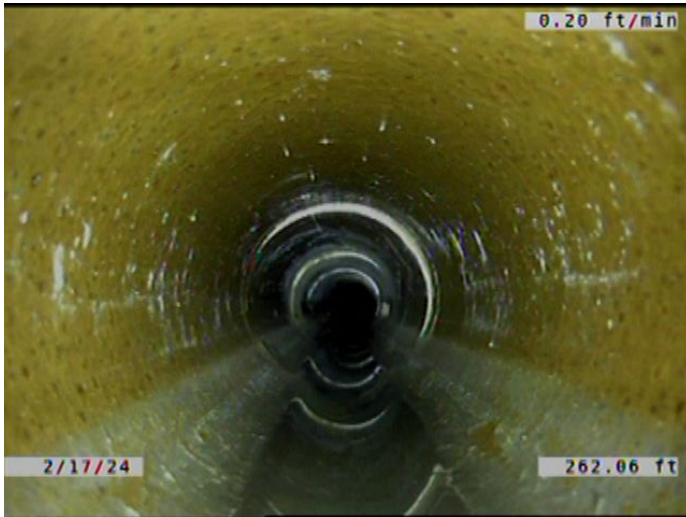
Code: **DAE**
Description: **Deposits Attached Encrustation**

Distance (ft): **259.5**
Structural Grade: **0**
O&M Grade: **2**
Clock Start/From: **7**
Clock To: **5**
1st Value:
2nd Value:
Value Percent: **5.000**
Continuous Index: **S23**
Within 8" of Joint: **YES**
Remarks:

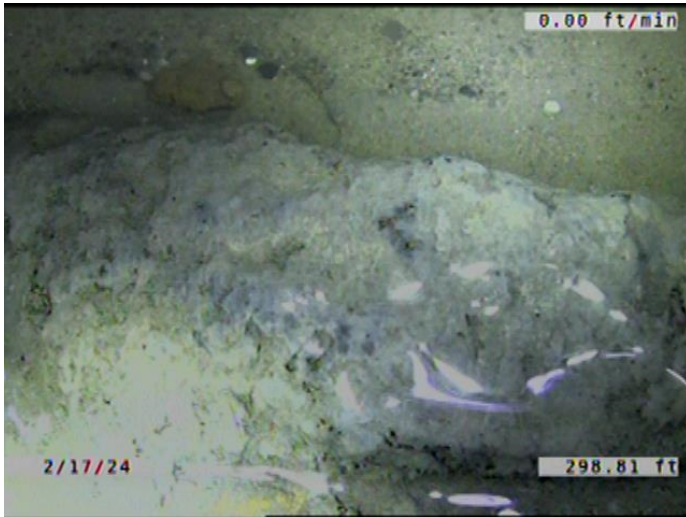
Code: **RFB**
Description: **Roots Fine Barrel**

Distance (ft): **295.4**
Structural Grade: **0**
O&M Grade: **2**
Clock Start/From: **10**
Clock To:
1st Value:
2nd Value:
Value Percent:
Continuous Index:
Within 8" of Joint: **NO**
Remarks:

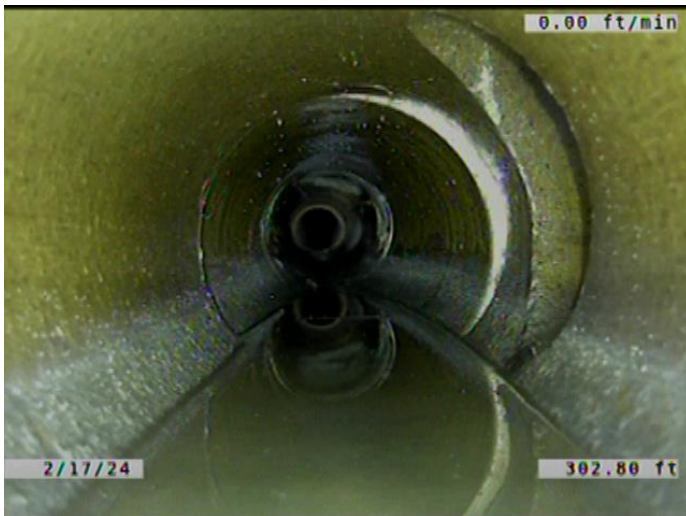
Code: **OBM**
Description: **Obstruction Pipe Material in Invert**

Distance (ft): **301.9**
Structural Grade: **0**
O&M Grade: **2**
Clock Start/From: **5**
Clock To: **7**
1st Value:
2nd Value:
Value Percent: **5.000**
Continuous Index:
Within 8" of Joint: **YES**
Remarks:

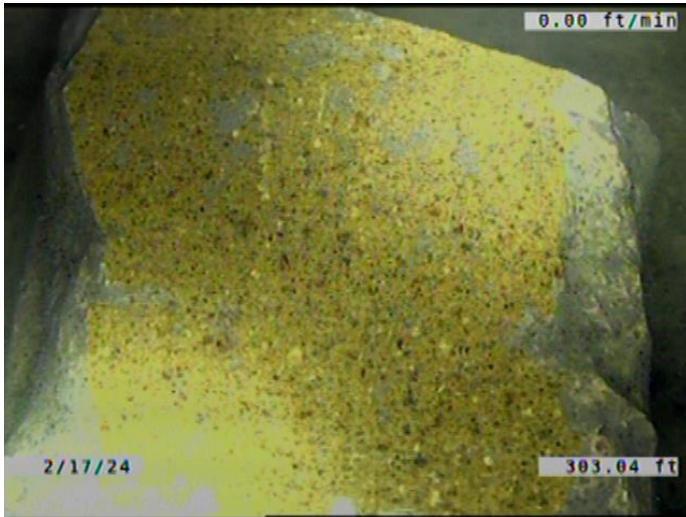
Code: **MWLS**
Description: **Miscellaneous Water Level Sag**

Distance (ft): **302.8**
Structural Grade: **2**
O&M Grade: **0**
Clock Start/From:
Clock To:
1st Value:
2nd Value:
Value Percent: **10.000**
Continuous Index: **S27**
Within 8" of Joint: **NO**
Remarks:

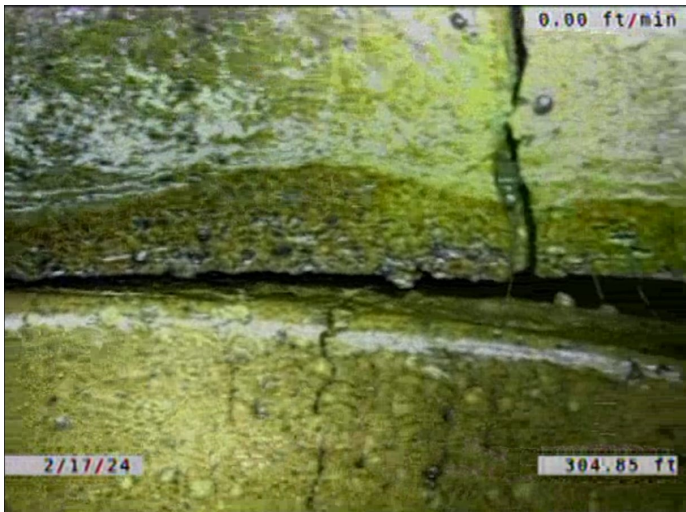
Code: **JOMD**
Description: **Joint Offset Medium Defective**

Distance (ft): **304.6**
Structural Grade: **3**
O&M Grade: **0**
Clock Start/From:
Clock To:
1st Value:
2nd Value:
Value Percent:
Continuous Index:
Within 8" of Joint: **NO**
Remarks: **SOIL VISIBLE.**

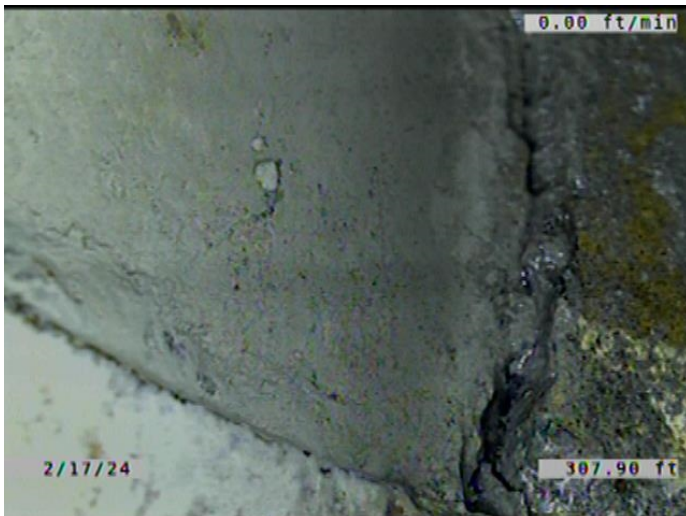
Code: **MWLS**
Description: **Miscellaneous Water Level Sag**

Distance (ft): **307.3**
Structural Grade: **2**
O&M Grade: **0**
Clock Start/From:
Clock To:
1st Value:
2nd Value:
Value Percent: **10.000**
Continuous Index: **F27**
Within 8" of Joint: **NO**
Remarks:

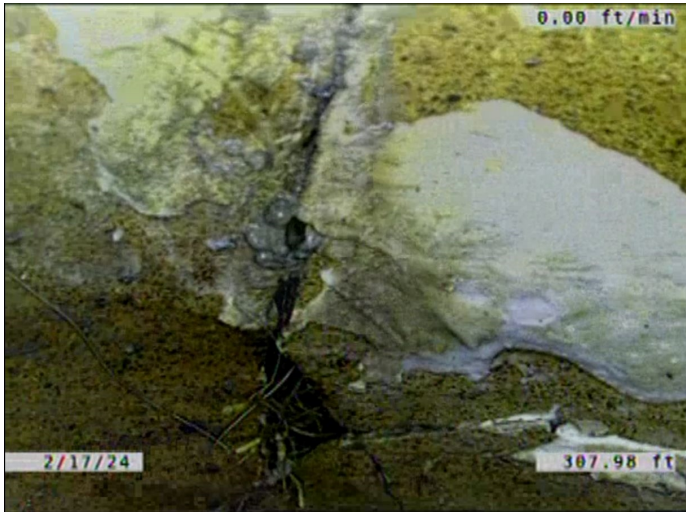
Code: **MGO**
Description: **Miscellaneous General Observation**

Distance (ft): **307.9**
Structural Grade: **0**
O&M Grade: **0**
Clock Start/From:
Clock To:
1st Value:
2nd Value:
Value Percent:
Continuous Index:
Within 8" of Joint: **NO**
Remarks: **WATER EXITING THE PIPE.**

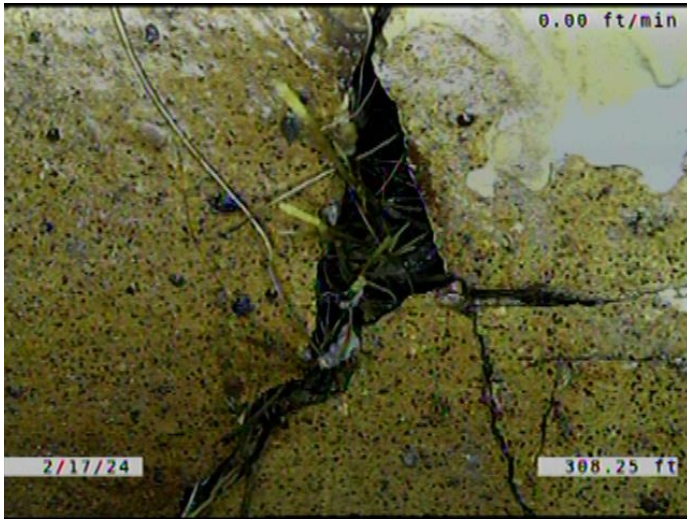
Code: **HVV**
Description: **Hole Void Visible**

Distance (ft): **308.3**
Structural Grade: **5**
O&M Grade: **0**
Clock Start/From: **9**
Clock To:
1st Value:
2nd Value:
Value Percent:
Continuous Index:
Within 8" of Joint: **YES**
Remarks: **ROOTS GROWING THROUGH THE HOLE.**

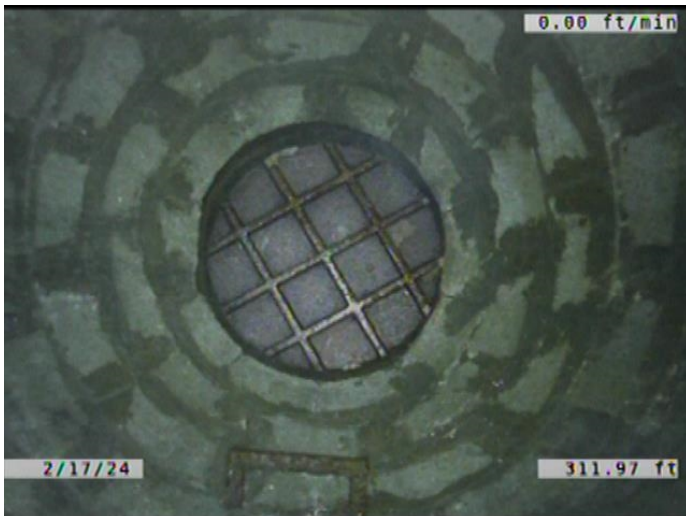
Code: **DAE**
Description: **Deposits Attached Encrustation**

Distance (ft): **310.5**
Structural Grade: **0**
O&M Grade: **2**
Clock Start/From: **7**
Clock To: **5**
1st Value:
2nd Value:
Value Percent: **5.000**
Continuous Index: **F23**
Within 8" of Joint: **YES**
Remarks:
