Profile/Photo Observation Report

Date:	04/20/2018	Weather:		Coding:	PACP 6.0
Pipe Length (ft):	264.1	Owner:	NA	Pre Clean:	No Pre-Cleaning
P.O.#:		Surveyor:	Byrd Fitzgerald	PSR:	P-405-040-039
Customer:		Clean Date:	01/01/1900	Shape:	C

Street:	ALLEY BETWEEN SOFTWOOD DR & 3	Flow Control:	Not Controlled
City:	Hobart, IN	Year Renewed:	
Location:	Yard	Tape/Media #:	
Purpose:	Routine Assessment	Dia/Height:	8"
Use:	Sanitary	Material:	PVC
Drain Area:	NA	Lining:	
Category:	NA		
Comment:	P_C at 180 ft debris / roots		
Location Details:		Direction of Survey:	Downstream
US MH:	M-405-039	DS MH:	M-405-040
		Total Length Surveyed (ft):	181.8

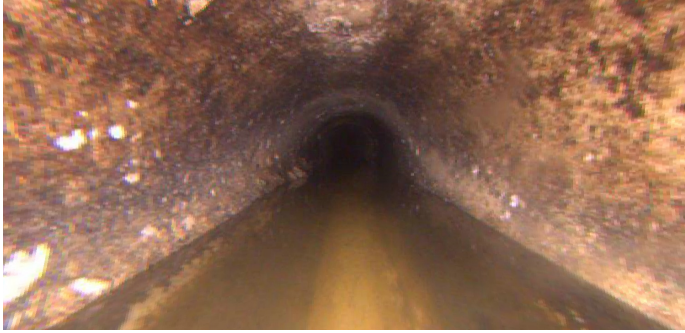
Code: **AMH**
Description: **Manhole**

Distance (ft): **.0**
Structural Grade: **0**
O&M Grade: **0**
Clock Start/From:
Clock To:
1st Value:
2nd Value:
Value Percent:
Continuous Index:
Within 8" of Joint: **NO**
Remarks: **M-405-039**

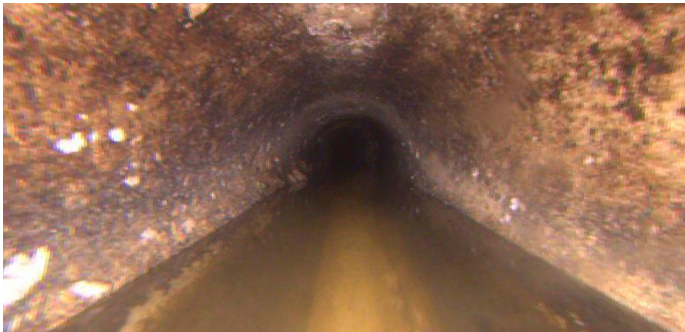
Code: **MWL**
Description: **Water Level**

Distance (ft): **.0**
Structural Grade: **0**
O&M Grade: **0**
Clock Start/From:
Clock To:
1st Value:
2nd Value:
Value Percent: **5.000**
Continuous Index:
Within 8" of Joint: **NO**
Remarks:

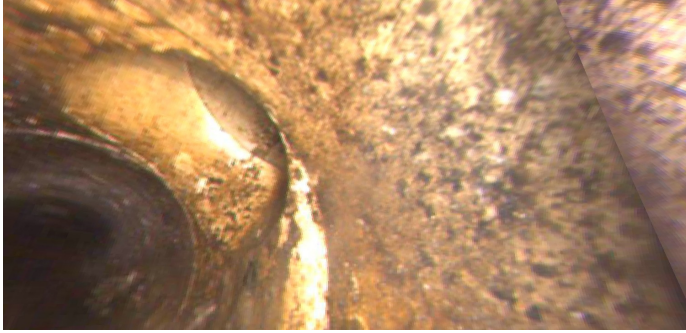
Code: **TF**
Description: **Tap Factory**

Distance (ft): **4.8**
Structural Grade: **0**
O&M Grade: **0**
Clock Start/From: **10**
Clock To:
1st Value: **4.000**
2nd Value:
Value Percent:
Continuous Index:
Within 8" of Joint: **YES**
Remarks:

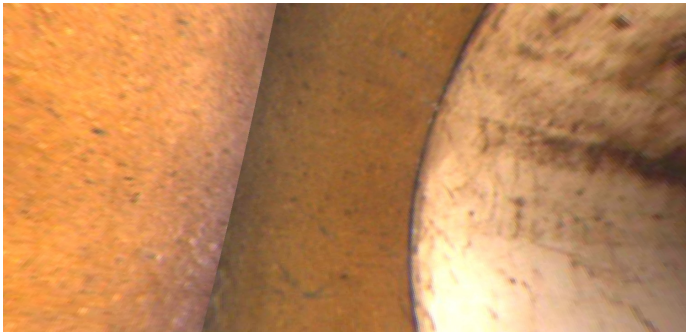
Code: **MMC**
Description: **Material Change**

Distance (ft): **19.0**
Structural Grade: **0**
O&M Grade: **0**
Clock Start/From:
Clock To:
1st Value:
2nd Value:
Value Percent:
Continuous Index:
Within 8" of Joint: **NO**
Remarks: **vcp**

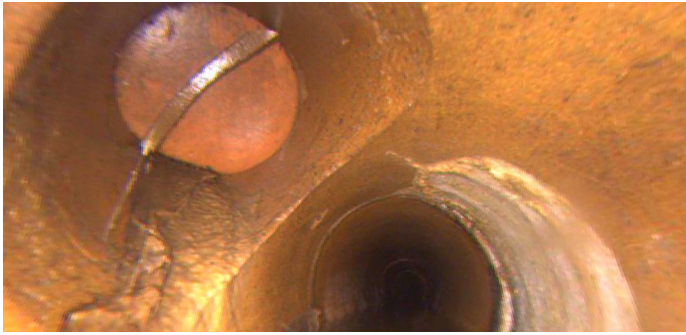
Code: **TFC**
Description: **Tap Factory Capped**

Distance (ft): **20.7**
Structural Grade: **0**
O&M Grade: **0**
Clock Start/From: **11**
Clock To:
1st Value: **4.000**
2nd Value:
Value Percent:
Continuous Index:
Within 8" of Joint: **YES**
Remarks:

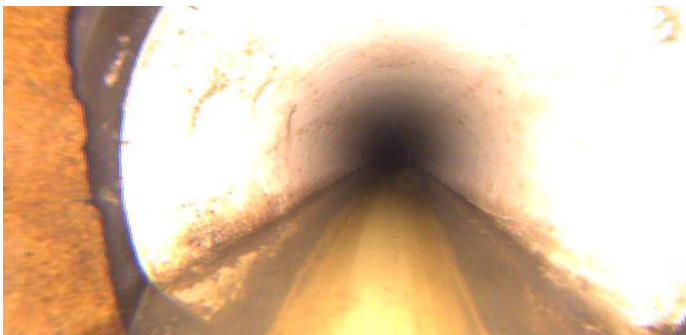
Code: **MMC**
Description: **Material Change**

Distance (ft): **27.2**
Structural Grade: **0**
O&M Grade: **0**
Clock Start/From:
Clock To:
1st Value:
2nd Value:
Value Percent:
Continuous Index:
Within 8" of Joint: **NO**
Remarks: **pvc**

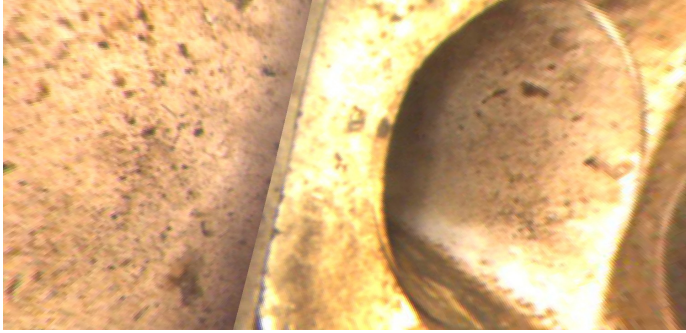
Code: **TF**
Description: **Tap Factory**

Distance (ft): **47.4**
Structural Grade: **0**
O&M Grade: **0**
Clock Start/From: **2**
Clock To:
1st Value: **4.000**
2nd Value:
Value Percent:
Continuous Index:
Within 8" of Joint: **YES**
Remarks:

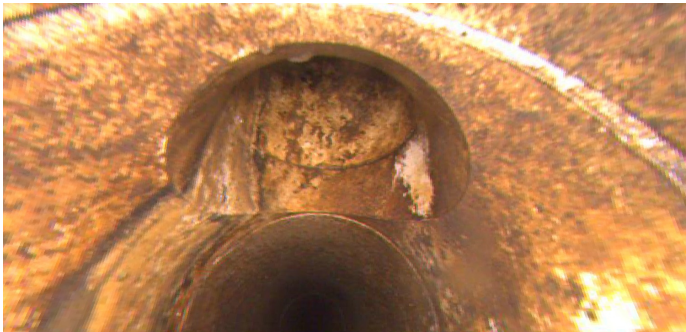
Code: **TF**
Description: **Tap Factory**

Distance (ft): **56.3**
Structural Grade: **0**
O&M Grade: **0**
Clock Start/From: **12**
Clock To:
1st Value: **4.000**
2nd Value:
Value Percent:
Continuous Index:
Within 8" of Joint: **YES**
Remarks:

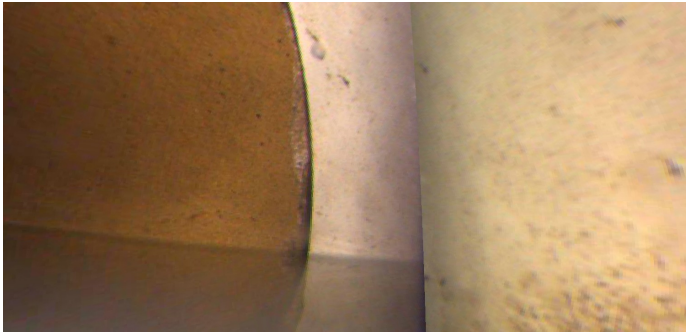
Code: **MMC**
Description: **Material Change**

Distance (ft): **72.3**
Structural Grade: **0**
O&M Grade: **0**
Clock Start/From:
Clock To:
1st Value:
2nd Value:
Value Percent:
Continuous Index:
Within 8" of Joint: **NO**
Remarks: **vcp**

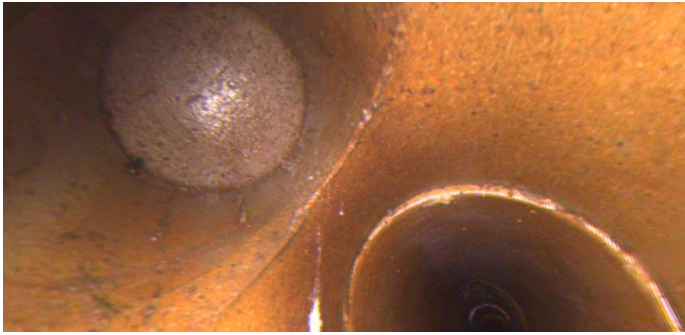
Code: **TFC**
Description: **Tap Factory Capped**

Distance (ft): **95.2**
Structural Grade: **0**
O&M Grade: **0**
Clock Start/From: **11**
Clock To:
1st Value: **4.000**
2nd Value:
Value Percent:
Continuous Index:
Within 8" of Joint: **YES**
Remarks:

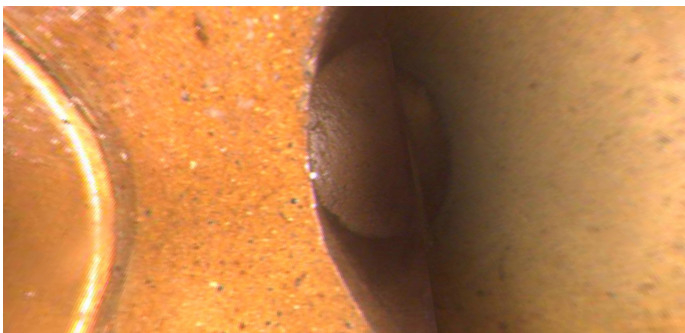
Code: **TFC**
Description: **Tap Factory Capped**

Distance (ft): **98.4**
Structural Grade: **0**
O&M Grade: **0**
Clock Start/From: **2**
Clock To:
1st Value: **4.000**
2nd Value:
Value Percent:
Continuous Index:
Within 8" of Joint: **YES**
Remarks:

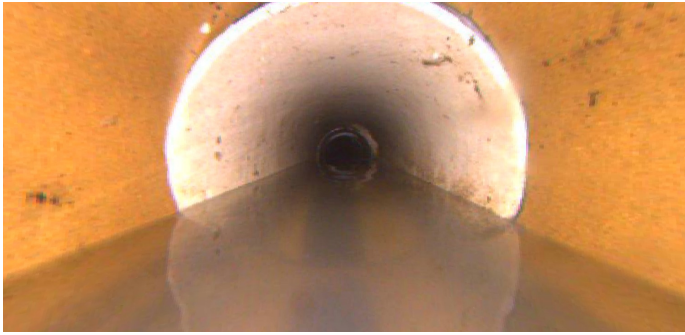
Code: **MMC**
Description: **Material Change**

Distance (ft): **101.0**
Structural Grade: **0**
O&M Grade: **0**
Clock Start/From:
Clock To:
1st Value:
2nd Value:
Value Percent:
Continuous Index:
Within 8" of Joint: **NO**
Remarks: **pvc**

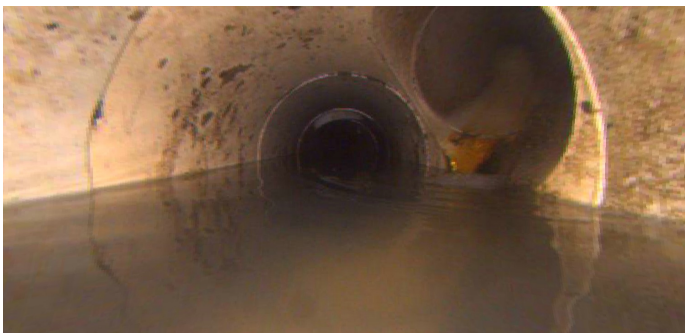
Code: **TF**
Description: **Tap Factory**

Distance (ft): **103.5**
Structural Grade: **0**
O&M Grade: **0**
Clock Start/From: **2**
Clock To:
1st Value: **4.000**
2nd Value:
Value Percent:
Continuous Index:
Within 8" of Joint: **YES**
Remarks:

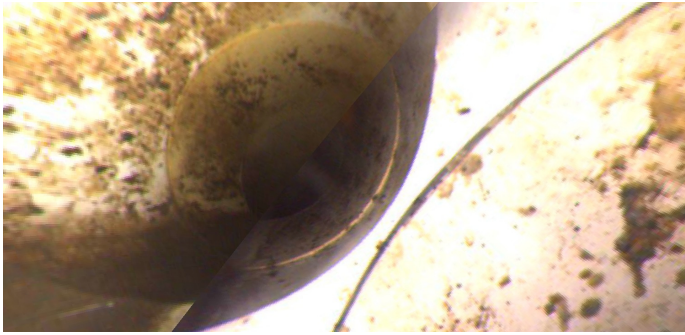
Code: **TF**
Description: **Tap Factory**

Distance (ft): **106.0**
Structural Grade: **0**
O&M Grade: **0**
Clock Start/From: **11**
Clock To:
1st Value: **4.000**
2nd Value:
Value Percent:
Continuous Index:
Within 8" of Joint: **YES**
Remarks:

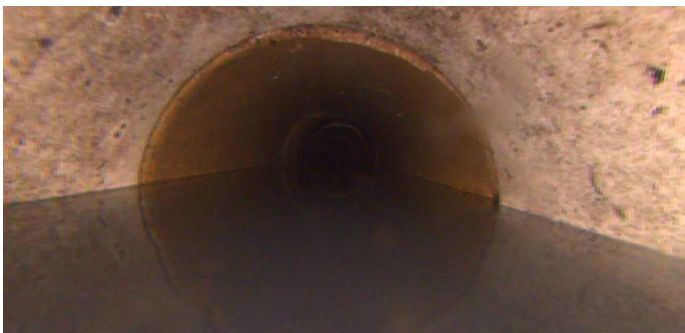
Code: **MWL**
Description: **Water Level**

Distance (ft): **110.2**
Structural Grade: **0**
O&M Grade: **0**
Clock Start/From:
Clock To:
1st Value:
2nd Value:
Value Percent: **50.000**
Continuous Index:
Within 8" of Joint: **NO**
Remarks:

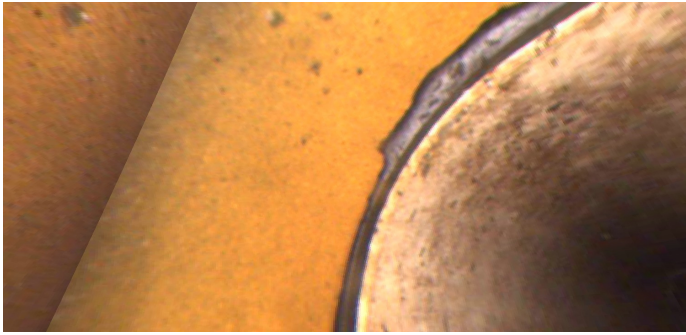
Code: **MMC**
Description: **Material Change**

Distance (ft): **111.0**
Structural Grade: **0**
O&M Grade: **0**
Clock Start/From:
Clock To:
1st Value:
2nd Value:
Value Percent:
Continuous Index:
Within 8" of Joint: **NO**
Remarks: **vcp**
