Profile/Photo Observation Report

Date:	03/06/2024	Weather:		Coding:	PACP 7.0
Pipe Length (ft):	264.0	Owner:	City of Hobart	Pre Clean:	Heavy Cleaning
P.O.#:		Surveyor:	S. Bucklin	PSR:	P-405-040-039
Customer:	City of Hobart	Clean Date:	10/24/2023	Shape:	C

Street:	SOFTWOOD DR	Flow Control:	Not Controlled
City:	Hobart, IN	Year Renewed:	
Location:	Easement/Right of Way	Tape/Media #:	
Purpose:	Sewer System Evaluation Survey (SS)	Dia/Height:	8"
Use:	Sanitary Sewage Pipe	Material:	VCP
Drain Area:		Lining:	None
Category:	NA		
Comment:			
Location Details:		Direction of Survey:	Downstream
US MH:	M-405-039	DS MH:	M-405-040
		Total Length Surveyed (ft):	255.6

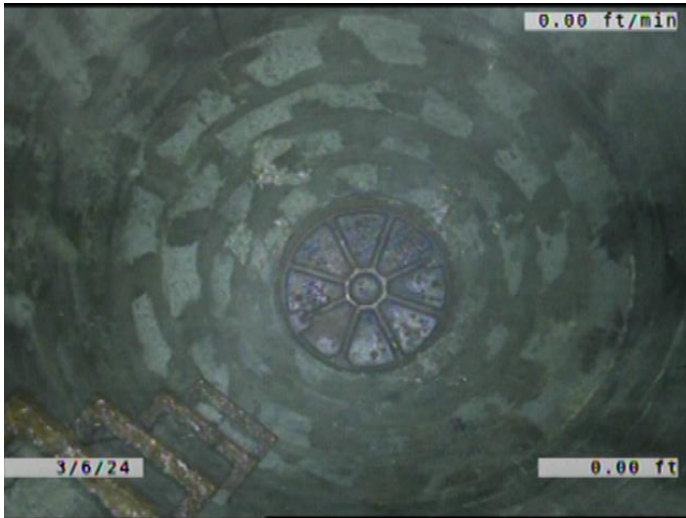
Code: **AMH**
Description: **Manhole**

Distance (ft): **.0**
Structural Grade: **0**
O&M Grade: **0**
Clock Start/From:
Clock To:
1st Value:
2nd Value:
Value Percent:
Continuous Index:
Within 8" of Joint: **NO**
Remarks: **M-405-039**

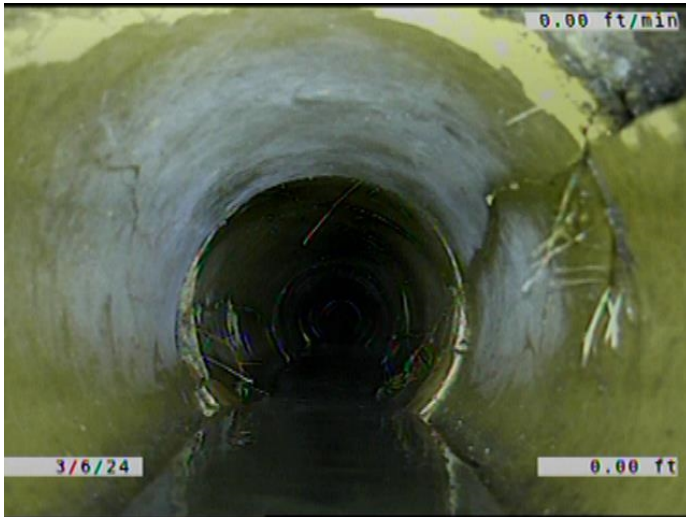
Code: **MWL**
 Description: **Miscellaneous Water Level**

Distance (ft): **.0**
 Structural Grade: **0**
 O&M Grade: **0**
 Clock Start/From:
 Clock To:
 1st Value:
 2nd Value:
 Value Percent: **10.000**
 Continuous Index:
 Within 8" of Joint: **NO**
 Remarks:

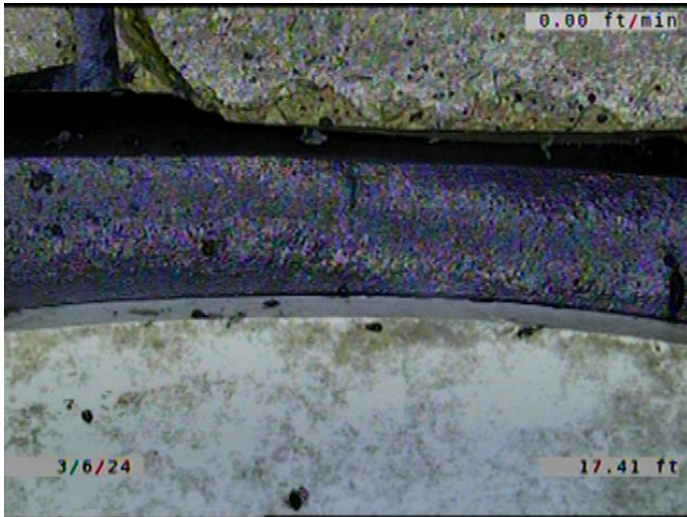
Code: **RPR**
Description: **Point Repair Replacement**

Distance (ft): **17.4**
Structural Grade: **0**
O&M Grade: **0**
Clock Start/From:
Clock To:
1st Value:
2nd Value:
Value Percent:
Continuous Index: **S04**
Within 8" of Joint: **YES**
Remarks: **REPLACED WITH PVC.**

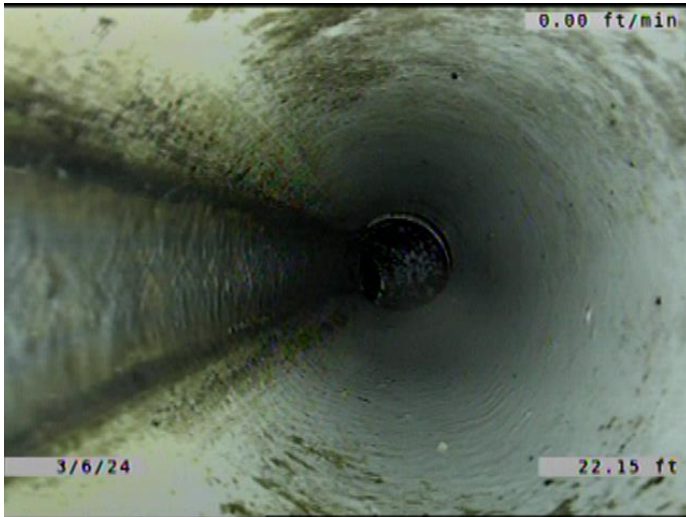
Code:	TF
Description:	Tap Factory
Distance (ft):	22.1
Structural Grade:	0
O&M Grade:	0
Clock Start/From:	10
Clock To:	
1st Value:	6.000
2nd Value:	
Value Percent:	
Continuous Index:	
Within 8" of Joint:	YES
Remarks:	TAP PVC. SERVICE VCP. CONSTANTLY RUNNING WATER.

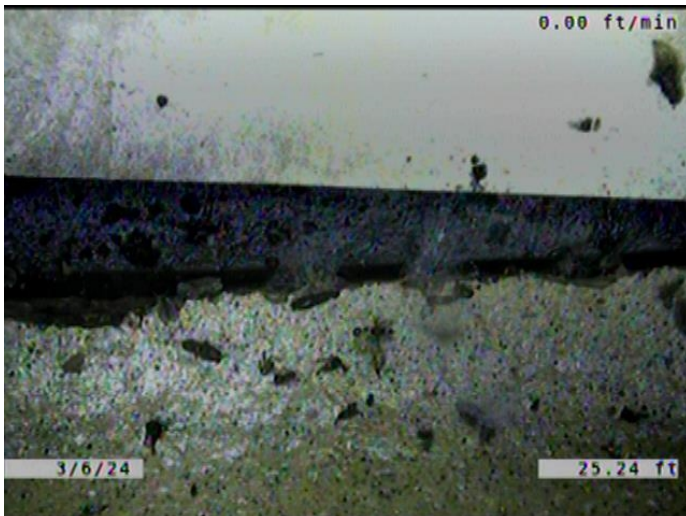
Code:	RPR
Description:	Point Repair Replacement
Distance (ft):	25.2
Structural Grade:	0
O&M Grade:	0
Clock Start/From:	
Clock To:	
1st Value:	
2nd Value:	
Value Percent:	
Continuous Index:	F04
Within 8" of Joint:	YES
Remarks:	REPLACED WITH PVC.

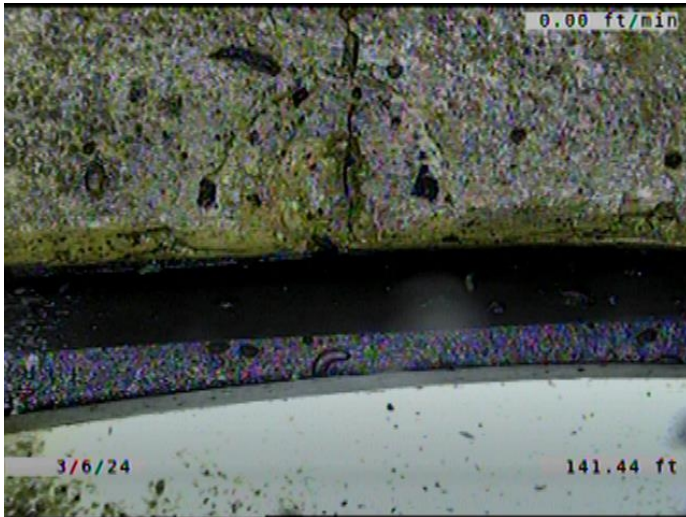
Code:	MMC
Description:	Miscellaneous Material Change
Distance (ft):	141.4
Structural Grade:	0
O&M Grade:	0
Clock Start/From:	
Clock To:	
1st Value:	
2nd Value:	
Value Percent:	
Continuous Index:	
Within 8" of Joint:	NO
Remarks:	PVC.

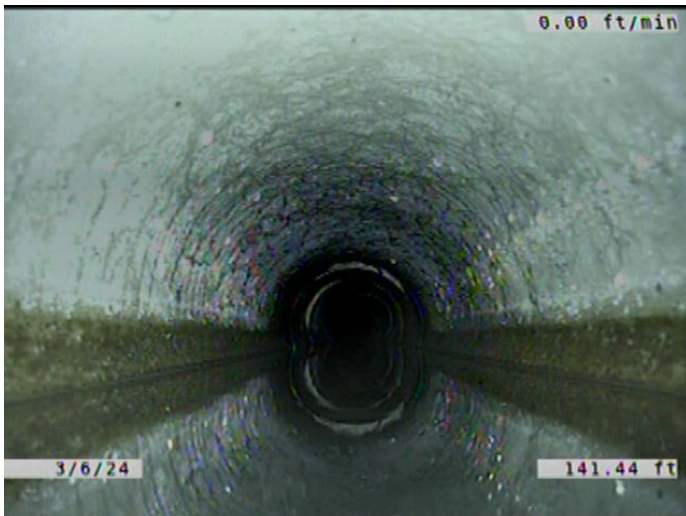
Code:	DAE
Description:	Deposits Attached Encrustation
Distance (ft):	141.4
Structural Grade:	0
O&M Grade:	2
Clock Start/From:	7
Clock To:	5
1st Value:	
2nd Value:	
Value Percent:	5.000
Continuous Index:	F06
Within 8" of Joint:	YES
Remarks:

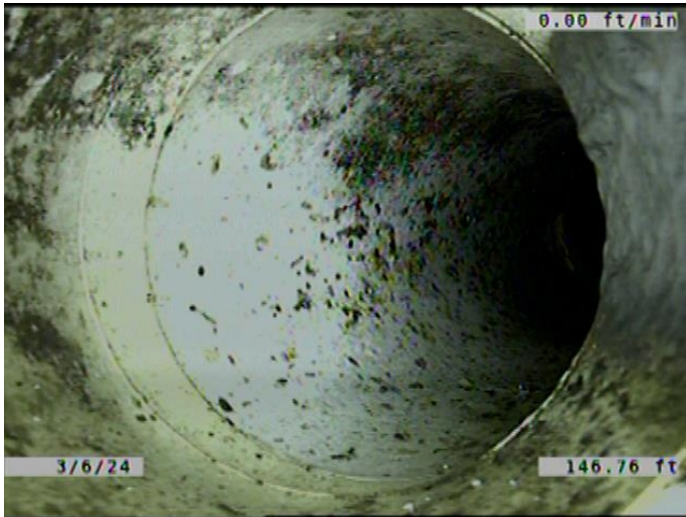
Code: **TF**
Description: **Tap Factory**

Distance (ft): **146.8**
Structural Grade: **0**
O&M Grade: **0**
Clock Start/From: **1**
Clock To:
1st Value: **6.000**
2nd Value:
Value Percent:
Continuous Index:
Within 8" of Joint: **YES**
Remarks: **TAP PVC. SERVICE VCP CONSTANTLY RUNNING WATER.**

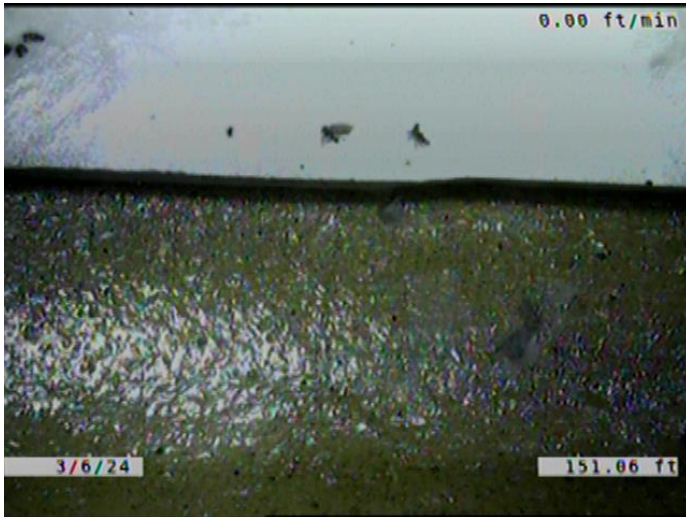
Code: **MMC**
Description: **Miscellaneous Material Change**

Distance (ft): **151.1**
Structural Grade: **0**
O&M Grade: **0**
Clock Start/From:
Clock To:
1st Value:
2nd Value:
Value Percent:
Continuous Index:
Within 8" of Joint: **NO**
Remarks: **VCP**

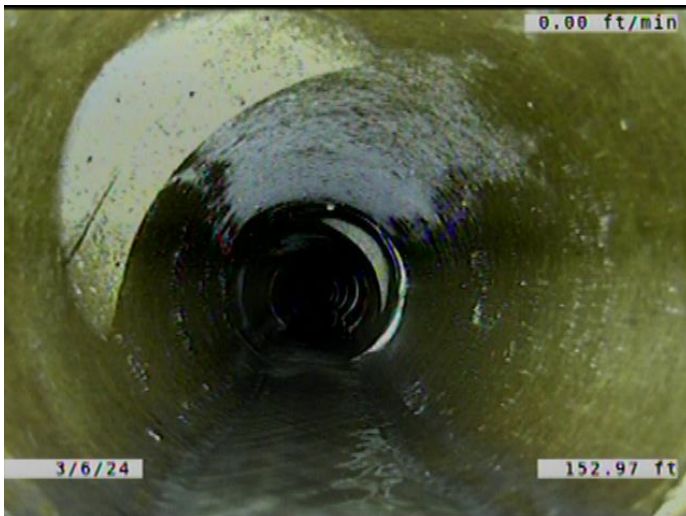
Code: **MWLS**
Description: **Miscellaneous Water Level Sag**

Distance (ft): **153.0**
Structural Grade: **2**
O&M Grade: **0**
Clock Start/From:
Clock To:
1st Value:
2nd Value:
Value Percent: **20.000**
Continuous Index: **F13**
Within 8" of Joint: **NO**
Remarks:

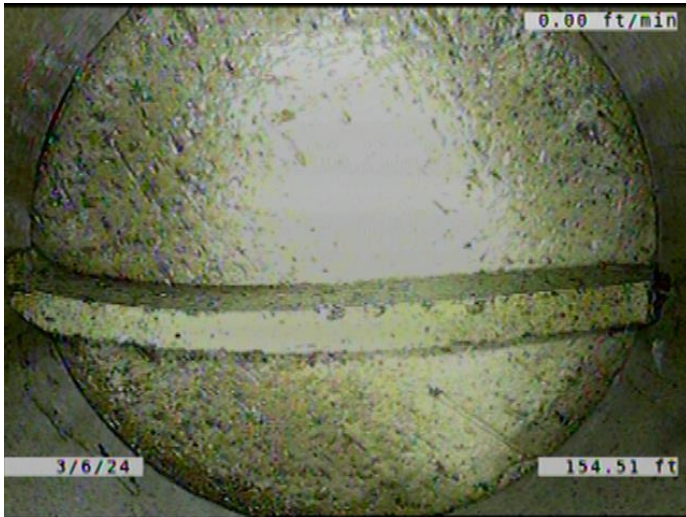
Code: **TFC**
Description: **Tap Factory Capped**

Distance (ft): **154.5**
Structural Grade: **0**
O&M Grade: **0**
Clock Start/From: **10**
Clock To:
1st Value: **6.000**
2nd Value:
Value Percent:
Continuous Index:
Within 8" of Joint: **YES**
Remarks:

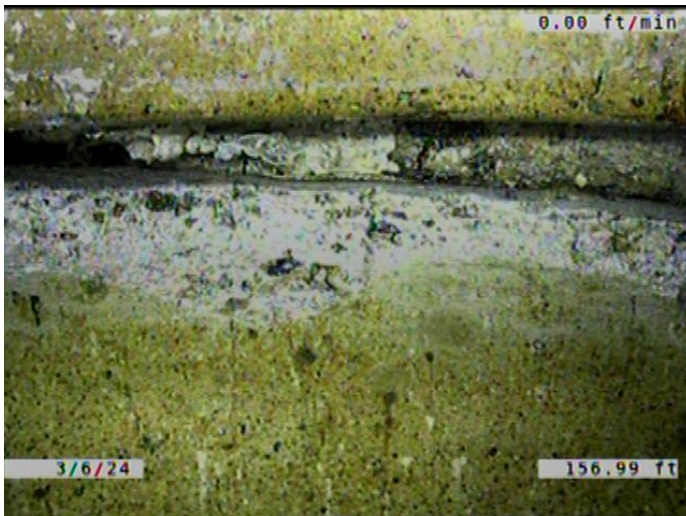
Code: **DAE**
Description: **Deposits Attached Encrustation**

Distance (ft): **157.0**
Structural Grade: **0**
O&M Grade: **2**
Clock Start/From: **7**
Clock To: **5**
1st Value:
2nd Value:
Value Percent: **5.000**
Continuous Index: **S15**
Within 8" of Joint: **YES**
Remarks:

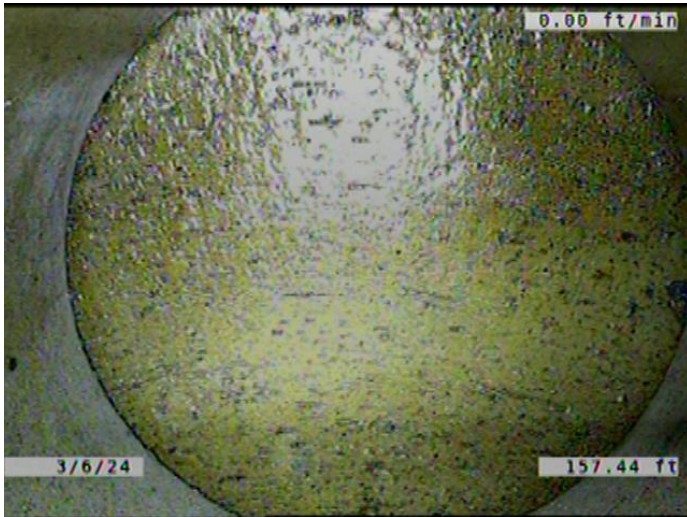
Code: **TFC**
 Description: **Tap Factory Capped**

Distance (ft): **157.4**
 Structural Grade: **0**
 O&M Grade: **0**
 Clock Start/From: **2**
 Clock To:
 1st Value: **6.000**
 2nd Value:
 Value Percent:
 Continuous Index:
 Within 8" of Joint: **YES**
 Remarks:

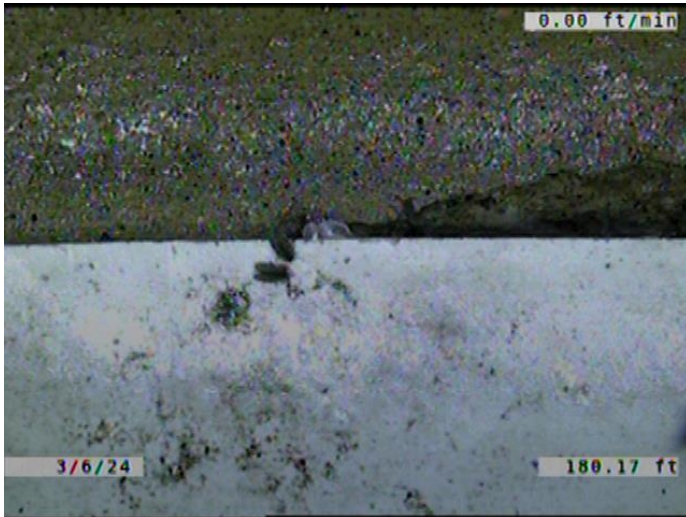
Code: **RPR**
Description: **Point Repair Replacement**

Distance (ft): **180.2**
Structural Grade: **0**
O&M Grade: **0**
Clock Start/From:
Clock To:
1st Value:
2nd Value:
Value Percent:
Continuous Index: **S17**
Within 8" of Joint: **YES**
Remarks: **REPLACED WITH PVC.**

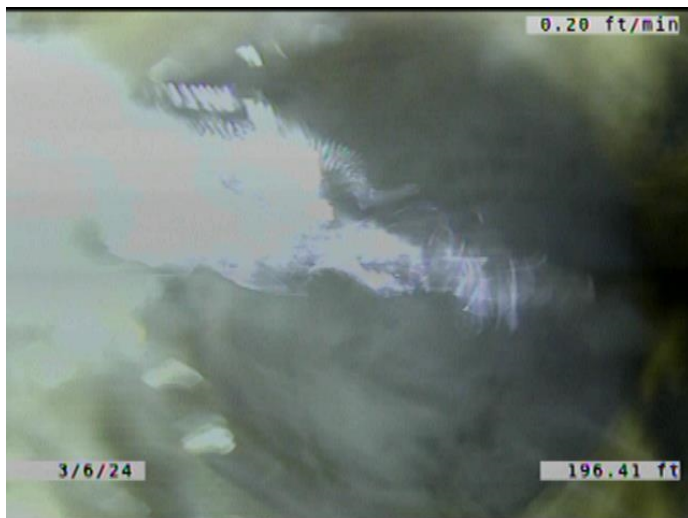
Code: **TF**
Description: **Tap Factory**

Distance (ft): **196.4**
Structural Grade: **0**
O&M Grade: **0**
Clock Start/From: **12**
Clock To:
1st Value: **6.000**
2nd Value:
Value Percent:
Continuous Index:
Within 8" of Joint: **YES**
Remarks: **CONSTANTLY RUNNING WATER.
SERVICE COMES FROM THE RIGHT (**

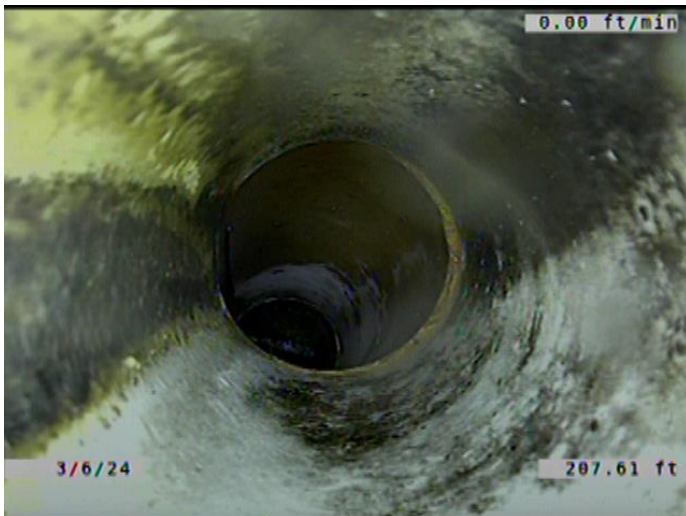
Code: **TF**
Description: **Tap Factory**

Distance (ft): **207.6**
Structural Grade: **0**
O&M Grade: **0**
Clock Start/From: **11**
Clock To:
1st Value: **6.000**
2nd Value:
Value Percent:
Continuous Index:
Within 8" of Joint: **YES**
Remarks: **TAP IS PVC. SERVICE IS VCP. CONSTANTLY RUNNING WATER. RO**

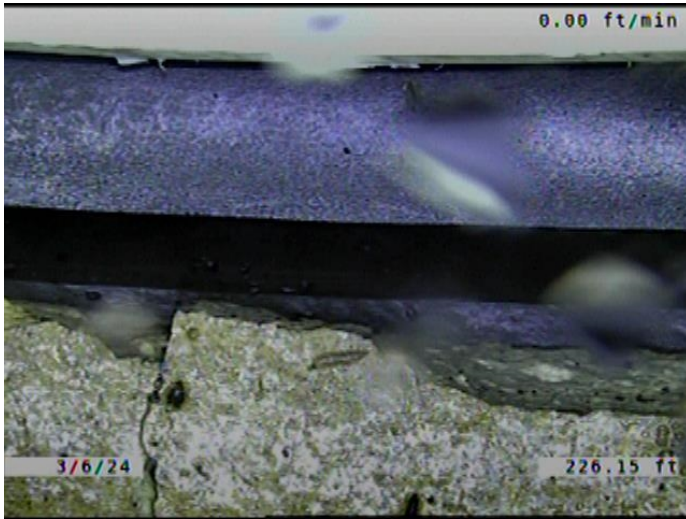
Code: **RPR**
Description: **Point Repair Replacement**

Distance (ft): **226.1**
Structural Grade: **0**
O&M Grade: **0**
Clock Start/From:
Clock To:
1st Value:
2nd Value:
Value Percent:
Continuous Index: **F17**
Within 8" of Joint: **YES**
Remarks: **REPLACED WITH PVC.**

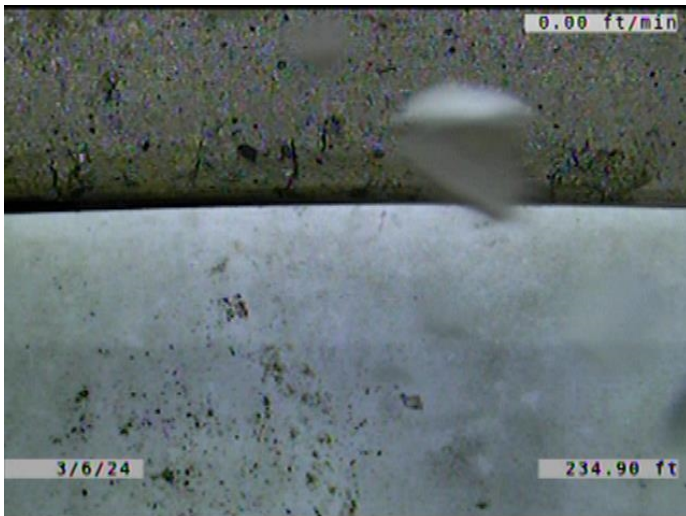
Code: **RPR**
Description: **Point Repair Replacement**

Distance (ft): **234.7**
Structural Grade: **0**
O&M Grade: **0**
Clock Start/From:
Clock To:
1st Value:
2nd Value:
Value Percent:
Continuous Index: **S20**
Within 8" of Joint: **YES**
Remarks: **REPLACED WITH PVC.**

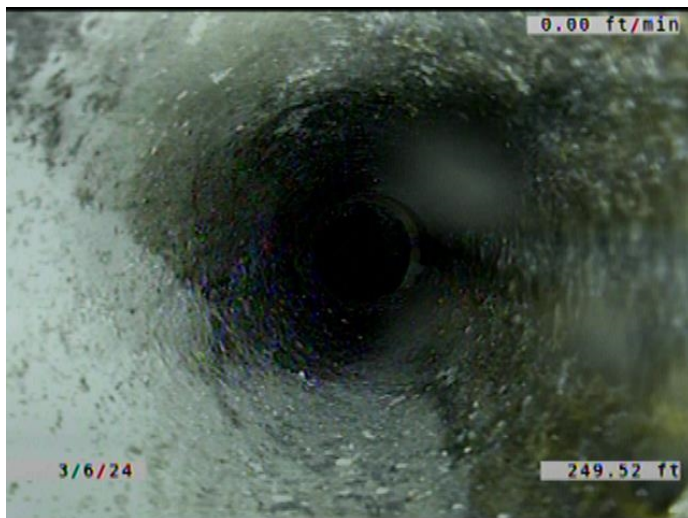
Code: **TF**
Description: **Tap Factory**

Distance (ft): **249.5**
Structural Grade: **0**
O&M Grade: **0**
Clock Start/From: **2**
Clock To:
1st Value: **6.000**
2nd Value:
Value Percent:
Continuous Index:
Within 8" of Joint: **YES**
Remarks: **TAP PVC. SERVICE VCP.**

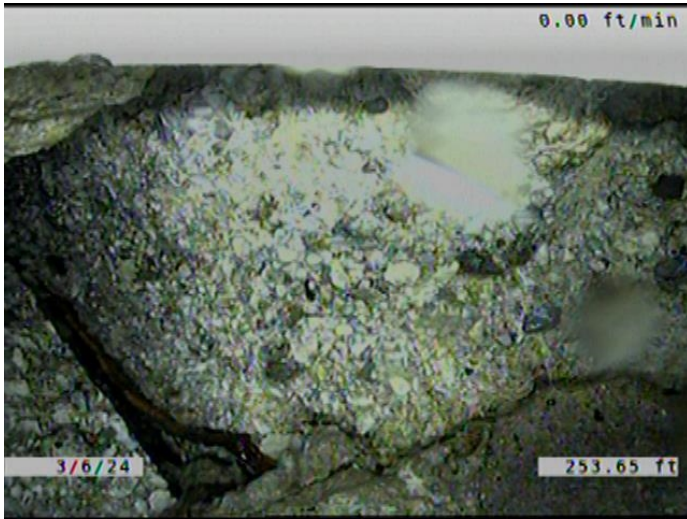
Code: **RPR**
Description: **Point Repair Replacement**

Distance (ft): **253.6**
Structural Grade: **0**
O&M Grade: **0**
Clock Start/From:
Clock To:
1st Value:
2nd Value:
Value Percent:
Continuous Index: **F20**
Within 8" of Joint: **YES**
Remarks: **REPLACED WITH PVC.**

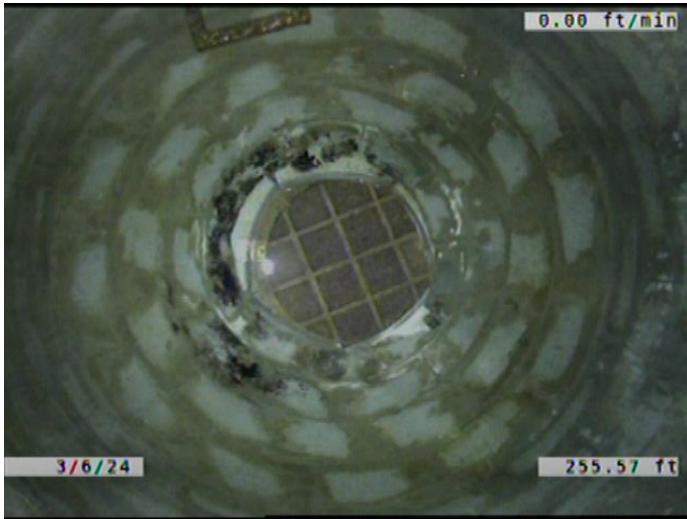
Code:	AMH
Description:	Manhole
Distance (ft):	255.6
Structural Grade:	0
O&M Grade:	0
Clock Start/From:	
Clock To:	
1st Value:	
2nd Value:	
Value Percent:	
Continuous Index:	
Within 8" of Joint:	NO
Remarks:	M-405-040
