## Profile/Photo Observation Report

Date:	<b>04/20/2018</b>	Weather:		Coding:	<b>PACP 6.0</b>
Pipe Length (ft):	<b>305.1</b>	Owner:	<b>NA</b>	Pre Clean:	<b>No Pre-Cleaning</b>
P.O.#:		Surveyor:	<b>Byrd Fitzgerald</b>	PSR:	<b>P-405-041-040</b>
Customer:		Clean Date:	<b>01/01/1900</b>	Shape:	<b>C</b>

Street:	<b>ALLEY BETWEEN SOFTWOOD DR &amp; 3</b>	Flow Control:	<b>Not Controlled</b>
City:	<b>Hobart, IN</b>	Year Renewed:	
Location:	<b>Yard</b>	Tape/Media #:	
Purpose:	<b>Routine Assessment</b>	Dia/Height:	<b>8"</b>
Use:	<b>Sanitary</b>	Material:	<b>PVC</b>
Drain Area:	<b>NA</b>	Lining:	
Category:	<b>NA</b>		
Comment:	<b>P_C at 142 ft roots Flow direction wrong</b>		
Location Details:		Direction of Survey:	<b>Upstream</b>
US MH:	<b>M-405-040</b>	DS MH:	<b>M-405-041</b>
		Total Length Surveyed (ft):	<b>143.4</b>

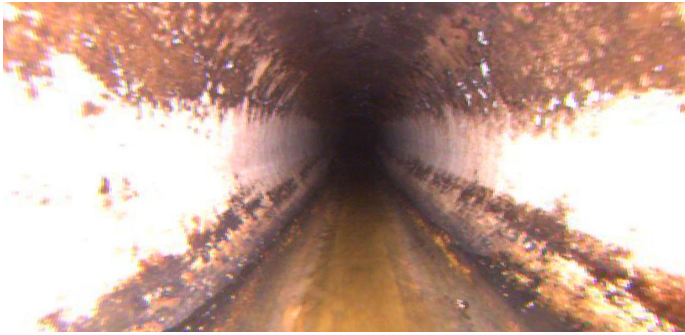
Code: **AMH**  
Description: **Manhole**

Distance (ft): **.0**  
Structural Grade: **0**  
O&M Grade: **0**  
Clock Start/From:  
Clock To:  
1st Value:  
2nd Value:  
Value Percent:  
Continuous Index:  
Within 8" of Joint: **NO**  
Remarks: **M-405-041**

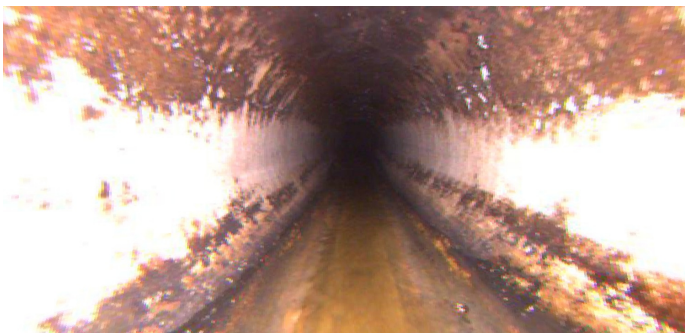
Code: **MWL**  
Description: **Water Level**

Distance (ft): **.0**  
Structural Grade: **0**  
O&M Grade: **0**  
Clock Start/From:  
Clock To:  
1st Value:  
2nd Value:  
Value Percent: **5.000**  
Continuous Index:  
Within 8" of Joint: **NO**  
Remarks:

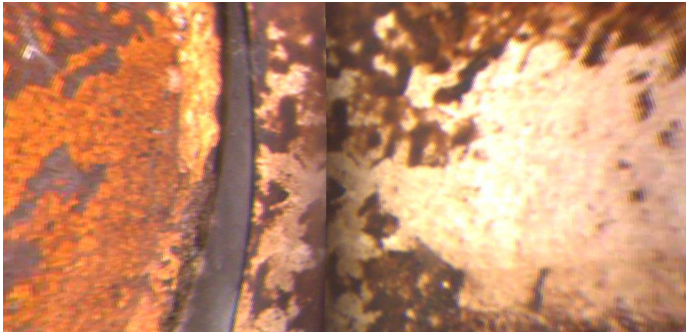
Code: **MMC**  
Description: **Material Change**

Distance (ft): **9.9**  
Structural Grade: **0**  
O&M Grade: **0**  
Clock Start/From:  
Clock To:  
1st Value:  
2nd Value:  
Value Percent:  
Continuous Index:  
Within 8" of Joint: **NO**  
Remarks: **vcp**

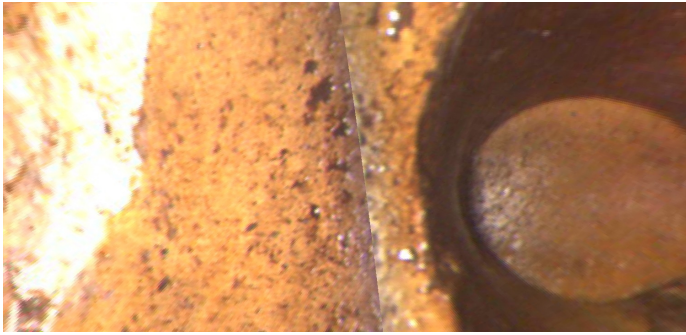
Code: **TFC**  
Description: **Tap Factory Capped**

Distance (ft): **22.5**  
Structural Grade: **0**  
O&M Grade: **0**  
Clock Start/From: **2**  
Clock To:  
1st Value: **4.000**  
2nd Value:  
Value Percent:  
Continuous Index:  
Within 8" of Joint: **YES**  
Remarks:

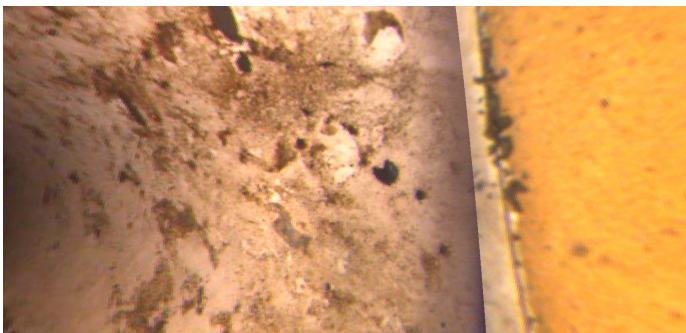
Code: **MMC**  
Description: **Material Change**

Distance (ft): **27.5**  
Structural Grade: **0**  
O&M Grade: **0**  
Clock Start/From:  
Clock To:  
1st Value:  
2nd Value:  
Value Percent:  
Continuous Index:  
Within 8" of Joint: **NO**  
Remarks: **pvc**

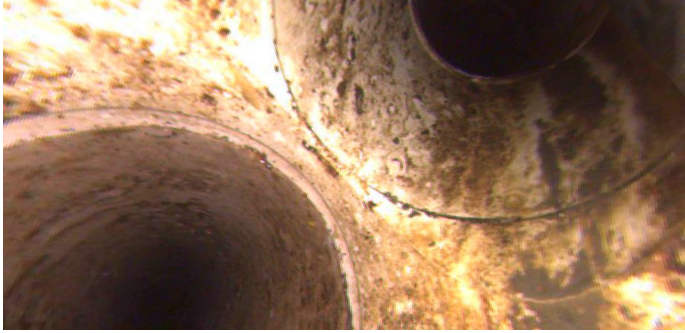
Code: **TF**  
Description: **Tap Factory**

Distance (ft): **29.9**  
Structural Grade: **0**  
O&M Grade: **0**  
Clock Start/From: **1**  
Clock To:  
1st Value: **4.000**  
2nd Value:  
Value Percent:  
Continuous Index:  
Within 8" of Joint: **YES**  
Remarks:

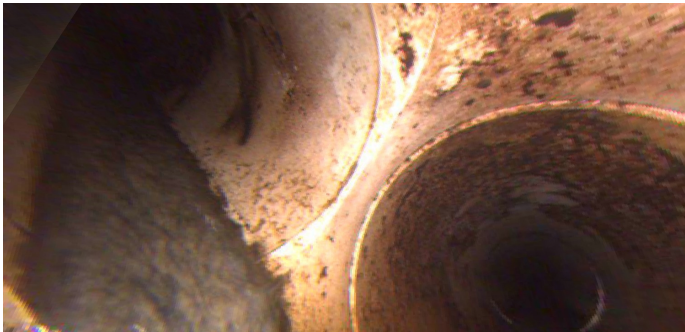
Code: **TF**  
Description: **Tap Factory**

Distance (ft): **53.6**  
Structural Grade: **0**  
O&M Grade: **0**  
Clock Start/From: **10**  
Clock To:  
1st Value: **4.000**  
2nd Value:  
Value Percent:  
Continuous Index:  
Within 8" of Joint: **YES**  
Remarks:

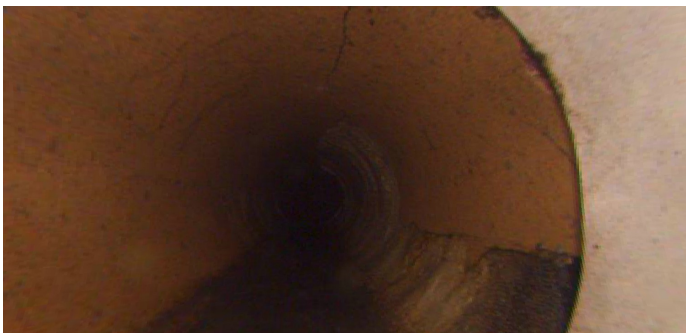
Code: **MMC**  
Description: **Material Change**

Distance (ft): **63.0**  
Structural Grade: **0**  
O&M Grade: **0**  
Clock Start/From:  
Clock To:  
1st Value:  
2nd Value:  
Value Percent:  
Continuous Index:  
Within 8" of Joint: **NO**  
Remarks: **vcp**

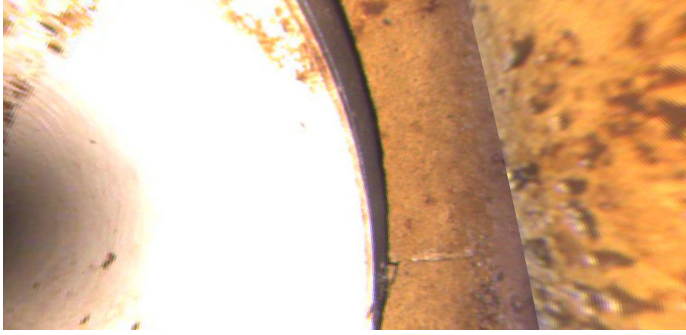
Code: **MMC**  
Description: **Material Change**

Distance (ft): **100.5**  
Structural Grade: **0**  
O&M Grade: **0**  
Clock Start/From:  
Clock To:  
1st Value:  
2nd Value:  
Value Percent:  
Continuous Index:  
Within 8" of Joint: **NO**  
Remarks: **pvc**

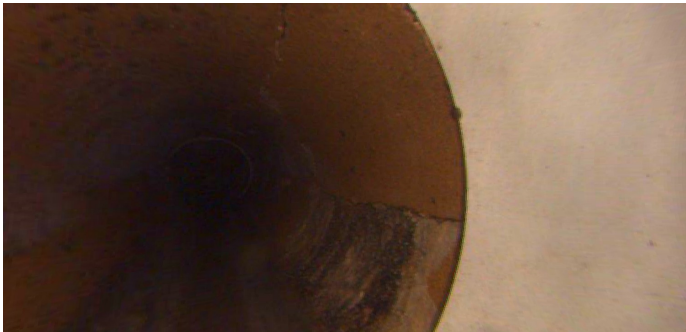
Code: **MMC**  
Description: **Material Change**

Distance (ft): **110.4**  
Structural Grade: **0**  
O&M Grade: **0**  
Clock Start/From:  
Clock To:  
1st Value:  
2nd Value:  
Value Percent:  
Continuous Index:  
Within 8" of Joint: **NO**  
Remarks: **vcp**

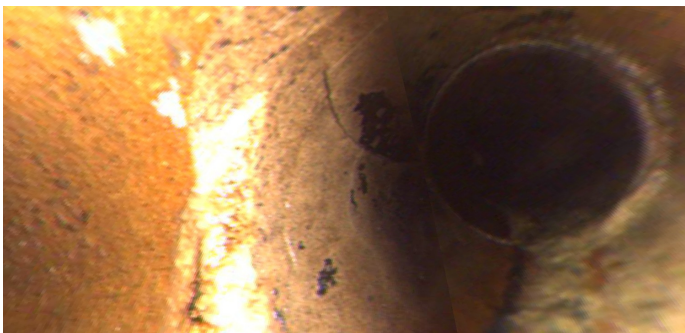
Code: **TF**  
Description: **Tap Factory**

Distance (ft): **125.9**  
Structural Grade: **0**  
O&M Grade: **0**  
Clock Start/From: **2**  
Clock To:  
1st Value: **4.000**  
2nd Value:  
Value Percent:  
Continuous Index:  
Within 8" of Joint: **YES**  
Remarks:
