Profile/Photo Observation Report

Date:	04/20/2018	Weather:		Coding:	PACP 6.0
Pipe Length (ft):	305.1	Owner:	NA	Pre Clean:	No Pre-Cleaning
P.O.#:		Surveyor:	Byrd Fitzgerald	PSR:	P-405-041-040
Customer:		Clean Date:	01/01/1900	Shape:	C

Street:	FOXCROFT STREET	Flow Control:	Not Controlled
City:	Hobart, IN	Year Renewed:	
Location:	Yard	Tape/Media #:	
Purpose:	Routine Assessment	Dia/Height:	8"
Use:	Sanitary	Material:	PVC
Drain Area:	NA	Lining:	
Category:	NA		
Comment:	P_C at 142 ft roots Flow direction wrong		
Location Details:		Direction of Survey:	Upstream
US MH:	M-405-040	DS MH:	M-405-041
		Total Length Surveyed (ft):	143.4

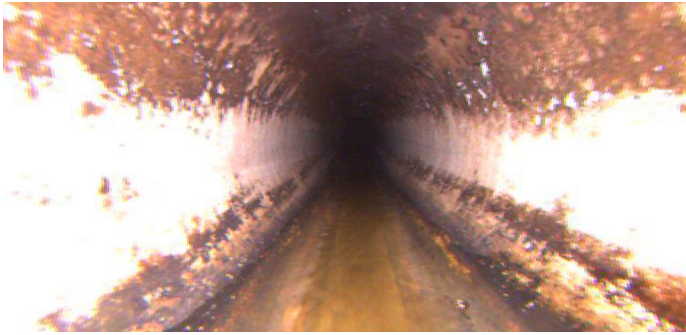
Code: **AMH**
Description: **Manhole**

Distance (ft): **.0**
Structural Grade: **0**
O&M Grade: **0**
Clock Start/From:
Clock To:
1st Value:
2nd Value:
Value Percent:
Continuous Index:
Within 8" of Joint: **NO**
Remarks: **M-405-041**

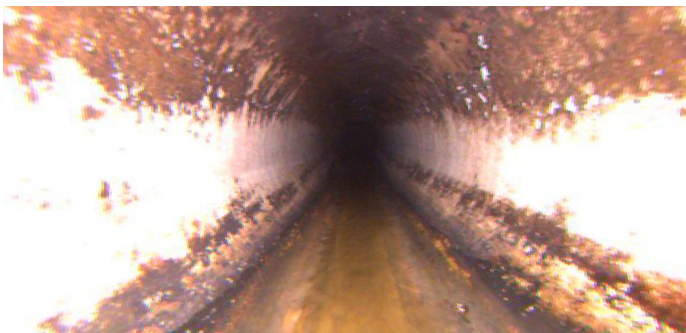
Code: **MWL**
Description: **Water Level**

Distance (ft): **.0**
Structural Grade: **0**
O&M Grade: **0**
Clock Start/From:
Clock To:
1st Value:
2nd Value:
Value Percent: **5.000**
Continuous Index:
Within 8" of Joint: **NO**
Remarks:

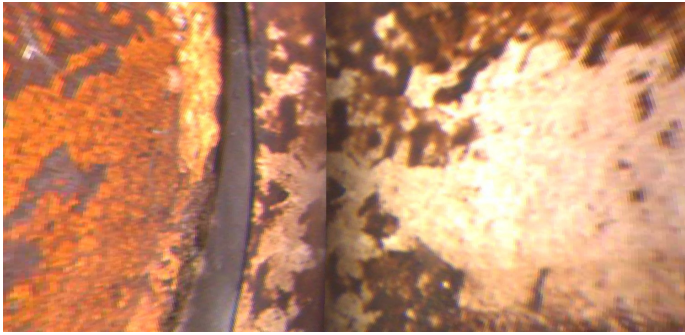
Code: **MMC**
Description: **Material Change**

Distance (ft): **9.9**
Structural Grade: **0**
O&M Grade: **0**
Clock Start/From:
Clock To:
1st Value:
2nd Value:
Value Percent:
Continuous Index:
Within 8" of Joint: **NO**
Remarks: **vcp**

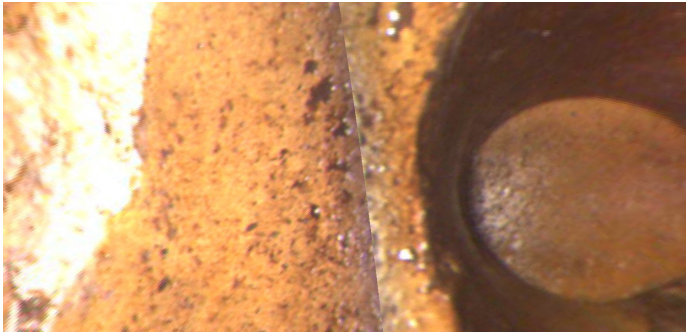
Code: **TFC**
Description: **Tap Factory Capped**

Distance (ft): **22.5**
Structural Grade: **0**
O&M Grade: **0**
Clock Start/From: **2**
Clock To:
1st Value: **4.000**
2nd Value:
Value Percent:
Continuous Index:
Within 8" of Joint: **YES**
Remarks:

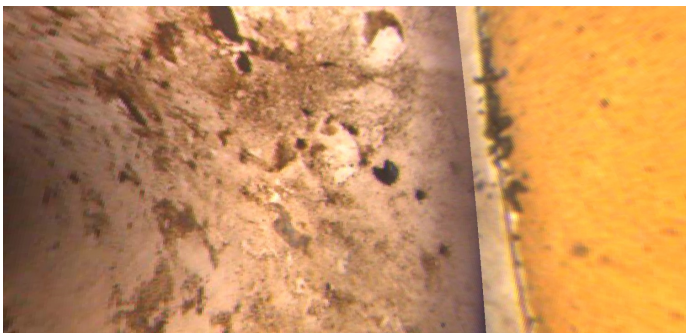
Code: **MMC**
Description: **Material Change**

Distance (ft): **27.5**
Structural Grade: **0**
O&M Grade: **0**
Clock Start/From:
Clock To:
1st Value:
2nd Value:
Value Percent:
Continuous Index:
Within 8" of Joint: **NO**
Remarks: **pvc**

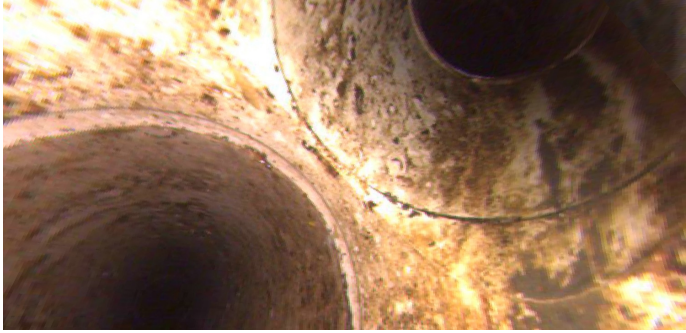
Code: **TF**
Description: **Tap Factory**

Distance (ft): **29.9**
Structural Grade: **0**
O&M Grade: **0**
Clock Start/From: **1**
Clock To:
1st Value: **4.000**
2nd Value:
Value Percent:
Continuous Index:
Within 8" of Joint: **YES**
Remarks:

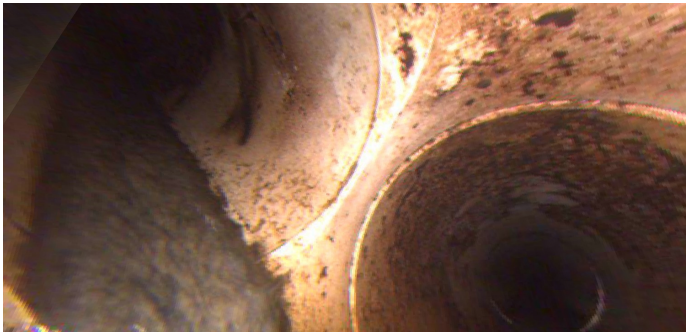
Code: **TF**
Description: **Tap Factory**

Distance (ft): **53.6**
Structural Grade: **0**
O&M Grade: **0**
Clock Start/From: **10**
Clock To:
1st Value: **4.000**
2nd Value:
Value Percent:
Continuous Index:
Within 8" of Joint: **YES**
Remarks:

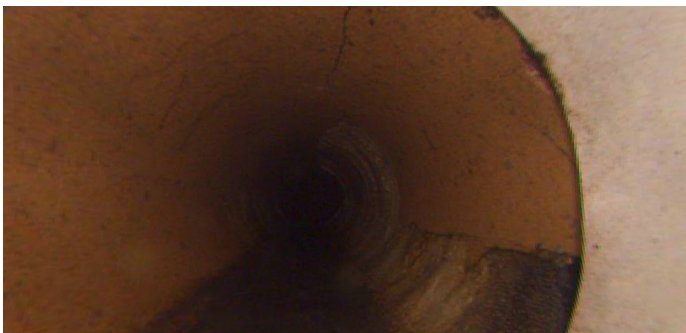
Code: **MMC**
Description: **Material Change**

Distance (ft): **63.0**
Structural Grade: **0**
O&M Grade: **0**
Clock Start/From:
Clock To:
1st Value:
2nd Value:
Value Percent:
Continuous Index:
Within 8" of Joint: **NO**
Remarks: **vcp**

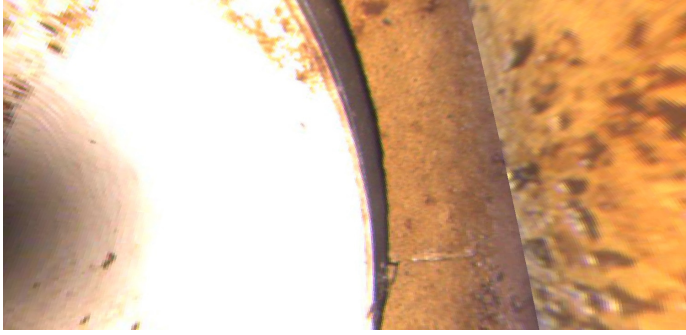
Code: **MMC**
Description: **Material Change**

Distance (ft): **100.5**
Structural Grade: **0**
O&M Grade: **0**
Clock Start/From:
Clock To:
1st Value:
2nd Value:
Value Percent:
Continuous Index:
Within 8" of Joint: **NO**
Remarks: **pvc**

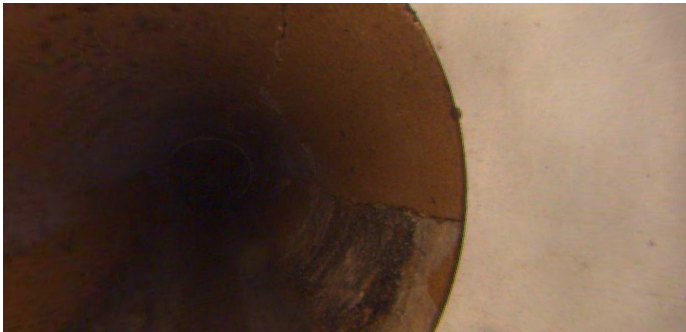
Code: **MMC**
Description: **Material Change**

Distance (ft): **110.4**
Structural Grade: **0**
O&M Grade: **0**
Clock Start/From:
Clock To:
1st Value:
2nd Value:
Value Percent:
Continuous Index:
Within 8" of Joint: **NO**
Remarks: **vcp**

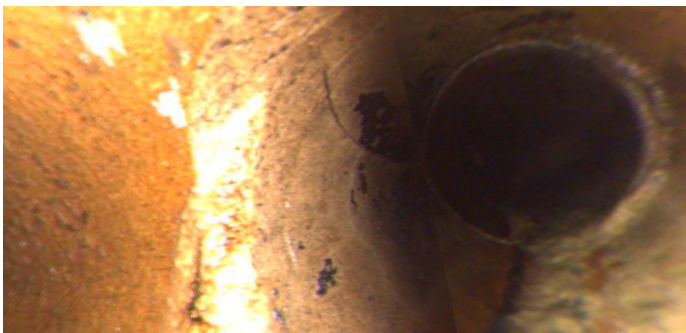
Code: **TF**
Description: **Tap Factory**

Distance (ft): **125.9**
Structural Grade: **0**
O&M Grade: **0**
Clock Start/From: **2**
Clock To:
1st Value: **4.000**
2nd Value:
Value Percent:
Continuous Index:
Within 8" of Joint: **YES**
Remarks:
