Profile/Photo Observation Report

| Pipe Length (ft): | 305.0 | Owner: | City of Hobart | Pre Clean: | Heavy Cleaning |

| Street: | SOFTWOOD DR | Flow Control: | Not Controlled |
| US MH: | M-405-040 | DS MH: | M-405-041 |

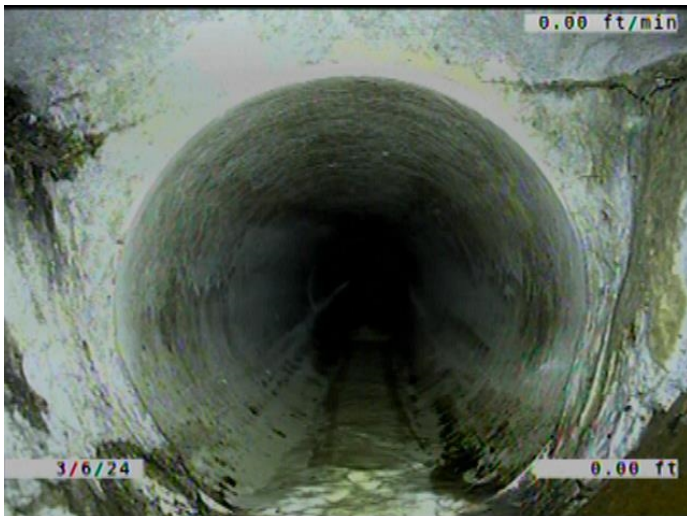
Code: **AMH**
Description: **Manhole**

Distance (ft): **.0**
Structural Grade: **0**
O&M Grade: **0**
Clock Start/From:
Clock To:
1st Value:
2nd Value:
Value Percent:
Continuous Index:
Within 8" of Joint: **NO**
Remarks: **M-405-040**

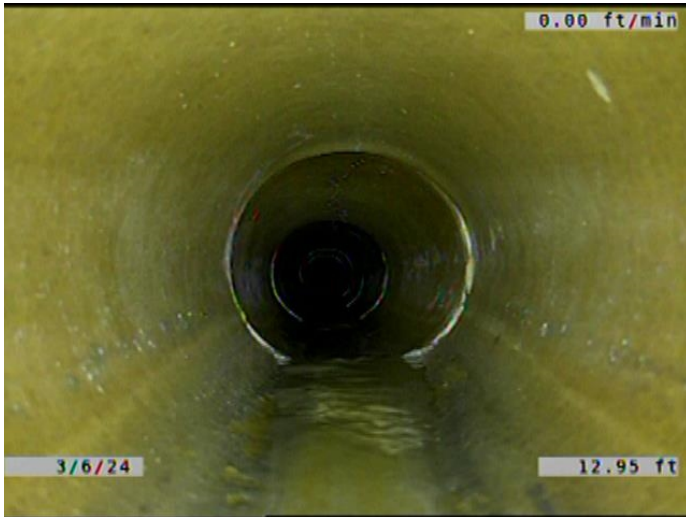
Code: **JAM**
Description: **Joint Angular Medium**

Distance (ft): **13.0**
Structural Grade: **3**
O&M Grade: **0**
Clock Start/From:
Clock To:
1st Value:
2nd Value:
Value Percent:
Continuous Index:
Within 8" of Joint: **NO**
Remarks:

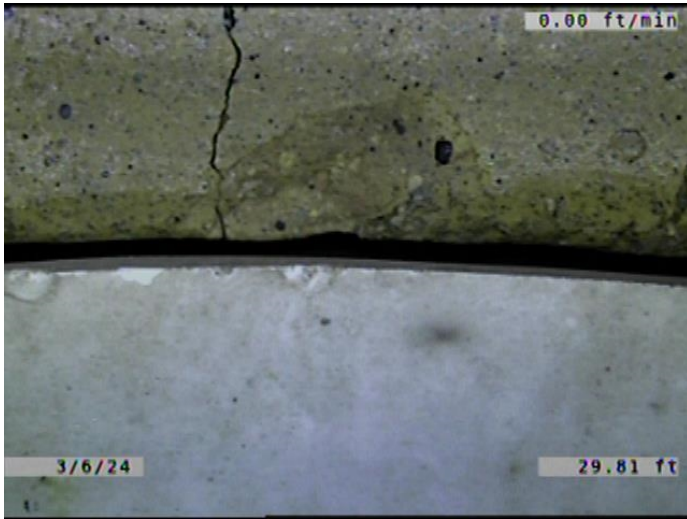
Code: **TFD**
Description: **Tap Factory Defective**

Distance (ft): **24.6**
Structural Grade: **0**
O&M Grade: **3**
Clock Start/From: **2**
Clock To:
1st Value: **6.000**
2nd Value:
Value Percent:
Continuous Index:
Within 8" of Joint: **YES**
Remarks: **CAPPED. TAP FRACTURED.
ENCrustation COMING AROUND T**

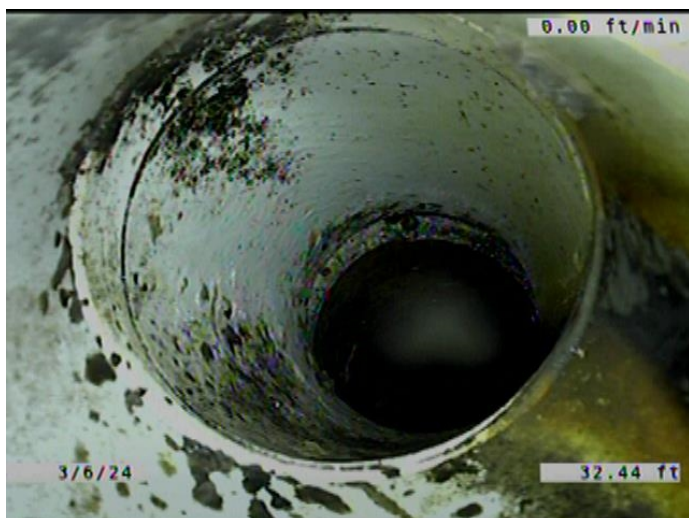
Code: **DAE**
Description: **Deposits Attached Encrustation**

Distance (ft): **30.0**
Structural Grade: **0**
O&M Grade: **2**
Clock Start/From: **7**
Clock To: **5**
1st Value:
2nd Value:
Value Percent: **5.000**
Continuous Index: **F04**
Within 8" of Joint: **YES**
Remarks:

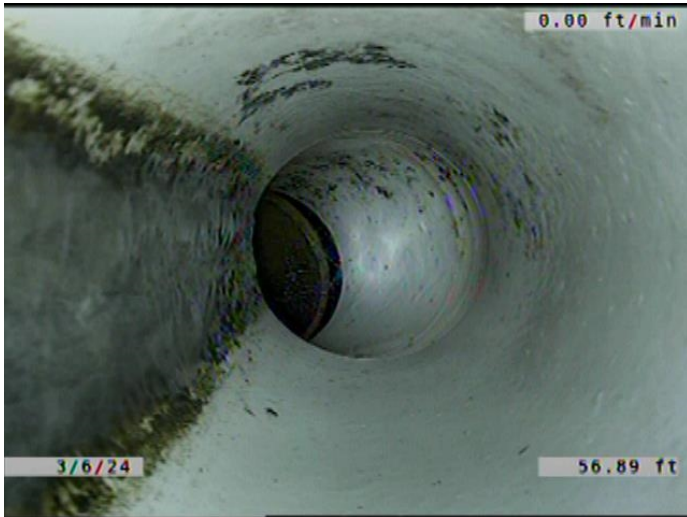
Code: **TF**
Description: **Tap Factory**

Distance (ft): **32.4**
Structural Grade: **0**
O&M Grade: **0**
Clock Start/From: **1**
Clock To:
1st Value: **6.000**
2nd Value:
Value Percent:
Continuous Index:
Within 8" of Joint: **YES**
Remarks: **TAP PVC. SERVICE VCP.**

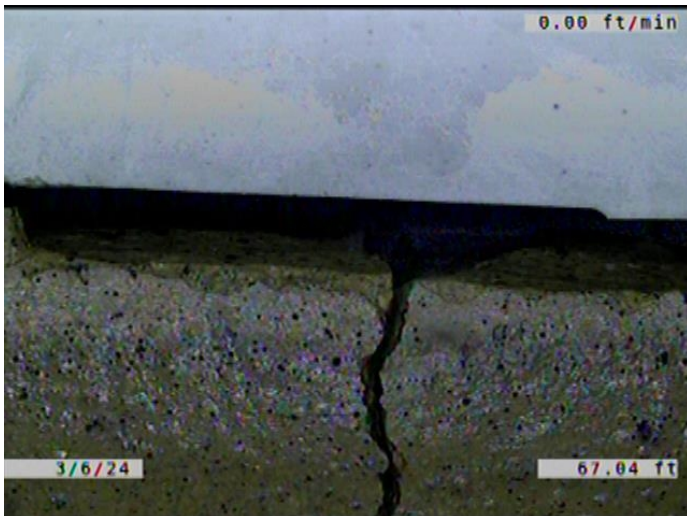
Code: **TF**
Description: **Tap Factory**

Distance (ft): **56.9**
Structural Grade: **0**
O&M Grade: **0**
Clock Start/From: **10**
Clock To:
1st Value: **6.000**
2nd Value:
Value Percent:
Continuous Index:
Within 8" of Joint: **YES**
Remarks: **TAP PVC. SERVICE VCP.**

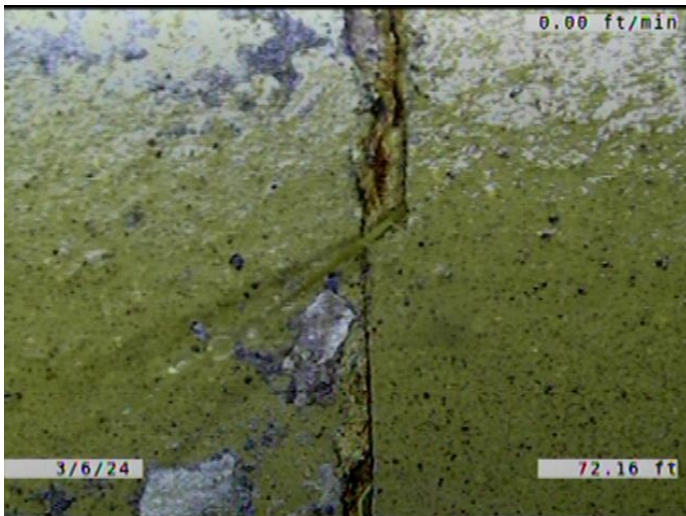
Code: **DAE**
 Description: **Deposits Attached Encrustation**

Distance (ft): **69.4**
 Structural Grade: **0**
 O&M Grade: **2**
 Clock Start/From: **7**
 Clock To: **5**
 1st Value:
 2nd Value:
 Value Percent: **5.000**
 Continuous Index: **S07**
 Within 8" of Joint: **YES**
 Remarks:

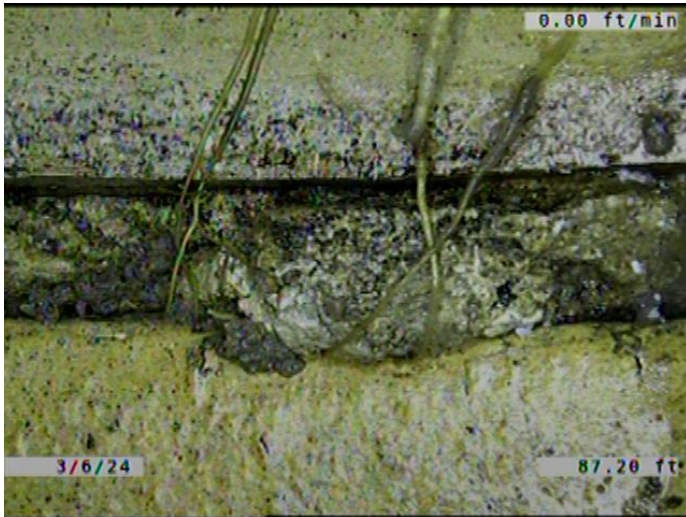
Code: **RFB**
 Description: **Roots Fine Barrel**

Distance (ft): **72.2**
 Structural Grade: **0**
 O&M Grade: **2**
 Clock Start/From: **8**
 Clock To: **4**
 1st Value:
 2nd Value:
 Value Percent:
 Continuous Index: **S08**
 Within 8" of Joint: **NO**
 Remarks:

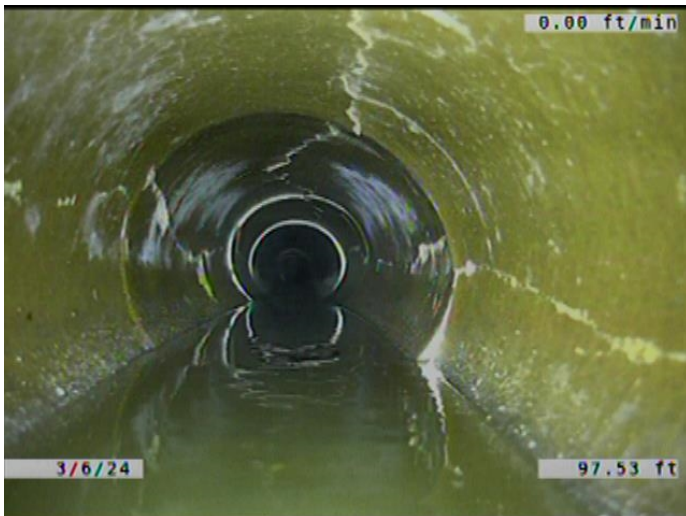
Code: **RFJ**
Description: **Roots Fine Joint**

Distance (ft): **87.2**
Structural Grade: **0**
O&M Grade: **1**
Clock Start/From: **7**
Clock To: **10**
1st Value:
2nd Value:
Value Percent:
Continuous Index:
Within 8" of Joint: **YES**
Remarks:

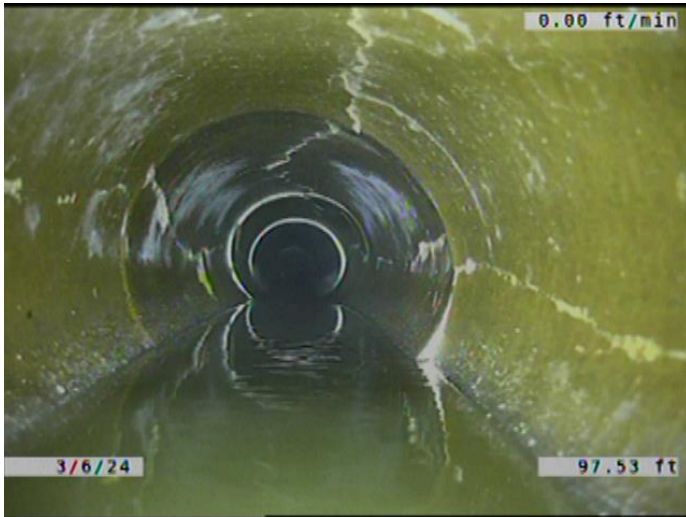
Code: **RFB**
Description: **Roots Fine Barrel**

Distance (ft): **97.5**
Structural Grade: **0**
O&M Grade: **2**
Clock Start/From: **8**
Clock To: **4**
1st Value:
2nd Value:
Value Percent:
Continuous Index: **F08**
Within 8" of Joint: **NO**
Remarks:

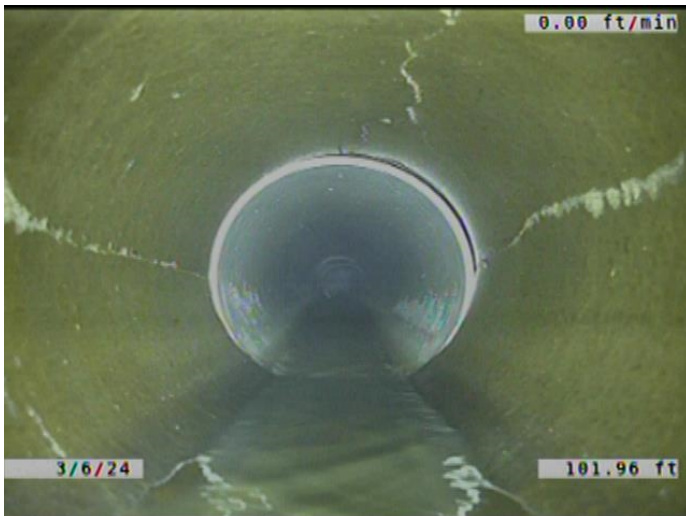
Code: **MWLS**
Description: **Miscellaneous Water Level Sag**

Distance (ft): **97.5**
Structural Grade: **2**
O&M Grade: **0**
Clock Start/From:
Clock To:
1st Value:
2nd Value:
Value Percent: **10.000**
Continuous Index: **S09**
Within 8" of Joint: **NO**
Remarks:

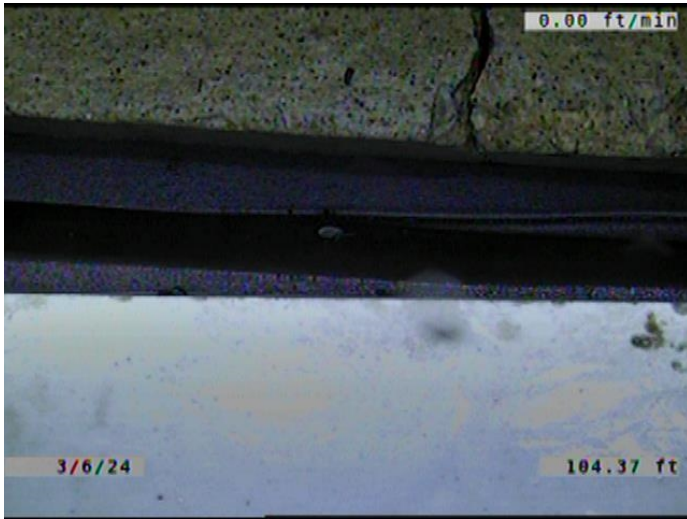
Code: **MWLS**
Description: **Miscellaneous Water Level Sag**

Distance (ft): **102.0**
Structural Grade: **2**
O&M Grade: **0**
Clock Start/From:
Clock To:
1st Value:
2nd Value:
Value Percent: **10.000**
Continuous Index: **F09**
Within 8" of Joint: **NO**
Remarks:

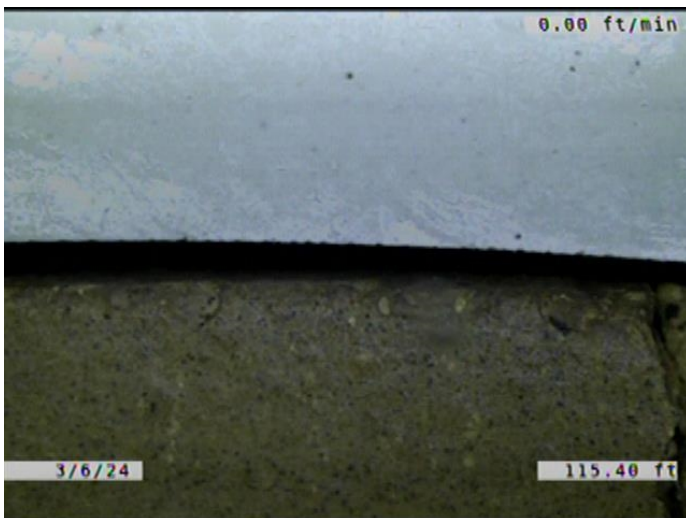
Code: **DAE**
Description: **Deposits Attached Encrustation**

Distance (ft): **104.4**
Structural Grade: **0**
O&M Grade: **2**
Clock Start/From: **7**
Clock To: **5**
1st Value:
2nd Value:
Value Percent: **5.000**
Continuous Index: **F07**
Within 8" of Joint: **YES**
Remarks:

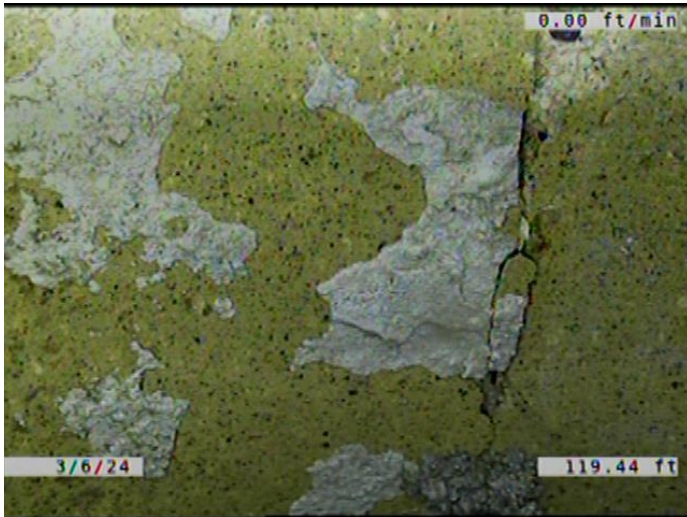
Code: **DAE**
Description: **Deposits Attached Encrustation**

Distance (ft): **116.3**
Structural Grade: **0**
O&M Grade: **2**
Clock Start/From: **8**
Clock To: **9**
1st Value:
2nd Value:
Value Percent: **5.000**
Continuous Index:
Within 8" of Joint: **YES**
Remarks:

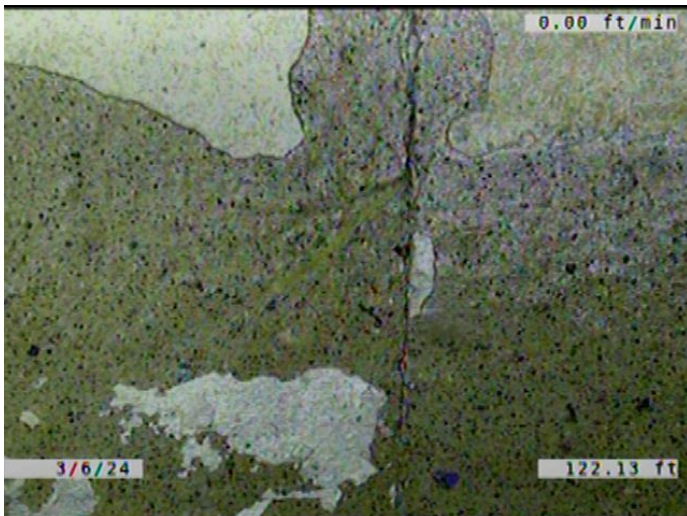
Code: **DAE**
Description: **Deposits Attached Encrustation**

Distance (ft): **119.4**
Structural Grade: **0**
O&M Grade: **2**
Clock Start/From: **7**
Clock To: **5**
1st Value:
2nd Value:
Value Percent: **5.000**
Continuous Index: **S12**
Within 8" of Joint: **YES**
Remarks:

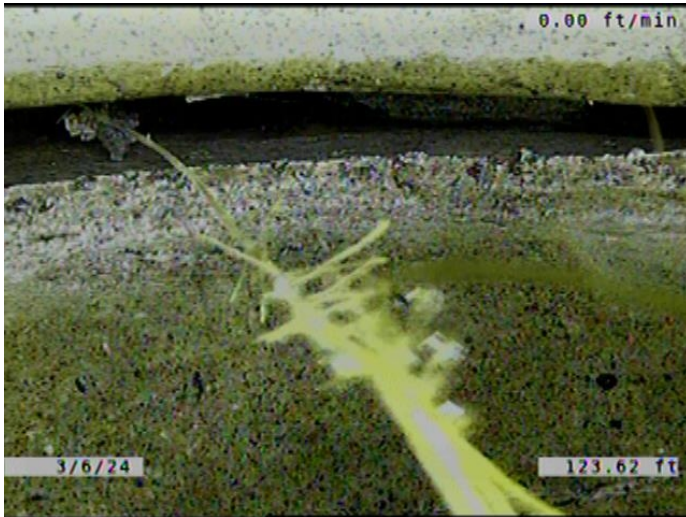
Code: **RFB**
Description: **Roots Fine Barrel**

Distance (ft): **122.1**
Structural Grade: **0**
O&M Grade: **2**
Clock Start/From: **8**
Clock To: **4**
1st Value:
2nd Value:
Value Percent:
Continuous Index: **S13**
Within 8" of Joint: **NO**
Remarks:

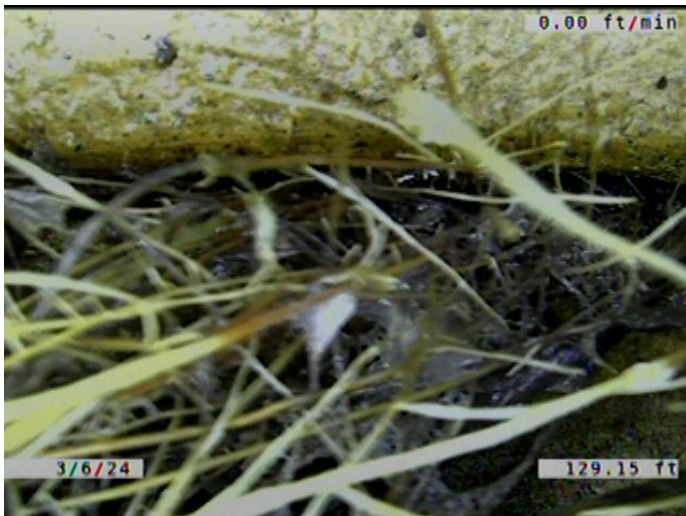
Code: **RFJ**
Description: **Roots Fine Joint**

Distance (ft): **123.6**
Structural Grade: **0**
O&M Grade: **1**
Clock Start/From: **7**
Clock To: **5**
1st Value:
2nd Value:
Value Percent:
Continuous Index: **S14**
Within 8" of Joint: **YES**
Remarks:

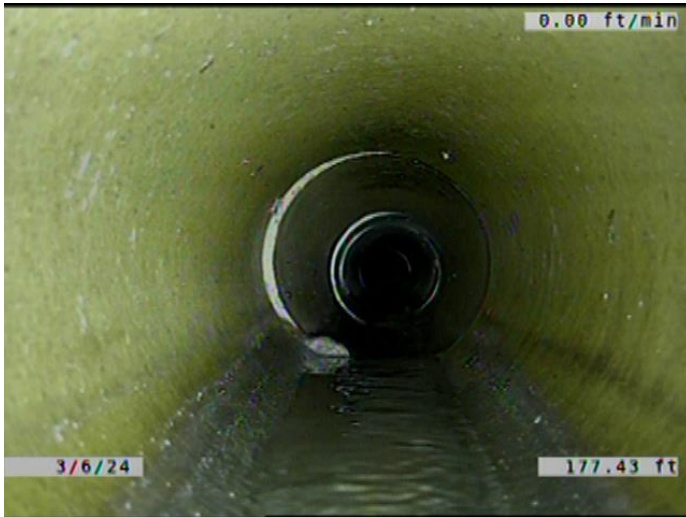
| 172.1 | FH4(F11) | Fracture Longitudinal Hinge, 4 | 2163 | S 4 |

| Code: | FH4 |
| Description: | Fracture Longitudinal Hinge, 4 |
| Distance (ft): | 172.1 |

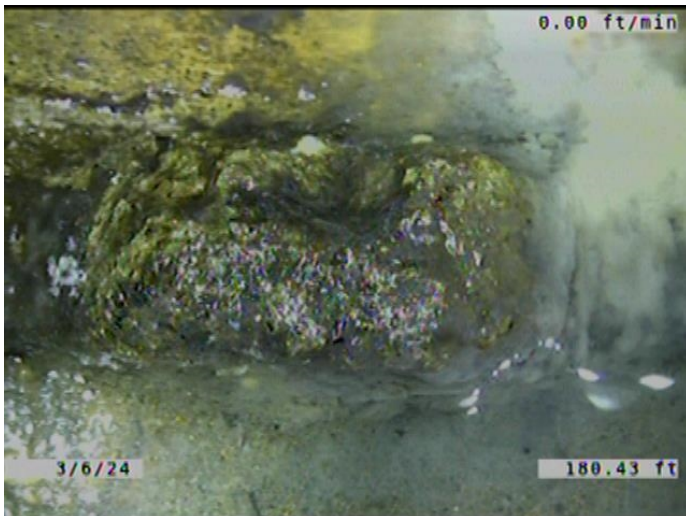
Code: **RFB**
Description: **Roots Fine Barrel**

Distance (ft): **177.4**
Structural Grade: **0**
O&M Grade: **2**
Clock Start/From: **8**
Clock To: **4**
1st Value:
2nd Value:
Value Percent:
Continuous Index: **F13**
Within 8" of Joint: **NO**
Remarks:

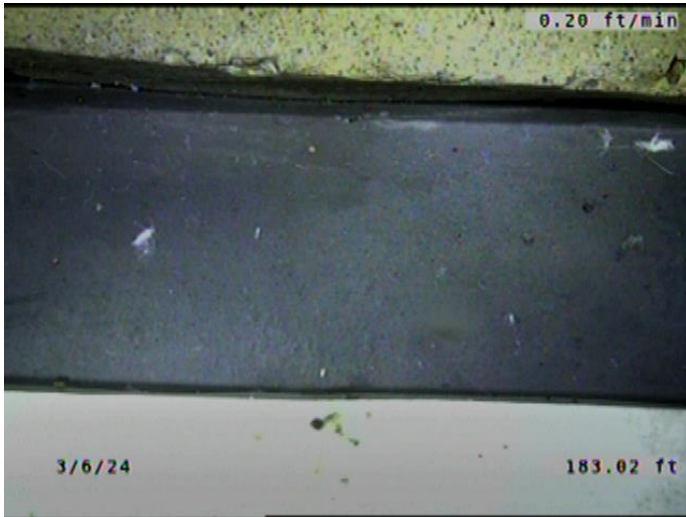
Code: **ISGT**
Description: **Intruding Sealing Material Grout**

Distance (ft): **180.4**
Structural Grade: **0**
O&M Grade: **2**
Clock Start/From: **7**
Clock To: **8**
1st Value:
2nd Value:
Value Percent: **5.000**
Continuous Index:
Within 8" of Joint: **NO**
Remarks:

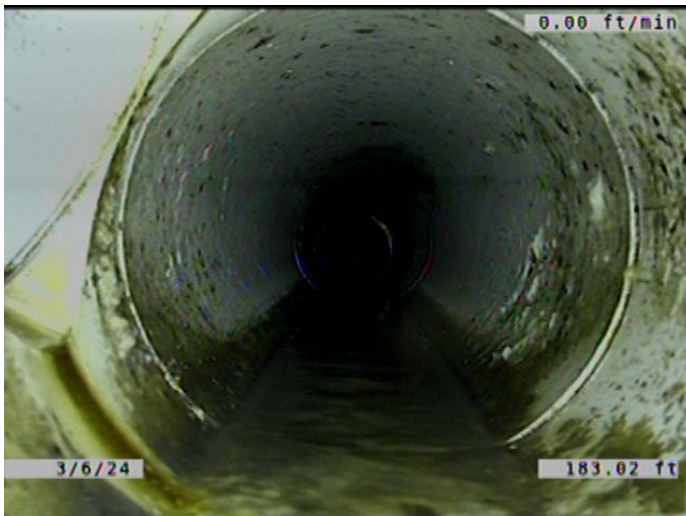
Code: **RPR**
Description: **Point Repair Replacement**

Distance (ft): **183.0**
Structural Grade: **0**
O&M Grade: **0**
Clock Start/From:
Clock To:
1st Value:
2nd Value:
Value Percent:
Continuous Index: **S15**
Within 8" of Joint: **YES**
Remarks: **REPLACED WITH PVC.**

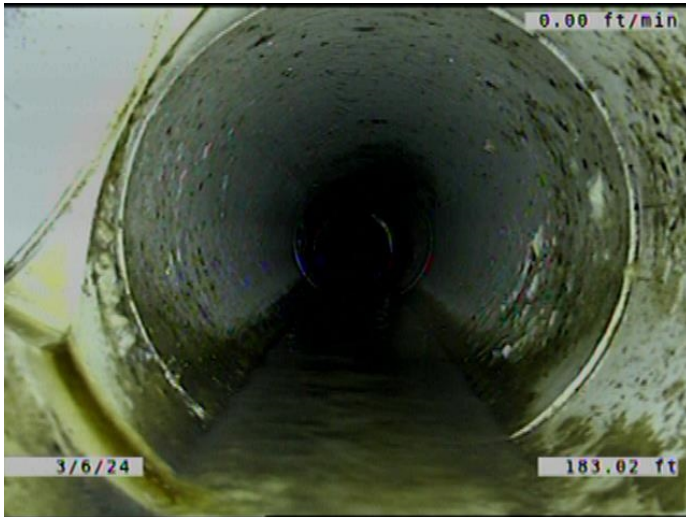
Code: **DAE**
Description: **Deposits Attached Encrustation**

Distance (ft): **183.0**
Structural Grade: **0**
O&M Grade: **2**
Clock Start/From: **7**
Clock To: **5**
1st Value:
2nd Value:
Value Percent: **5.000**
Continuous Index: **F12**
Within 8" of Joint: **YES**
Remarks:

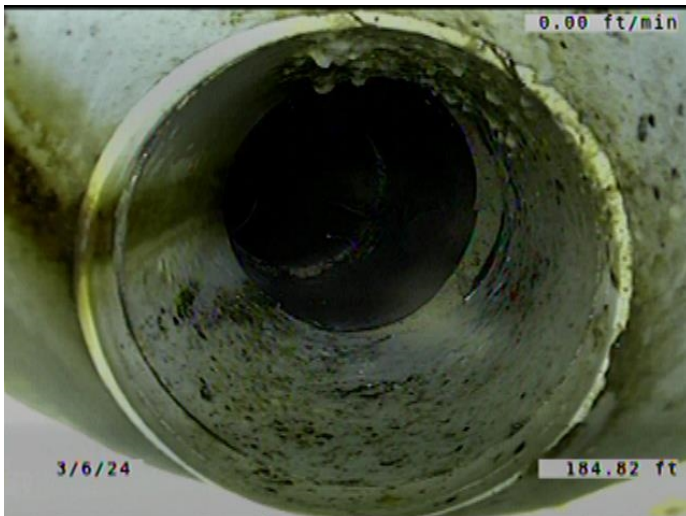
Code: **RFJ**
Description: **Roots Fine Joint**

Distance (ft): **183.0**
Structural Grade: **0**
O&M Grade: **1**
Clock Start/From: **7**
Clock To: **5**
1st Value:
2nd Value:
Value Percent:
Continuous Index: **F14**
Within 8" of Joint: **YES**
Remarks:

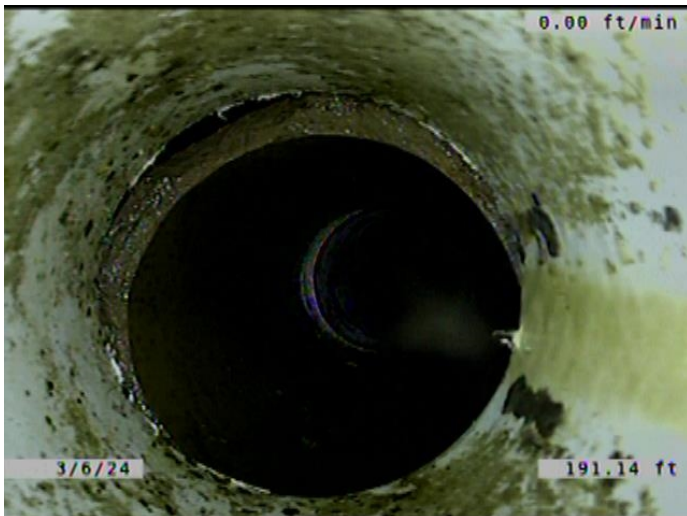
| 191.1 | IRL | Infiltration Runner Lateral | 2431 | M 4 |

Code: **IRL**
Description: **Infiltration Runner Lateral**

Distance (ft): **191.1**
Structural Grade: **0**
O&M Grade: **4**
Clock Start/From: **2**
Clock To:
1st Value:
2nd Value:
Value Percent:
Continuous Index:
Within 8" of Joint: **YES**
Remarks:

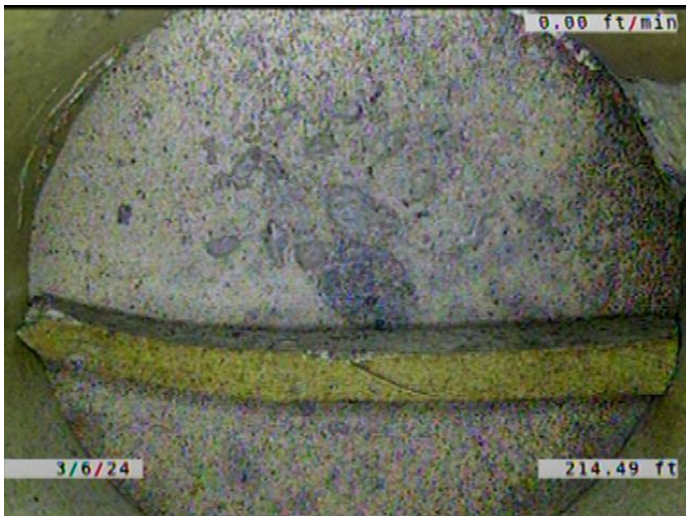
| 212.5 | FS | Fracture Spiral | 2990 | S 3 |

Code: **FS**
Description: **Fracture Spiral**

Distance (ft): **212.5**
Structural Grade: **3**
O&M Grade: **0**
Clock Start/From: **3**
Clock To: **4**
1st Value:
2nd Value:
Value Percent:
Continuous Index:
Within 8" of Joint: **YES**
Remarks:

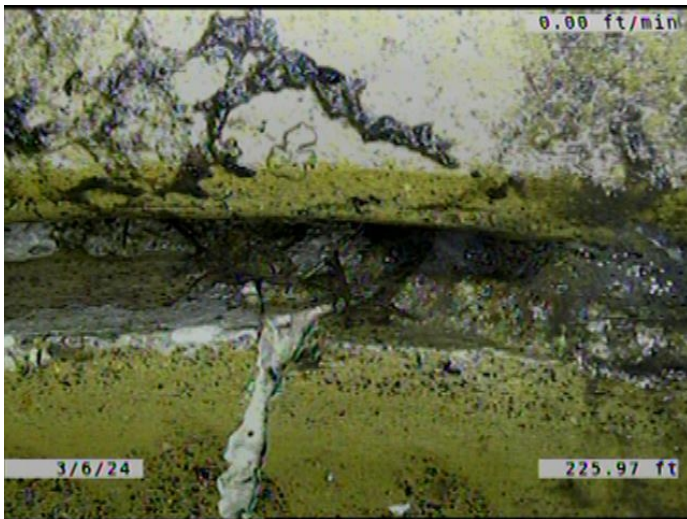
| 226.0 | B | Broken | 3292 | S 4 |

Code: **B**
Description: **Broken**

Distance (ft): **226.0**
Structural Grade: **4**
O&M Grade: **0**
Clock Start/From: **1**
Clock To: **5**
1st Value:
2nd Value:
Value Percent:
Continuous Index:
Within 8" of Joint: **YES**
Remarks:

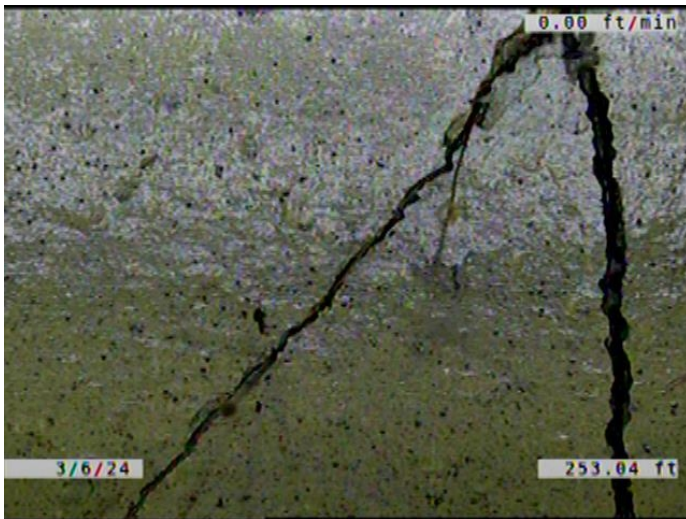
Code: **RFJ**
Description: **Roots Fine Joint**

Distance (ft): **249.8**
Structural Grade: **0**
O&M Grade: **1**
Clock Start/From: **7**
Clock To: **5**
1st Value:
2nd Value:
Value Percent:
Continuous Index: **S21**
Within 8" of Joint: **YES**
Remarks:

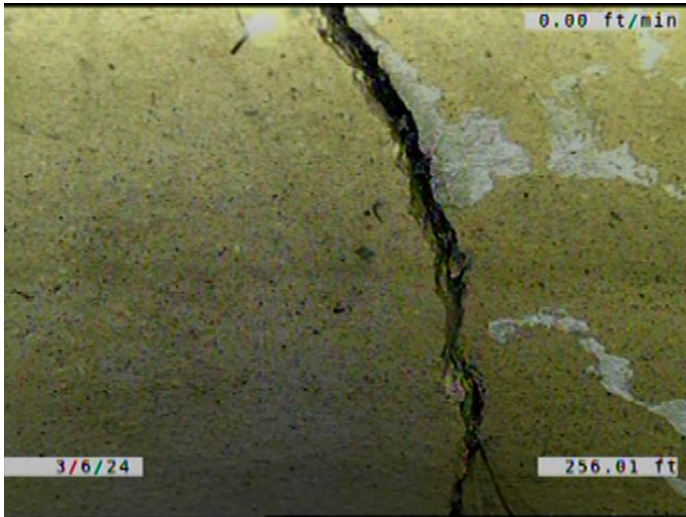
Code: **RFB**
Description: **Roots Fine Barrel**

Distance (ft): **253.0**
Structural Grade: **0**
O&M Grade: **2**
Clock Start/From: **7**
Clock To: **5**
1st Value:
2nd Value:
Value Percent:
Continuous Index: **S22**
Within 8" of Joint: **NO**
Remarks:

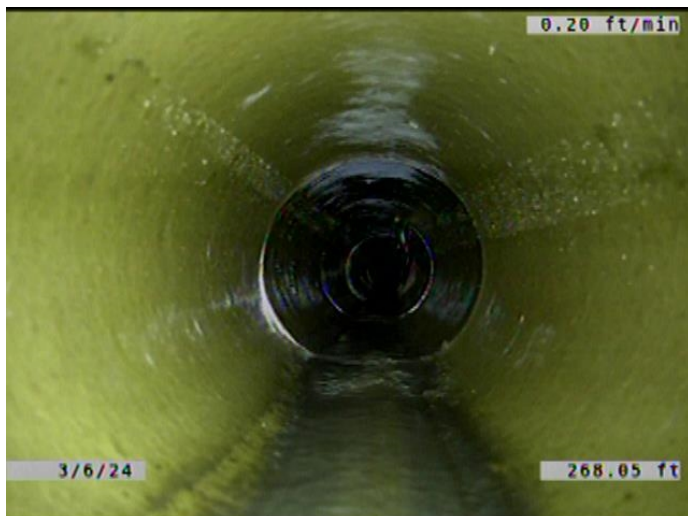
Code: **FM**
Description: **Fracture Multiple**

Distance (ft): **268.0**
Structural Grade: **4**
O&M Grade: **0**
Clock Start/From: **12**
Clock To: **12**
1st Value:
2nd Value:
Value Percent:
Continuous Index: **F20**
Within 8" of Joint: **YES**
Remarks:

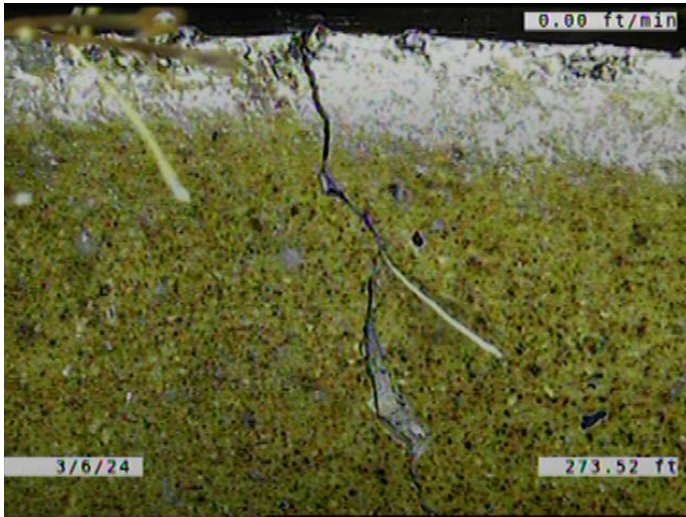
Code: **RFB**
Description: **Roots Fine Barrel**

Distance (ft): **268.0**
Structural Grade: **0**
O&M Grade: **2**
Clock Start/From: **7**
Clock To: **5**
1st Value:
2nd Value:
Value Percent:
Continuous Index: **F22**
Within 8" of Joint: **NO**
Remarks:

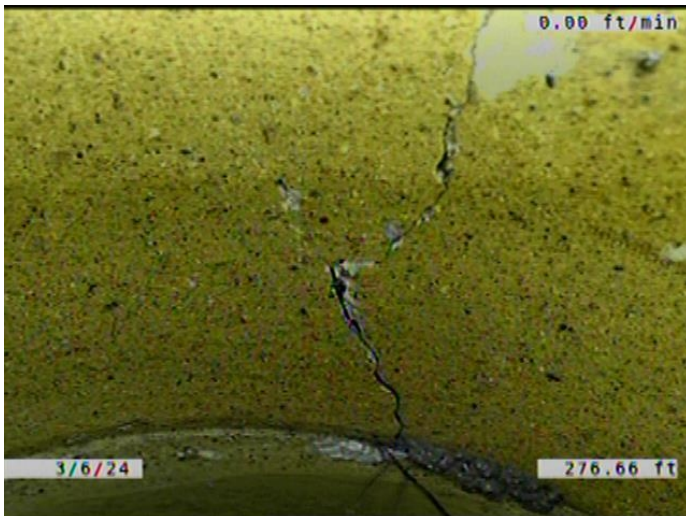
Code: **FS**
Description: **Fracture Spiral**

Distance (ft): **273.5**
Structural Grade: **3**
O&M Grade: **0**
Clock Start/From: **2**
Clock To: **3**
1st Value:
2nd Value:
Value Percent:
Continuous Index:
Within 8" of Joint: **YES**
Remarks:

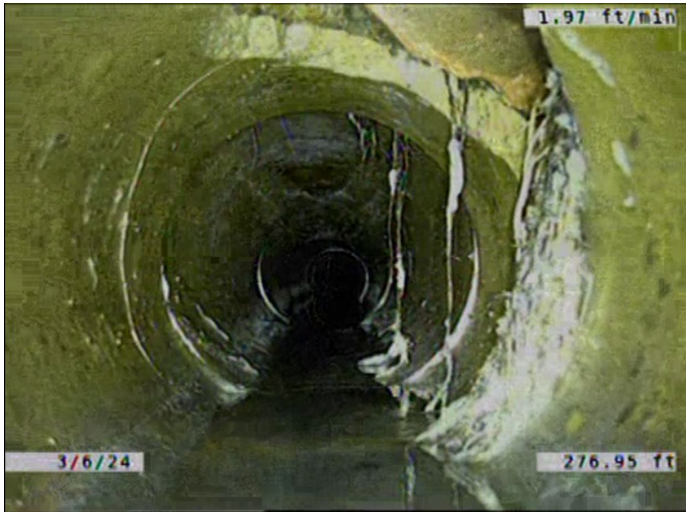
Code: **FM**
Description: **Fracture Multiple**

Distance (ft): **276.7**
Structural Grade: **4**
O&M Grade: **0**
Clock Start/From: **12**
Clock To: **12**
1st Value:
2nd Value:
Value Percent:
Continuous Index: **S23**
Within 8" of Joint: **YES**
Remarks:

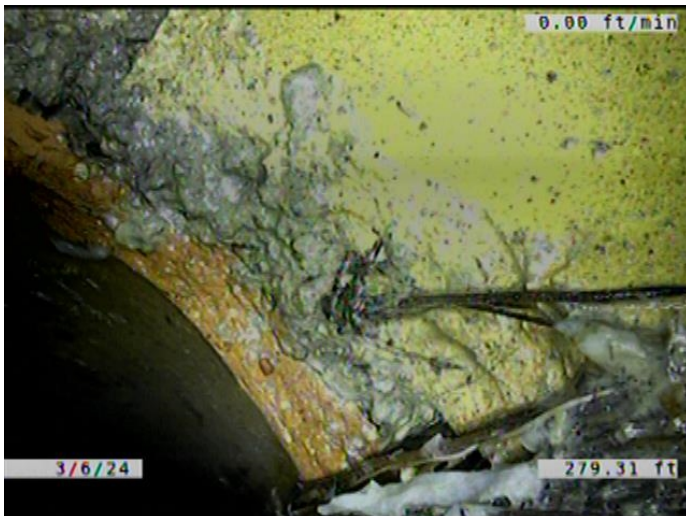
Code: **CC**
Description: **Crack Circumferential**

Distance (ft): **277.0**
Structural Grade: **1**
O&M Grade: **0**
Clock Start/From: **7**
Clock To: **11**
1st Value:
2nd Value:
Value Percent:
Continuous Index:
Within 8" of Joint: **NO**
Remarks:

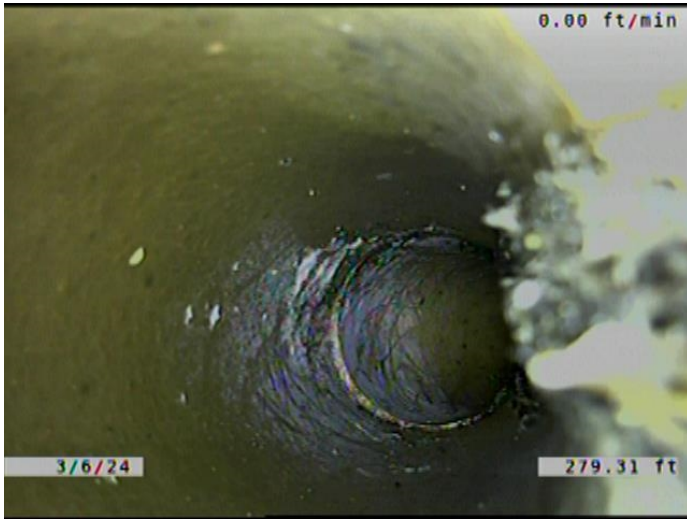
Code: **RFC**
Description: **Roots Fine Connection**

Distance (ft): **279.3**
Structural Grade: **0**
O&M Grade: **1**
Clock Start/From: **2**
Clock To: **3**
1st Value:
2nd Value:
Value Percent:
Continuous Index:
Within 8" of Joint: **NO**
Remarks:

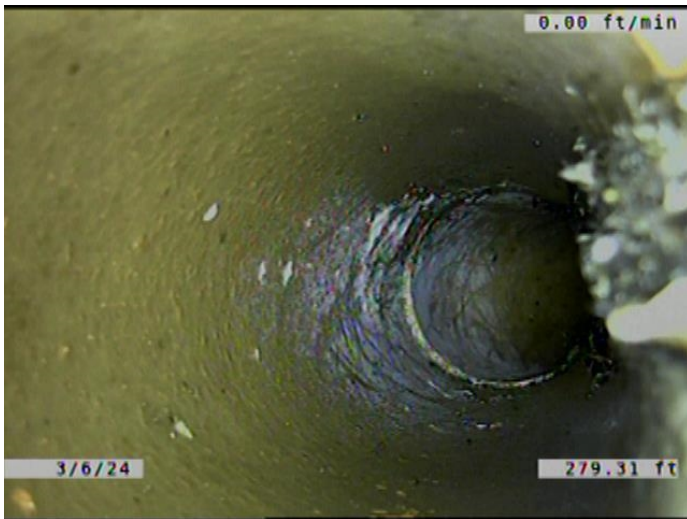
Code: **RML**
Description: **Roots Medium Lateral**

Distance (ft): **279.3**
Structural Grade: **0**
O&M Grade: **3**
Clock Start/From: **2**
Clock To: **3**
1st Value:
2nd Value:
Value Percent: **5.000**
Continuous Index:
Within 8" of Joint: **NO**
Remarks:

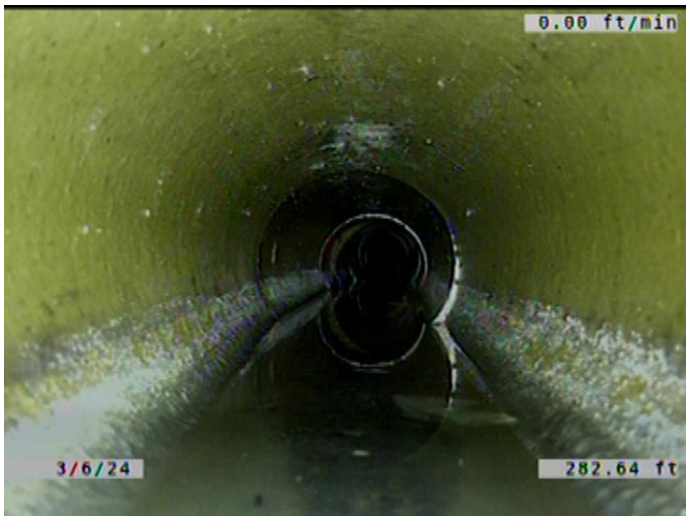
Code: **MWLS**
Description: **Miscellaneous Water Level Sag**

Distance (ft): **282.6**
Structural Grade: **2**
O&M Grade: **0**
Clock Start/From:
Clock To:
1st Value:
2nd Value:
Value Percent: **15.000**
Continuous Index: **S24**
Within 8" of Joint: **NO**
Remarks:

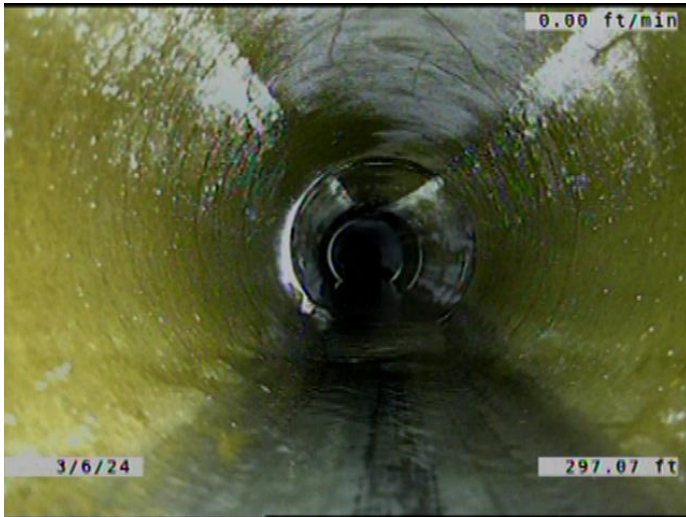
Code: **TFD**
Description: **Tap Factory Defective**

Distance (ft): **296.0**
Structural Grade: **0**
O&M Grade: **3**
Clock Start/From: **2**
Clock To:
1st Value: **6.000**
2nd Value:
Value Percent:
Continuous Index:
Within 8" of Joint: **YES**
Remarks: **CAPPED. TAP CRACKED. ENCRUSTATION COMING IN AROUN**

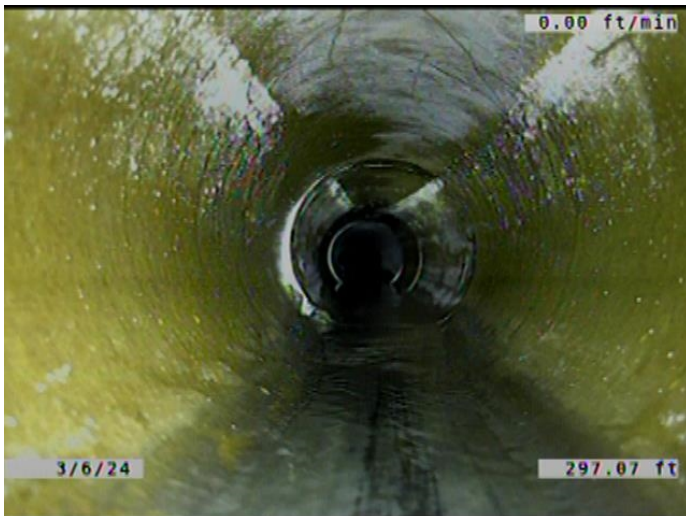
Code: **MWLS**
Description: **Miscellaneous Water Level Sag**

Distance (ft): **297.1**
Structural Grade: **2**
O&M Grade: **0**
Clock Start/From:
Clock To:
1st Value:
2nd Value:
Value Percent: **15.000**
Continuous Index: **F24**
Within 8" of Joint: **NO**
Remarks:

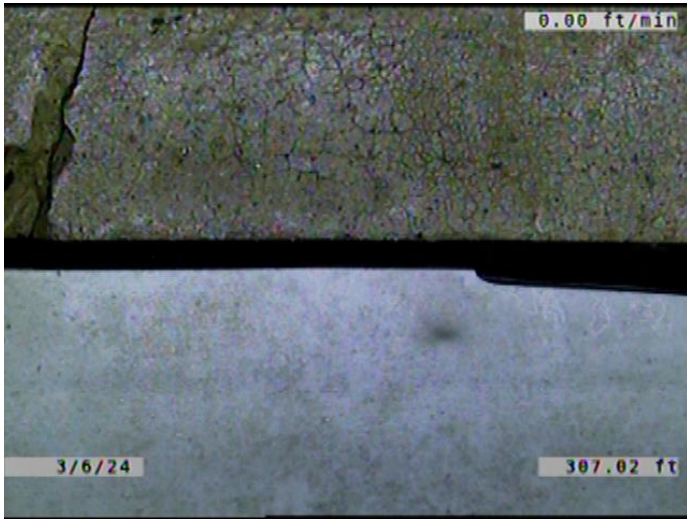
Code: **DSF**
Description: **Deposits Settled Fine**

Distance (ft): **297.1**
Structural Grade: **0**
O&M Grade: **2**
Clock Start/From: **5**
Clock To: **7**
1st Value:
2nd Value:
Value Percent: **5.000**
Continuous Index: **F25**
Within 8" of Joint: **YES**
Remarks:

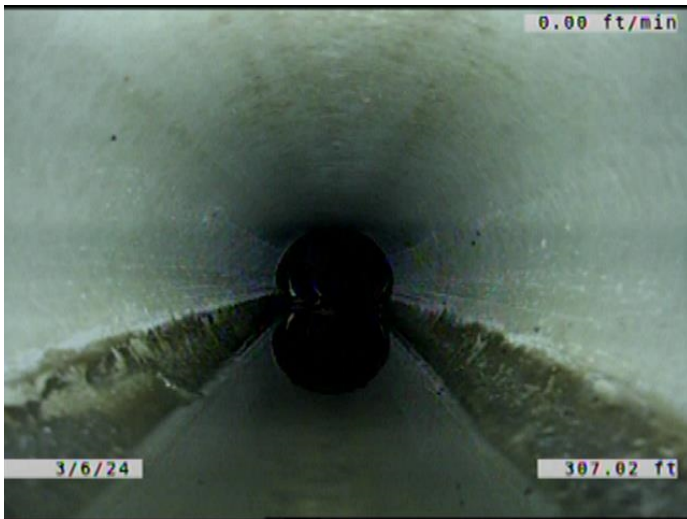
| Code: | RPR |
| Description: | Point Repair Replacement |
| Remarks: | REPLACED WITH PVC. |

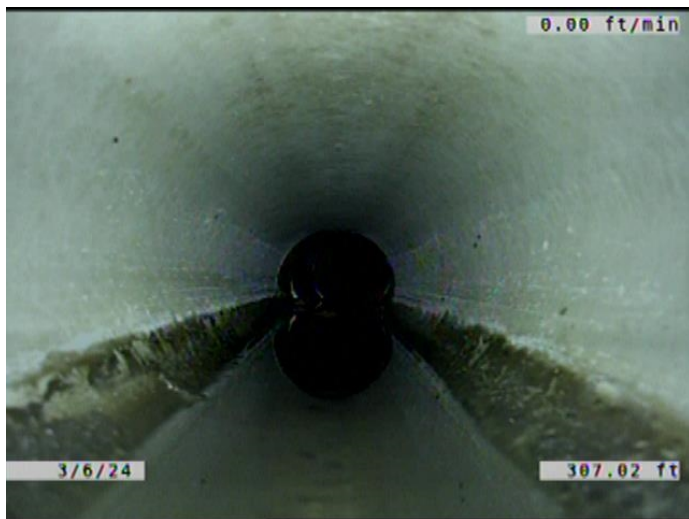
| Code: | DAE |
| Description: | Deposits Attached Encrustation |

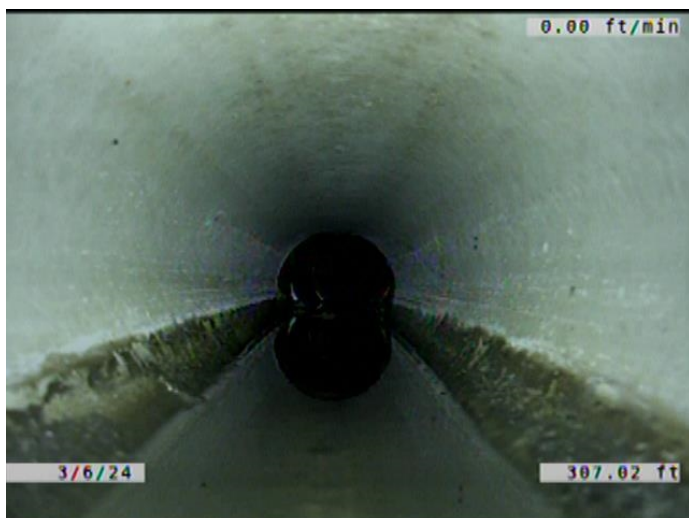
Code: **RFJ**
Description: **Roots Fine Joint**

Distance (ft): **307.0**
Structural Grade: **0**
O&M Grade: **1**
Clock Start/From: **7**
Clock To: **5**
1st Value:
2nd Value:
Value Percent:
Continuous Index: **F21**
Within 8" of Joint: **YES**
Remarks:

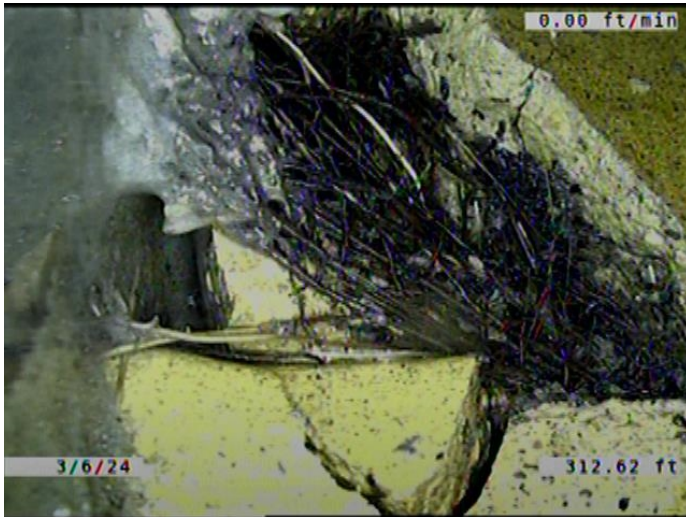
Code: **RPR**
Description: **Point Repair Replacement**

Distance (ft): **312.6**
Structural Grade: **0**
O&M Grade: **0**
Clock Start/From:
Clock To:
1st Value:
2nd Value:
Value Percent:
Continuous Index: **F26**
Within 8" of Joint: **YES**
Remarks: **REPLACED WITH PVC.**

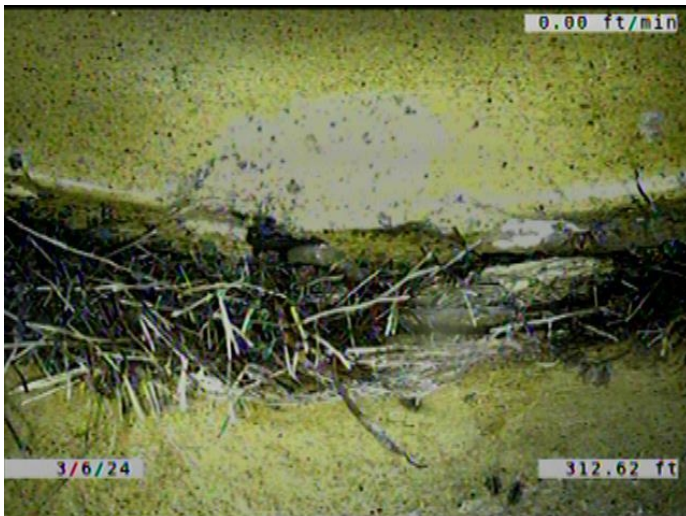
Code: **BVV**
Description: **Broken Void Visible**

Distance (ft): **312.6**
Structural Grade: **5**
O&M Grade: **0**
Clock Start/From: **1**
Clock To: **9**
1st Value:
2nd Value:
Value Percent:
Continuous Index:
Within 8" of Joint: **YES**
Remarks: **SOIL VISIBLE ALSO.**
