# Profile/Photo Observation Report

Date:	<b>03/06/2024</b>	Weather:		Coding:	<b>PACP 7.0</b>
Pipe Length (ft):	<b>338.0</b>	Owner:	<b>City of Hobart</b>	Pre Clean:	<b>Heavy Cleaning</b>
P.O.#:		Surveyor:	<b>S. Bucklin</b>	PSR:	<b>P-405-042-041</b>
Customer:	<b>City of Hobart</b>	Clean Date:	<b>10/21/2023</b>	Shape:	<b>C</b>

Street:	<b>SOFTWOOD DR</b>	Flow Control:	<b>Not Controlled</b>
City:	<b>Hobart, IN</b>	Year Renewed:	
Location:	<b>Easement/Right of Way</b>	Tape/Media #:	
Purpose:	<b>Sewer System Evaluation Survey (SS)</b>	Dia/Height:	<b>8"</b>
Use:	<b>Sanitary Sewage Pipe</b>	Material:	<b>VCP</b>
Drain Area:		Lining:	<b>None</b>
Category:	<b>NA</b>		
Comment:			
Location Details:		Direction of Survey:	<b>Upstream</b>
US MH:	<b>M-405-041</b>	DS MH:	<b>M-405-042</b>
		Total Length Surveyed (ft):	<b>338.4</b>

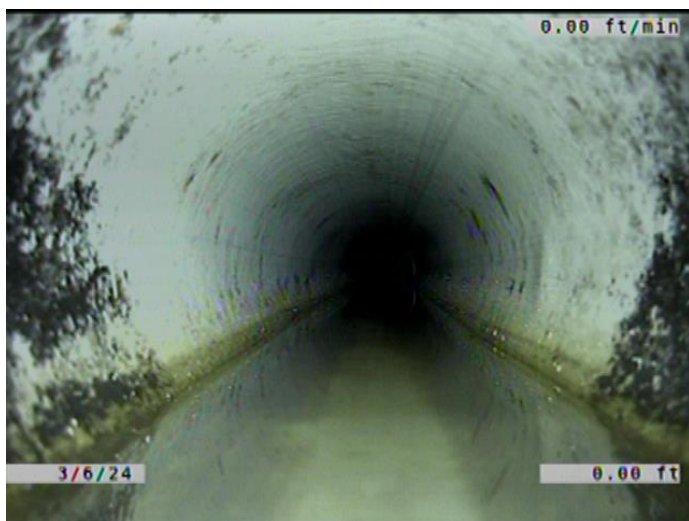
Code: **AMH**  
Description: **Manhole**

Distance (ft): **.0**  
Structural Grade: **0**  
O&M Grade: **0**  
Clock Start/From:  
Clock To:  
1st Value:  
2nd Value:  
Value Percent:  
Continuous Index:  
Within 8" of Joint: **NO**  
Remarks: **M-405-042**

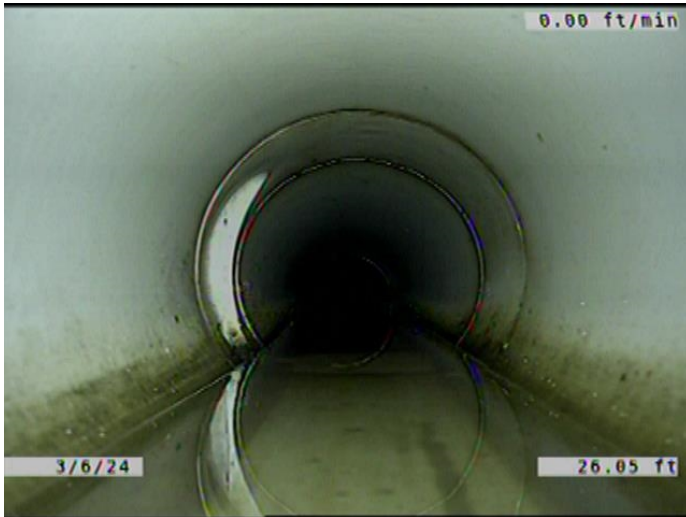
Code: **LR**  
Description: **Line Right**

Distance (ft): **12.6**  
Structural Grade: **0**  
O&M Grade: **1**  
Clock Start/From:  
Clock To:  
1st Value:  
2nd Value:  
Value Percent: **5.000**  
Continuous Index:  
Within 8" of Joint: **NO**  
Remarks:

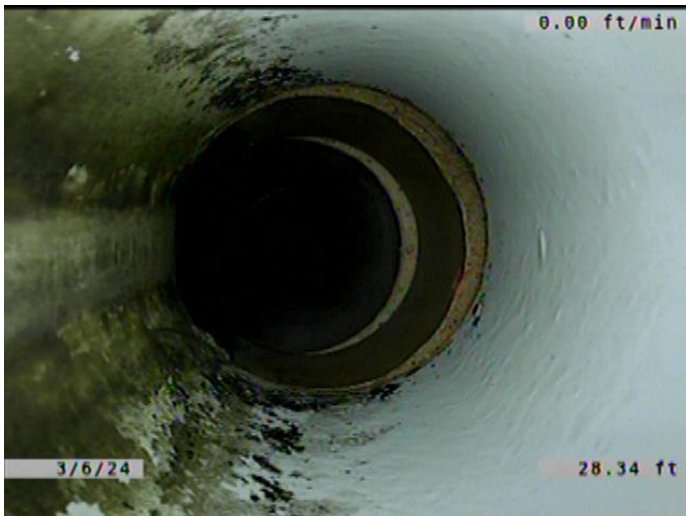
Code: **LL**  
Description: **Line Left**

Distance (ft): **26.0**  
Structural Grade: **0**  
O&M Grade: **2**  
Clock Start/From:  
Clock To:  
1st Value:  
2nd Value:  
Value Percent: **15.000**  
Continuous Index:  
Within 8" of Joint: **NO**  
Remarks:

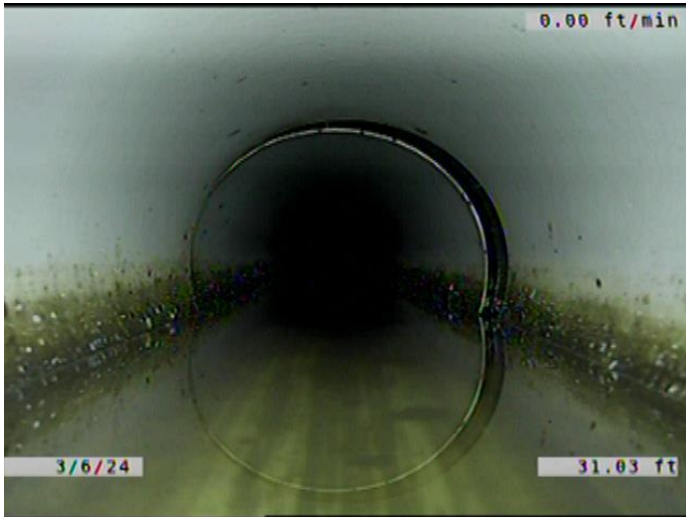
Code: **TF**  
Description: **Tap Factory**

Distance (ft): **28.3**  
Structural Grade: **0**  
O&M Grade: **0**  
Clock Start/From: **9**  
Clock To:  
1st Value: **6.000**  
2nd Value:  
Value Percent:  
Continuous Index:  
Within 8" of Joint: **YES**  
Remarks: **TAP PVC. SERVICE VCP.**

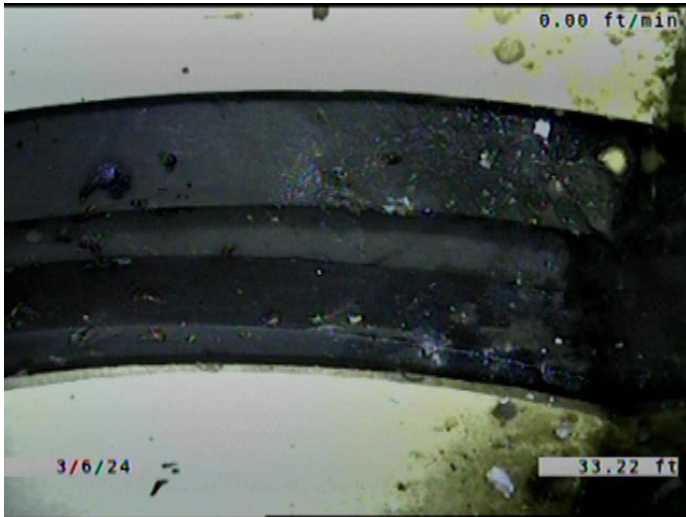
Code: **JOMD**  
Description: **Joint Offset Medium Defective**

Distance (ft): **33.2**  
Structural Grade: **3**  
O&M Grade: **0**  
Clock Start/From:  
Clock To:  
1st Value:  
2nd Value:  
Value Percent:  
Continuous Index:  
Within 8" of Joint: **NO**  
Remarks:

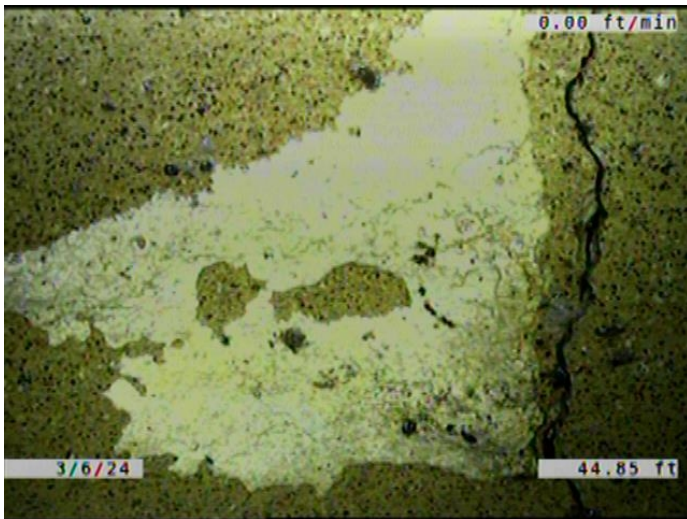
Code: **FM**  
Description: **Fracture Multiple**

Distance (ft): **43.4**  
Structural Grade: **4**  
O&M Grade: **0**  
Clock Start/From: **8**  
Clock To: **4**  
1st Value:  
2nd Value:  
Value Percent:  
Continuous Index: **S03**  
Within 8" of Joint: **YES**  
Remarks:

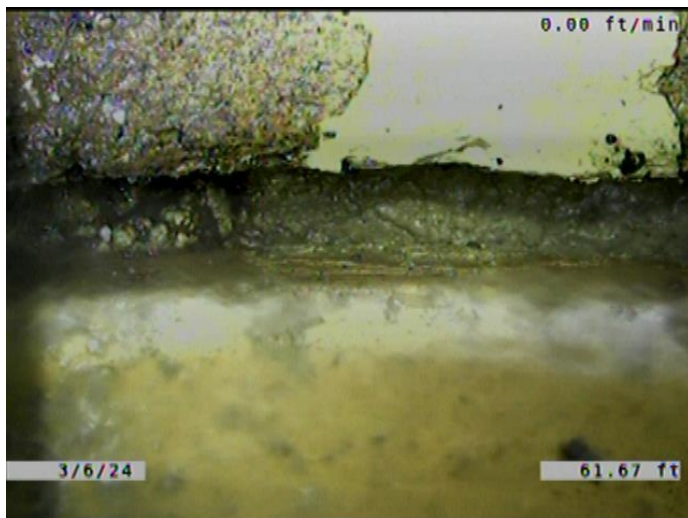
Code: **FM**  
Description: **Fracture Multiple**

Distance (ft): **53.4**  
Structural Grade: **4**  
O&M Grade: **0**  
Clock Start/From: **8**  
Clock To: **4**  
1st Value:  
2nd Value:  
Value Percent:  
Continuous Index: **F03**  
Within 8" of Joint: **YES**  
Remarks:

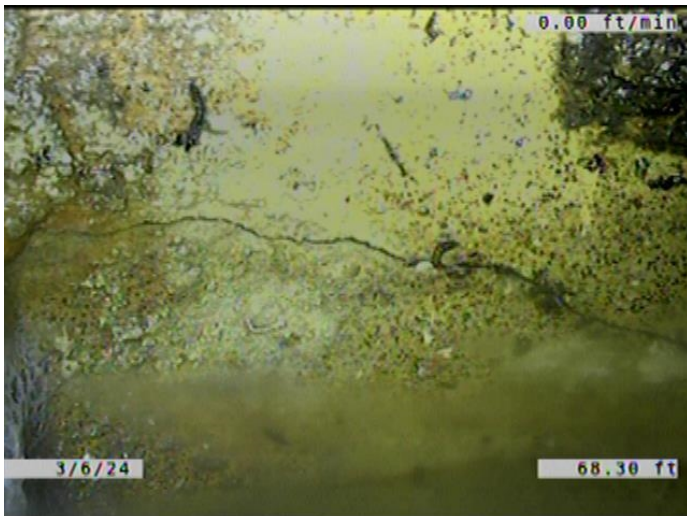
Code: **FC**  
Description: **Fracture Circumferential**

Distance (ft): **68.3**  
Structural Grade: **2**  
O&M Grade: **0**  
Clock Start/From: **8**  
Clock To: **4**  
1st Value:  
2nd Value:  
Value Percent:  
Continuous Index:  
Within 8" of Joint: **NO**  
Remarks:

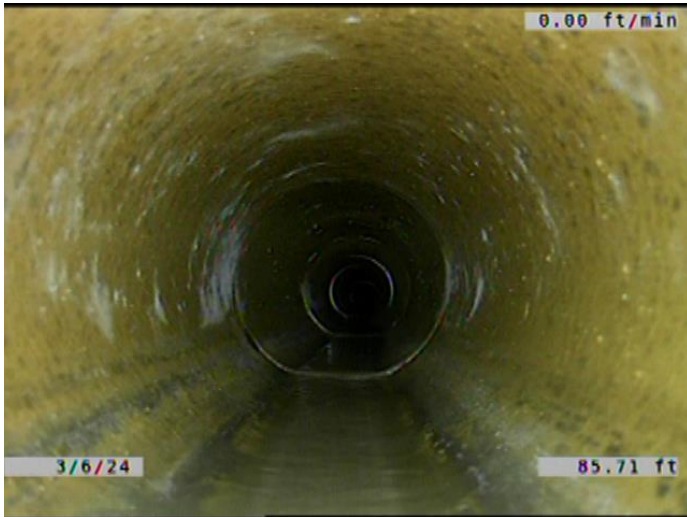
Code: **RFJ**  
 Description: **Roots Fine Joint**

Distance (ft): **85.7**  
 Structural Grade: **0**  
 O&M Grade: **1**  
 Clock Start/From: **1**  
 Clock To: **5**  
 1st Value:  
 2nd Value:  
 Value Percent:  
 Continuous Index:  
 Within 8" of Joint: **YES**  
 Remarks:

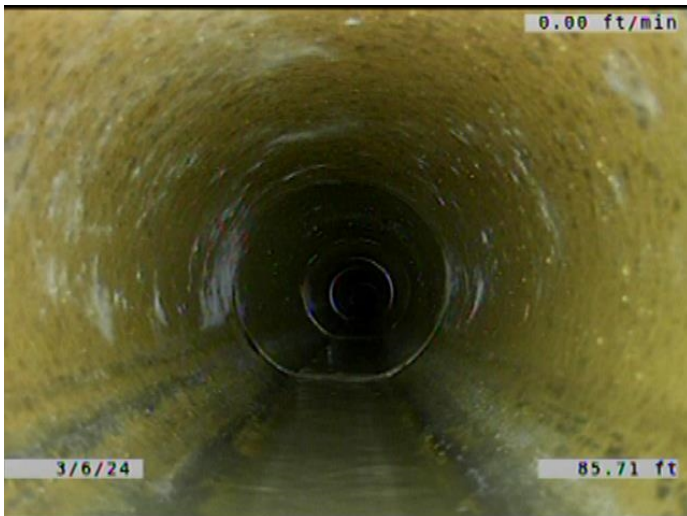
Code: **MWLS**  
Description: **Miscellaneous Water Level Sag**

Distance (ft): **85.7**  
Structural Grade: **3**  
O&M Grade: **0**  
Clock Start/From:  
Clock To:  
1st Value:  
2nd Value:  
Value Percent: **35.000**  
Continuous Index: **F02**  
Within 8" of Joint: **NO**  
Remarks:

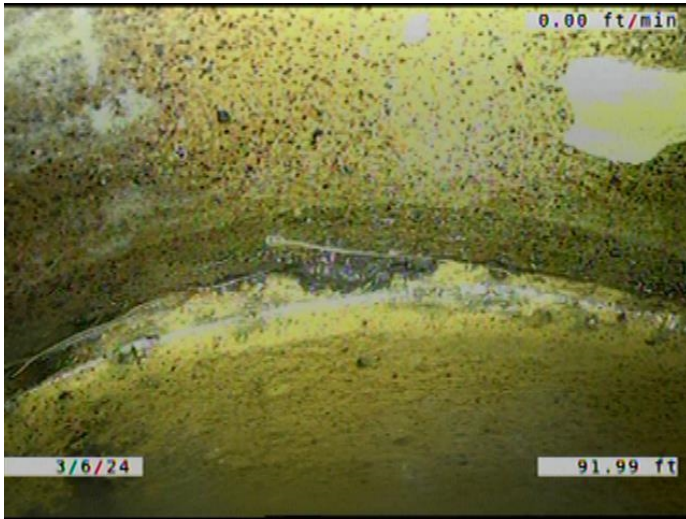
Code: **MWL**  
Description: **Miscellaneous Water Level**

Distance (ft): **85.7**  
Structural Grade: **0**  
O&M Grade: **0**  
Clock Start/From:  
Clock To:  
1st Value:  
2nd Value:  
Value Percent: **5.000**  
Continuous Index:  
Within 8" of Joint: **NO**  
Remarks:

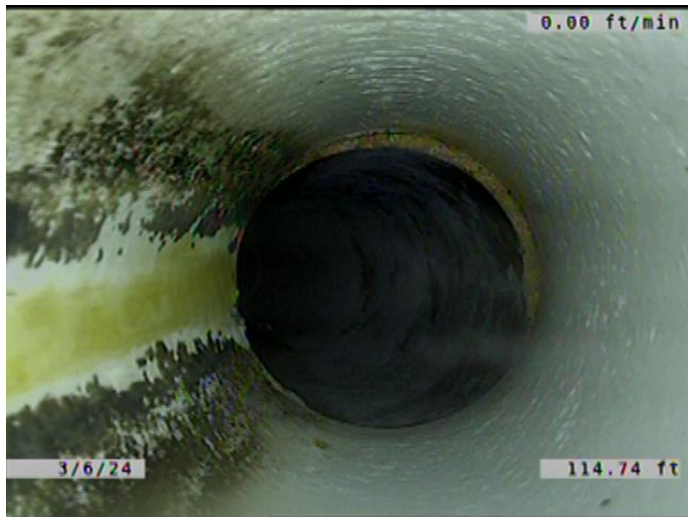
Distance (ft): **97.2**  
Structural Grade: **0**  
O&M Grade: **2**  
Clock Start/From: **8**  
Clock To: **4**  
1st Value:  
2nd Value:  
Value Percent: **5.000**  
Continuous Index: **F04**  
Within 8" of Joint: **YES**  
Remarks:

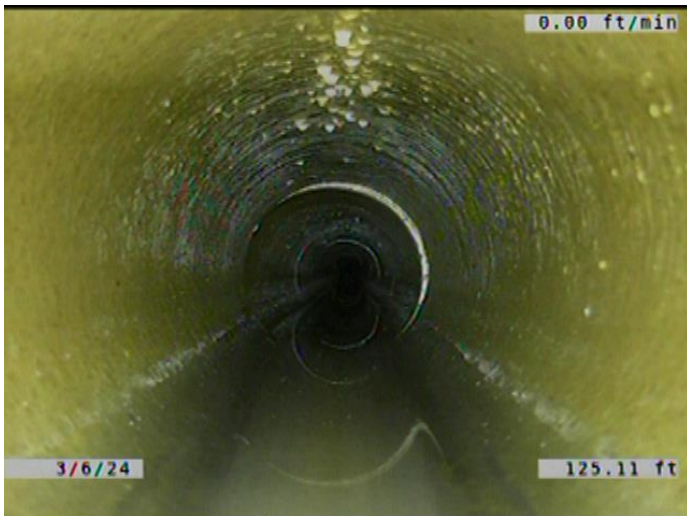
Code: **DAR**  
 Description: **Deposits Attached Ragging**

Distance (ft): **124.9**  
 Structural Grade: **0**  
 O&M Grade: **2**  
 Clock Start/From: **5**  
 Clock To:  
 1st Value:  
 2nd Value:  
 Value Percent: **5.000**  
 Continuous Index:  
 Within 8" of Joint: **YES**  
 Remarks:

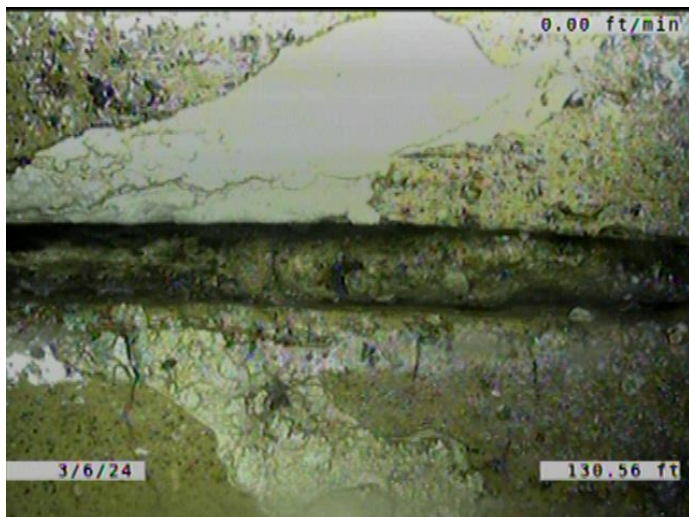
Code: **JOMD**  
Description: **Joint Offset Medium Defective**

Distance (ft): **128.1**  
Structural Grade: **3**  
O&M Grade: **0**  
Clock Start/From:  
Clock To:  
1st Value:  
2nd Value:  
Value Percent:  
Continuous Index:  
Within 8" of Joint: **NO**  
Remarks:

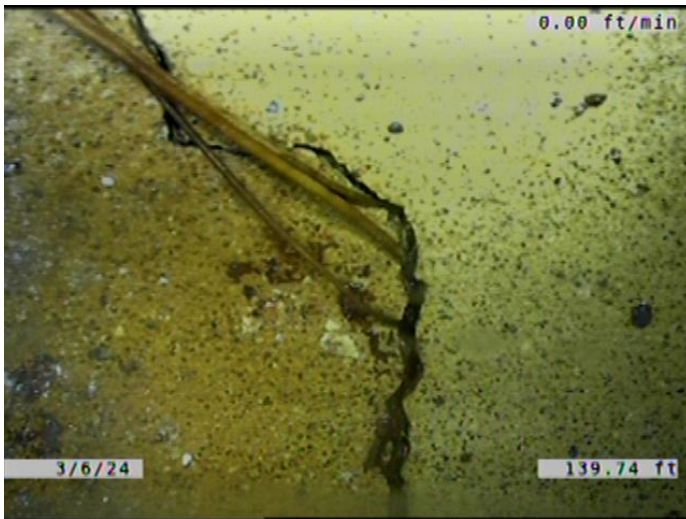
Code: **B**  
Description: **Broken**

Distance (ft): **139.7**  
Structural Grade: **4**  
O&M Grade: **0**  
Clock Start/From: **7**  
Clock To: **9**  
1st Value:  
2nd Value:  
Value Percent:  
Continuous Index:  
Within 8" of Joint: **YES**  
Remarks:

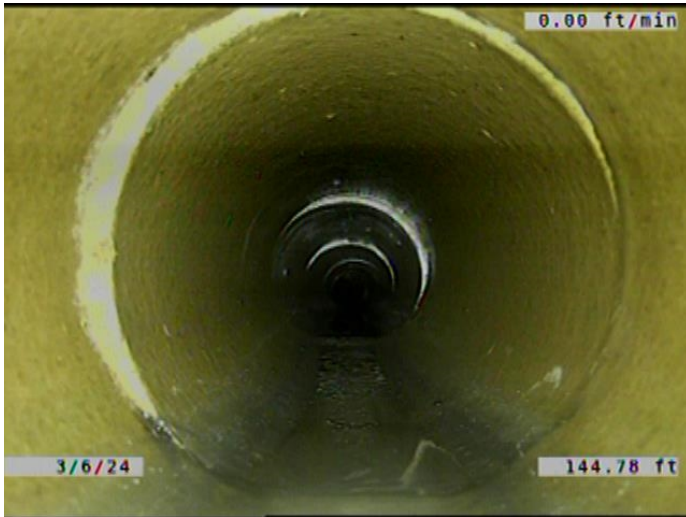
Code: **CM**  
Description: **Crack Multiple**

Distance (ft): **142.1**  
Structural Grade: **3**  
O&M Grade: **0**  
Clock Start/From: **10**  
Clock To: **4**  
1st Value:  
2nd Value:  
Value Percent:  
Continuous Index:  
Within 8" of Joint: **YES**  
Remarks:

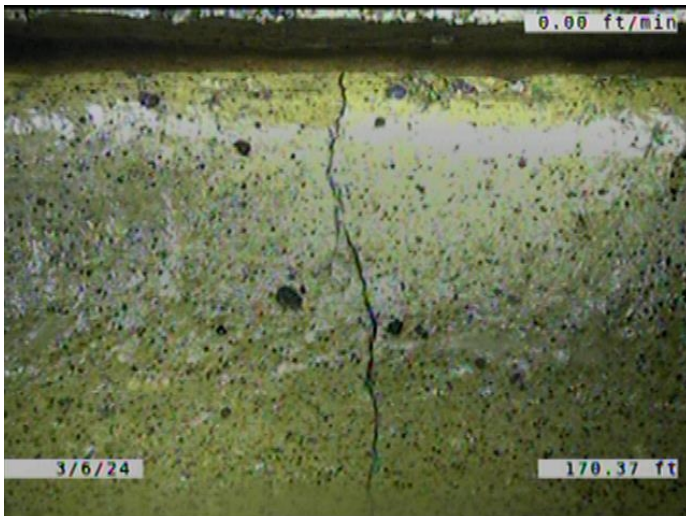
Code: **ISB**  
Description: **Infiltration Stain Barrel**

Distance (ft): **166.5**  
Structural Grade: **0**  
O&M Grade: **1**  
Clock Start/From: **3**  
Clock To: **5**  
1st Value:  
2nd Value:  
Value Percent:  
Continuous Index:  
Within 8" of Joint: **YES**  
Remarks:

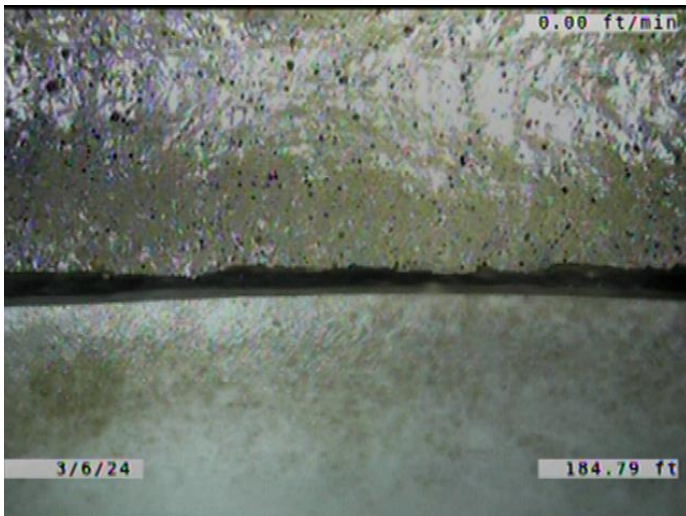
Code: **ISB**  
Description: **Infiltration Stain Barrel**

Distance (ft): **181.8**  
Structural Grade: **0**  
O&M Grade: **1**  
Clock Start/From: **7**  
Clock To: **9**  
1st Value:  
2nd Value:  
Value Percent:  
Continuous Index:  
Within 8" of Joint: **YES**  
Remarks:

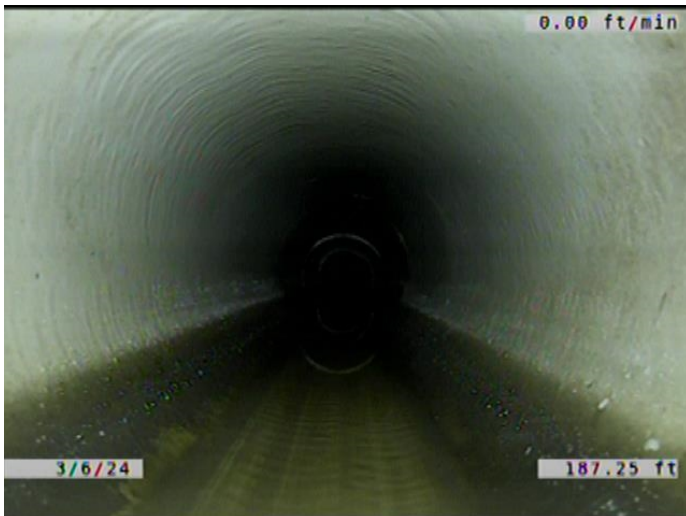
Distance (ft): **187.2**  
Structural Grade: **0**  
O&M Grade: **0**  
Clock Start/From: **3**  
Clock To:  
1st Value: **6.000**  
2nd Value:  
Value Percent:  
Continuous Index:  
Within 8" of Joint: **YES**  
Remarks: **TAP PVC. SERVICE IS VCP.**

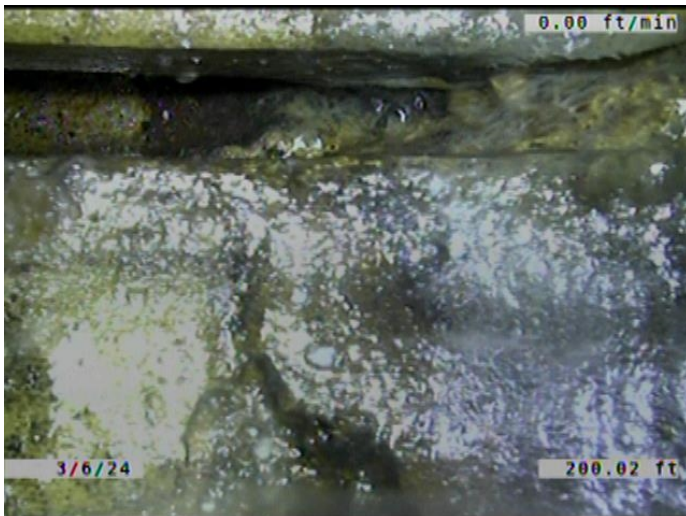
Code: **JOMD**  
Description: **Joint Offset Medium Defective**

Distance (ft): **200.0**  
Structural Grade: **3**  
O&M Grade: **0**  
Clock Start/From:  
Clock To:  
1st Value:  
2nd Value:  
Value Percent:  
Continuous Index:  
Within 8" of Joint: **NO**  
Remarks:

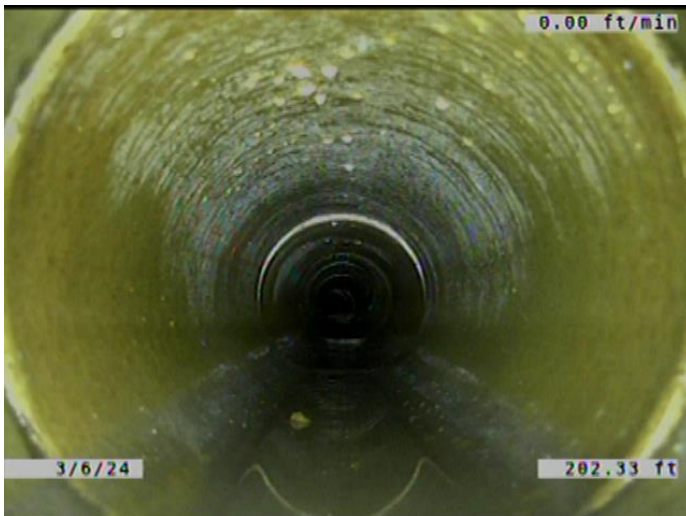
Code: **TFD**  
Description: **Tap Factory Defective**

Distance (ft): **202.3**  
Structural Grade: **0**  
O&M Grade: **3**  
Clock Start/From: **2**  
Clock To:  
1st Value: **6.000**  
2nd Value:  
Value Percent:  
Continuous Index:  
Within 8" of Joint: **YES**  
Remarks: **CAPPED. ENCRUSTATION COMING AROUND THE CAP INTO THE MAIN.**

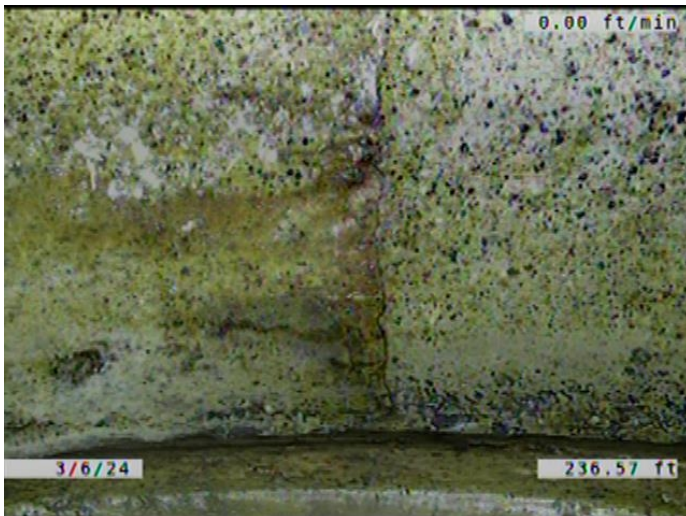
Code: **CL**  
Description: **Crack Longitudinal**

Distance (ft): **236.6**  
Structural Grade: **2**  
O&M Grade: **0**  
Clock Start/From: **3**  
Clock To:  
1st Value:  
2nd Value:  
Value Percent:  
Continuous Index:  
Within 8" of Joint: **YES**  
Remarks:

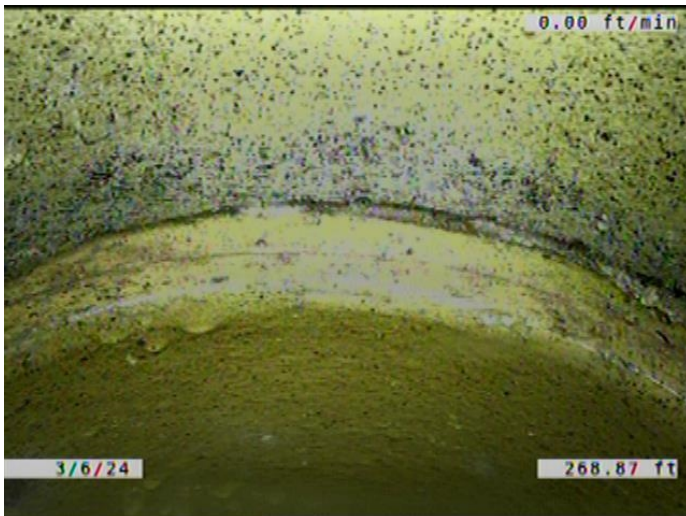
Code: **FM**  
Description: **Fracture Multiple**

Distance (ft): **263.0**  
Structural Grade: **4**  
O&M Grade: **0**  
Clock Start/From: **1**  
Clock To: **4**  
1st Value:  
2nd Value:  
Value Percent:  
Continuous Index: **S10**  
Within 8" of Joint: **YES**  
Remarks:

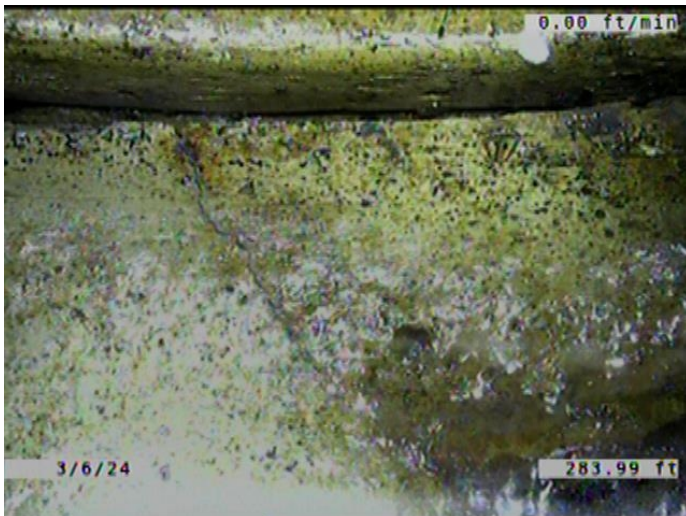
Code: **JOMD**  
 Description: **Joint Offset Medium Defective**

Distance (ft): **275.1**  
 Structural Grade: **3**  
 O&M Grade: **0**  
 Clock Start/From:  
 Clock To:  
 1st Value:  
 2nd Value:  
 Value Percent:  
 Continuous Index:  
 Within 8" of Joint: **NO**  
 Remarks:

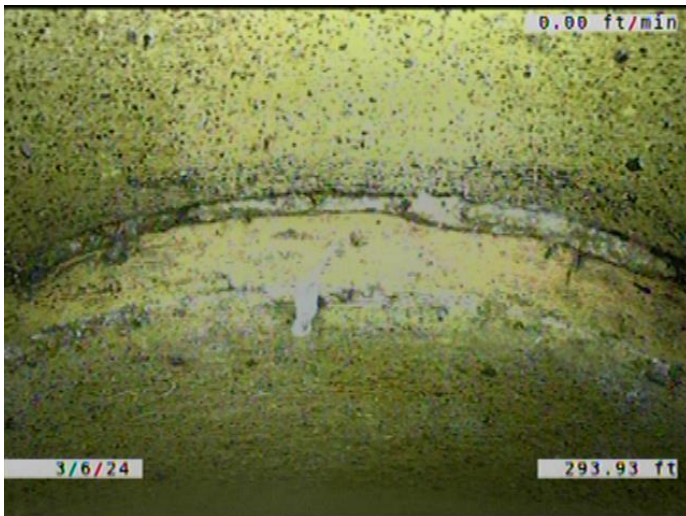
Distance (ft): **287.4**  
Structural Grade: **0**  
O&M Grade: **0**  
Clock Start/From: **3**  
Clock To:  
1st Value: **6.000**  
2nd Value:  
Value Percent:  
Continuous Index:  
Within 8" of Joint: **YES**  
Remarks:

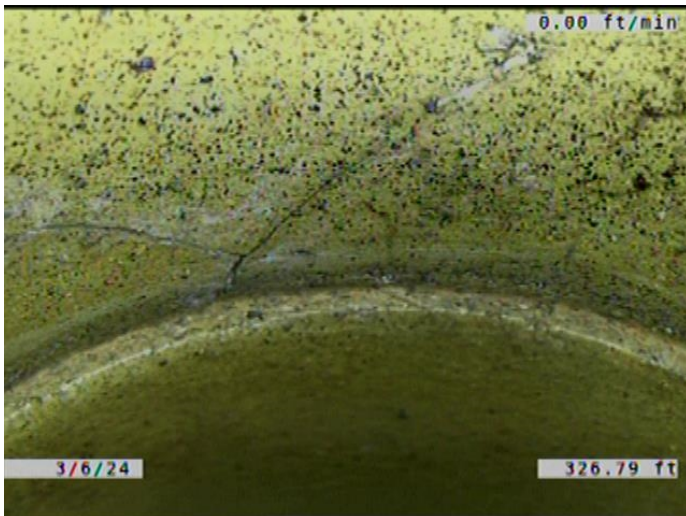
Code: **JOMD**  
Description: **Joint Offset Medium Defective**

Distance (ft): **324.3**  
Structural Grade: **3**  
O&M Grade: **0**  
Clock Start/From:  
Clock To:  
1st Value:  
2nd Value:  
Value Percent:  
Continuous Index: **F11**  
Within 8" of Joint: **NO**  
Remarks:

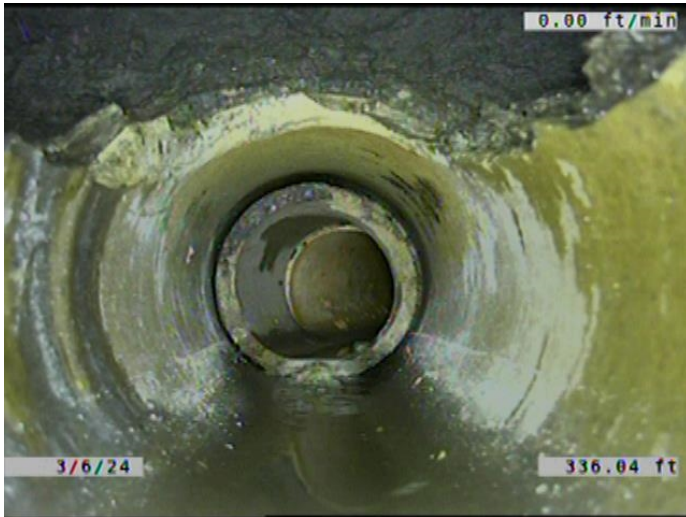
Code: **FM**  
Description: **Fracture Multiple**

Distance (ft): **326.8**  
Structural Grade: **4**  
O&M Grade: **0**  
Clock Start/From: **8**  
Clock To: **4**  
1st Value:  
2nd Value:  
Value Percent:  
Continuous Index:  
Within 8" of Joint: **YES**  
Remarks:

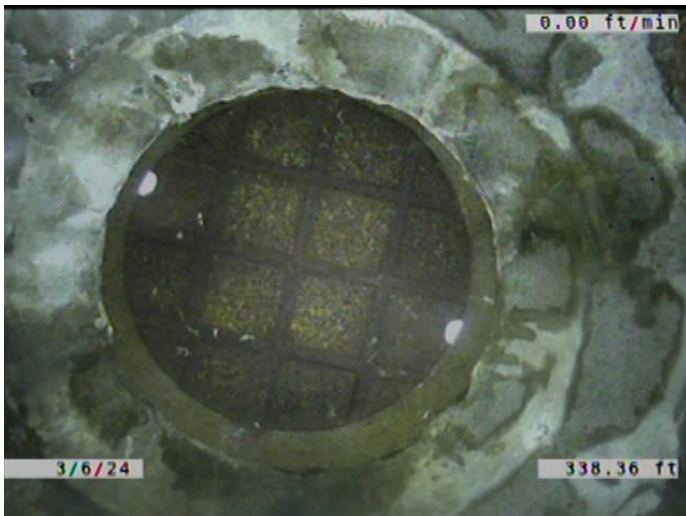
Code: **DAE**  
 Description: **Deposits Attached Encrustation**

Distance (ft): **336.0**  
 Structural Grade: **0**  
 O&M Grade: **2**  
 Clock Start/From: **8**  
 Clock To: **4**  
 1st Value:  
 2nd Value:  
 Value Percent: **5.000**  
 Continuous Index: **F09**  
 Within 8" of Joint: **YES**  
 Remarks:
