Profile/Photo Observation Report

Date:	09/15/2022	Weather:		Coding:	PACP 7.0
Pipe Length (ft):	297.0	Owner:	City of Hobart	Pre Clean:	Heavy Cleaning
P.O.#:	YES502259	Surveyor:	S. Bucklin	PSR:	P-405-045-044
Customer:	City of Hobart	Clean Date:	08/15/2022	Shape:	C

Street:	West 3rd Street	Flow Control:	Not Controlled
City:	Hobart, IN	Year Renewed:	
Location:	Local rural streets with light traffic, t	Tape/Media #:	
Purpose:	Routine Assessment	Dia/Height:	15"
Use:	Sanitary Sewage Pipe	Material:	RCP
Drain Area:		Lining:	None
Category:	NA		
Comment:

Location Details:		Direction of Survey:	Downstream
US MH:	M-405-045	DS MH:	M-405-044
		Total Length Surveyed (ft):	289.7

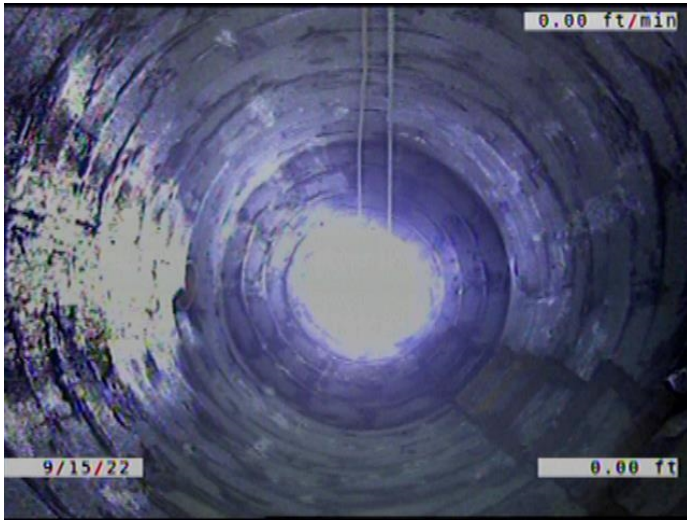
Code: **AMH**
Description: **Manhole**

Distance (ft): **.0**
Structural Grade: **0**
O&M Grade: **0**
Clock Start/From:
Clock To:
1st Value:
2nd Value:
Value Percent:
Continuous Index:
Within 8" of Joint: **NO**
Remarks: **M-405-045**

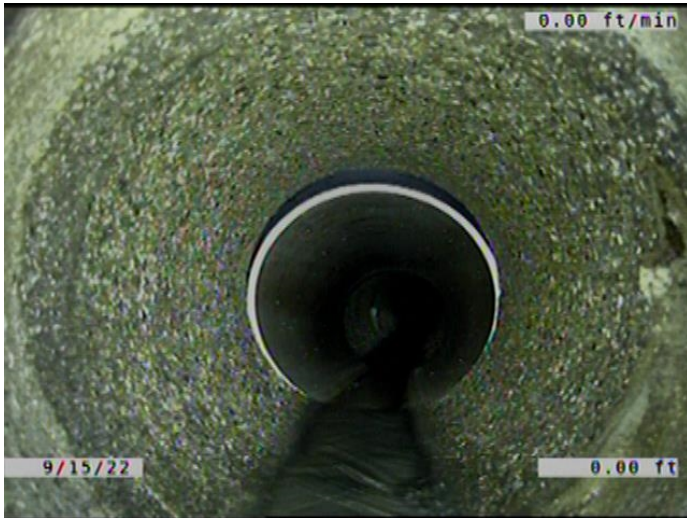
Code: **MWL**
Description: **Miscellaneous Water Level**

Distance (ft): **.0**
Structural Grade: **0**
O&M Grade: **0**
Clock Start/From:
Clock To:
1st Value:
2nd Value:
Value Percent: **5.000**
Continuous Index:
Within 8" of Joint: **NO**
Remarks:

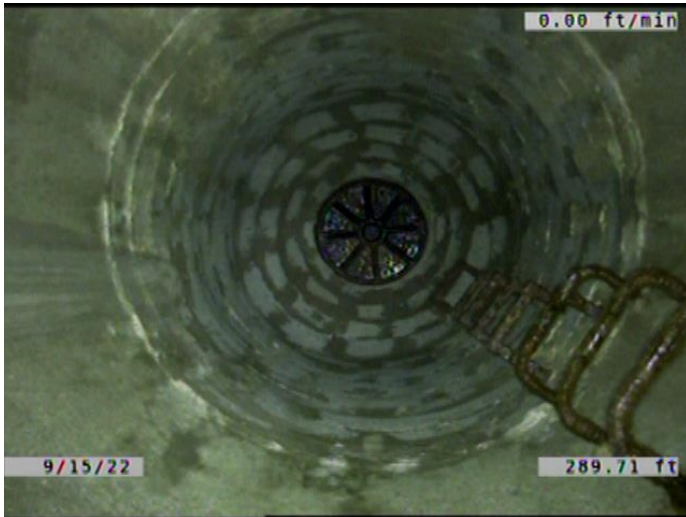
Code:	AMH
Description:	Manhole
Distance (ft):	289.7
Structural Grade:	0
O&M Grade:	0
Clock Start/From:	
Clock To:	
1st Value:	
2nd Value:	
Value Percent:	
Continuous Index:	
Within 8" of Joint:	NO
Remarks:	M-405-044
