Profile/Photo Observation Report

Street:	FOXCROFT STREET	Flow Control:	Not Controlled
City:	Hobart, IN	Year Renewed:	
Location:	Yard	Tape/Media #:	
Purpose:	Routine Assessment	Dia/Height:	10"
Use:	Sanitary	Material:	VCP
Drain Area:	NA	Lining:	
Category:	NA		
Comment:	P_C at 6 ft roots. Flow direction wrong		
Location Details:		Direction of Survey:	Downstream
US MH:	M-405-052	DS MH:	M-405-054
		Total Length Surveyed (ft):	8.0

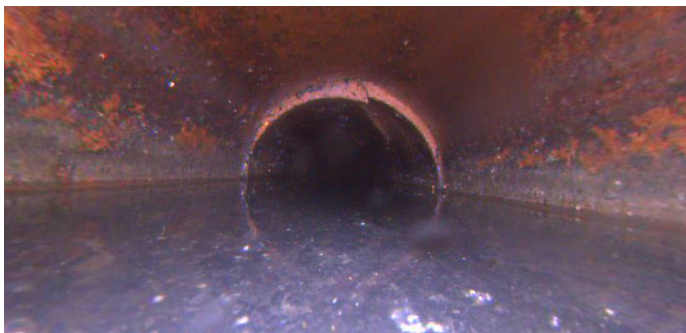
Code: **AMH**
Description: **Manhole**

Distance (ft): **.0**
Structural Grade: **0**
O&M Grade: **0**
Clock Start/From:
Clock To:
1st Value:
2nd Value:
Value Percent:
Continuous Index:
Within 8" of Joint: **NO**
Remarks: **M-405-052**
