## Profile/Photo Observation Report

Date:	<b>03/07/2024</b>	Weather:		Coding:	<b>PACP 7.0</b>
Pipe Length (ft):	<b>84.0</b>	Owner:	<b>City of Hobart</b>	Pre Clean:	<b>Heavy Cleaning</b>
P.O.#:		Surveyor:	<b>S. Bucklin</b>	PSR:	<b>P-405-060-059</b>
Customer:	<b>City of Hobart</b>	Clean Date:	<b>09/19/2023</b>	Shape:	<b>C</b>

Street:	<b>CRESTWOOD DR</b>	Flow Control:	<b>Not Controlled</b>
City:	<b>Hobart, IN</b>	Year Renewed:	
Location:	<b>Easement/Right of Way</b>	Tape/Media #:	
Purpose:	<b>Sewer System Evaluation Survey (SS</b>	Dia/Height:	<b>10"</b>
Use:	<b>Sanitary Sewage Pipe</b>	Material:	<b>VCP</b>
Drain Area:		Lining:	<b>None</b>
Category:	<b>NA</b>		
Comment:			
Location Details:		Direction of Survey:	<b>Upstream</b>
US MH:	<b>M-405-059</b>	DS MH:	<b>M-405-060</b>
		Total Length Surveyed (ft):	<b>82.4</b>

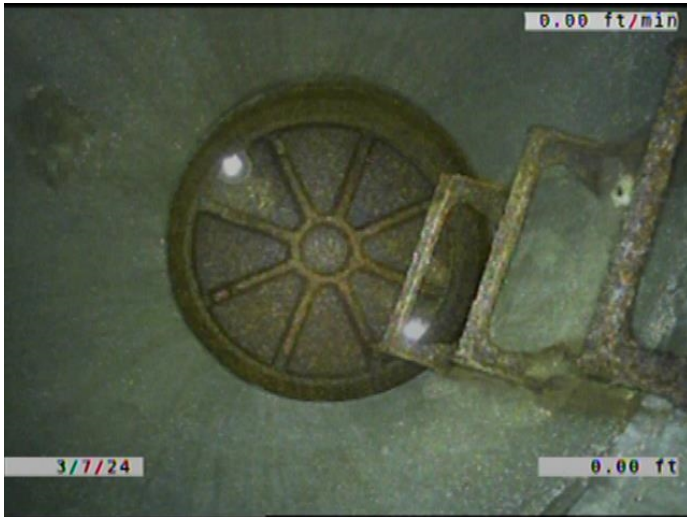
Code: **AMH**  
Description: **Manhole**

Distance (ft): **.0**  
Structural Grade: **0**  
O&M Grade: **0**  
Clock Start/From:  
Clock To:  
1st Value:  
2nd Value:  
Value Percent:  
Continuous Index:  
Within 8" of Joint: **NO**  
Remarks: **M-405-060**

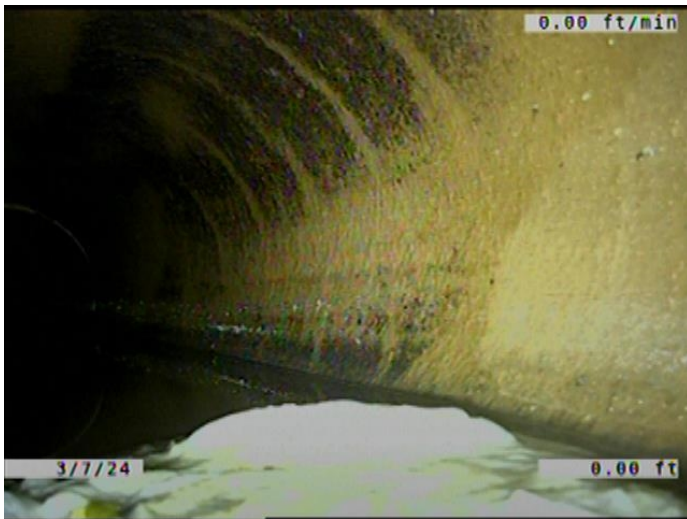
Code: **MWL**  
Description: **Miscellaneous Water Level**

Distance (ft): **.0**  
Structural Grade: **0**  
O&M Grade: **0**  
Clock Start/From:  
Clock To:  
1st Value:  
2nd Value:  
Value Percent: **10.000**  
Continuous Index:  
Within 8" of Joint: **NO**  
Remarks:

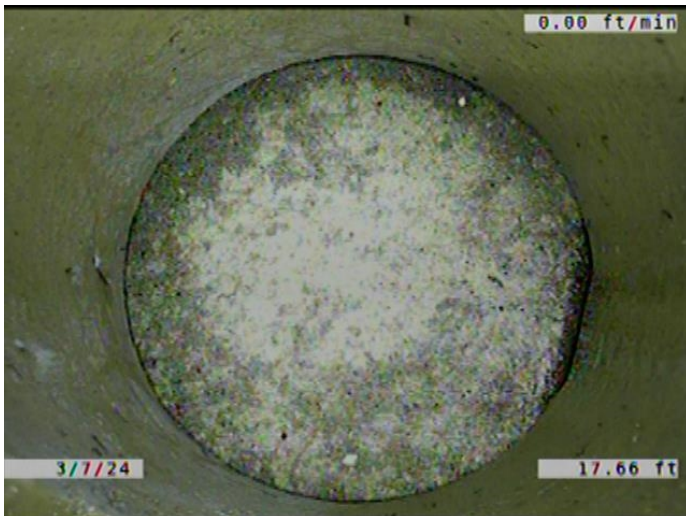
Code: **TFC**  
Description: **Tap Factory Capped**

Distance (ft): **17.7**  
Structural Grade: **0**  
O&M Grade: **0**  
Clock Start/From: **2**  
Clock To:  
1st Value: **6.000**  
2nd Value:  
Value Percent:  
Continuous Index:  
Within 8" of Joint: **YES**  
Remarks:

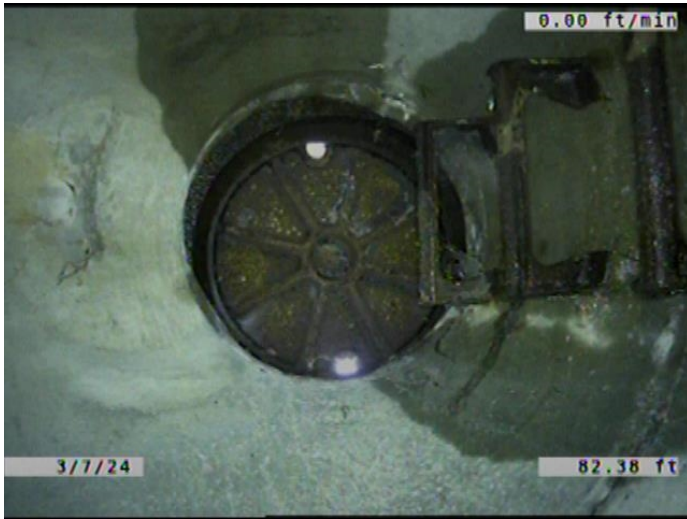
Code:	AMH
Description:	Manhole
Distance (ft):	82.4
Structural Grade:	0
O&M Grade:	0
Clock Start/From:	
Clock To:	
1st Value:	
2nd Value:	
Value Percent:	
Continuous Index:	
Within 8" of Joint:	NO
Remarks:	M-405-059
