RedZone
ROBOTICS

Street:	South Wabash Street	Flow Control:	Not Controlled
City:	Hobart, IN	Year Renewed:	
Location:	Alley	Tape/Media #:	
Purpose:	Routine Assessment	Dia/Height:	10"
Use:	Sanitary Sewage Pipe	Material:	VCP
Drain Area:		Lining:	None
Category:	NA		
Comment:			
Location Details:		Direction of Survey:	Upstream
US MH:	M-405-068	DS MH:	M-405-066
		Total Length Surveyed (ft):	322.9

Tuesday, April 25, 2023

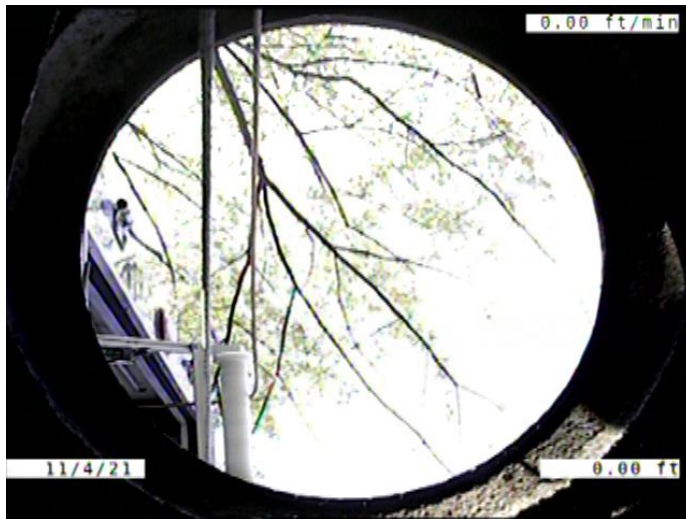
Code: **AMH**
 Description: **Manhole**

Distance (ft): **.0**
 Structural Grade: **0**
 O&M Grade: **0**
 Clock Start/From:
 Clock To:
 1st Value:
 2nd Value:
 Value Percent:
 Continuous Index:
 Within 8" of Joint: **NO**
 Remarks: **M-405-066**

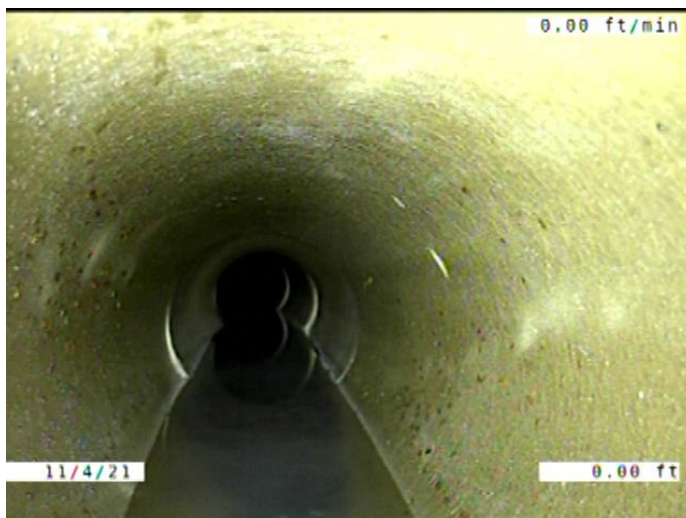
Code: **MWL**
 Description: **Miscellaneous Water Level**

Distance (ft): **.0**
 Structural Grade: **0**
 O&M Grade: **0**
 Clock Start/From:
 Clock To:
 1st Value:
 2nd Value:
 Value Percent: **5.000**
 Continuous Index:
 Within 8" of Joint: **NO**
 Remarks:

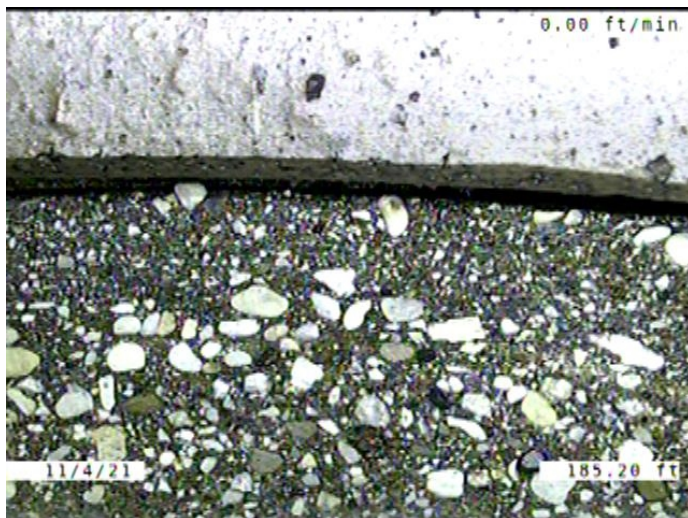
Code: **MMC**
 Description: **Miscellaneous Material Change**

Distance (ft): **185.2**
 Structural Grade: **0**
 O&M Grade: **0**
 Clock Start/From:
 Clock To:
 1st Value:
 2nd Value:
 Value Percent:
 Continuous Index:
 Within 8" of Joint: **NO**
 Remarks: **VCP TO CONCRETE**
