Profile/Photo Observation Report

Date:	11/04/2021	Weather:		Coding:	PACP 7.0
Pipe Length (ft):	330.0	Owner:	City of Hobart	Pre Clean:	Heavy Cleaning
P.O.#:	YES502259	Surveyor:	S. Bucklin	PSR:	P-405-066-068
Customer:	City of Hobart	Clean Date:	11/04/2021	Shape:	C

Street:	South Wabash Street	Flow Control:	Not Controlled
City:	Hobart, IN	Year Renewed:	
Location:	Alley	Tape/Media #:	
Purpose:	Routine Assessment	Dia/Height:	10"
Use:	Sanitary Sewage Pipe	Material:	VCP
Drain Area:		Lining:	None
Category:	NA		
Comment:			
Location Details:		Direction of Survey:	Upstream
US MH:	M-405-068	DS MH:	M-405-066
		Total Length Surveyed (ft):	322.9

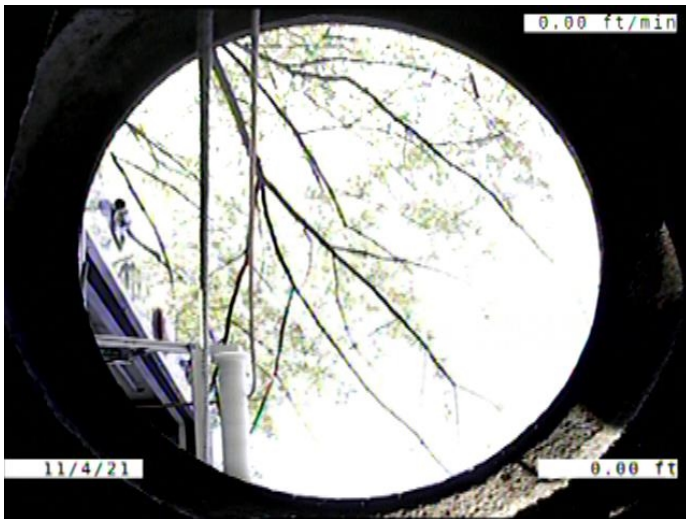
Code: **AMH**
Description: **Manhole**

Distance (ft): **.0**
Structural Grade: **0**
O&M Grade: **0**
Clock Start/From:
Clock To:
1st Value:
2nd Value:
Value Percent:
Continuous Index:
Within 8" of Joint: **NO**
Remarks: **M-405-066**

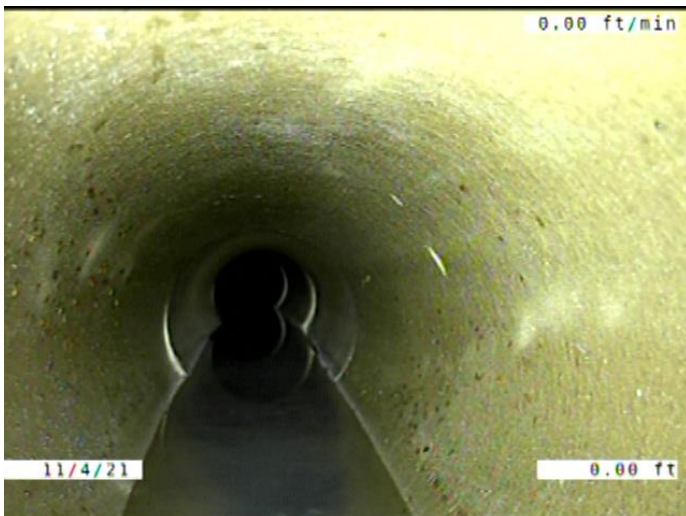
Code: **MWL**
Description: **Miscellaneous Water Level**

Distance (ft): **.0**
Structural Grade: **0**
O&M Grade: **0**
Clock Start/From:
Clock To:
1st Value:
2nd Value:
Value Percent: **5.000**
Continuous Index:
Within 8" of Joint: **NO**
Remarks:

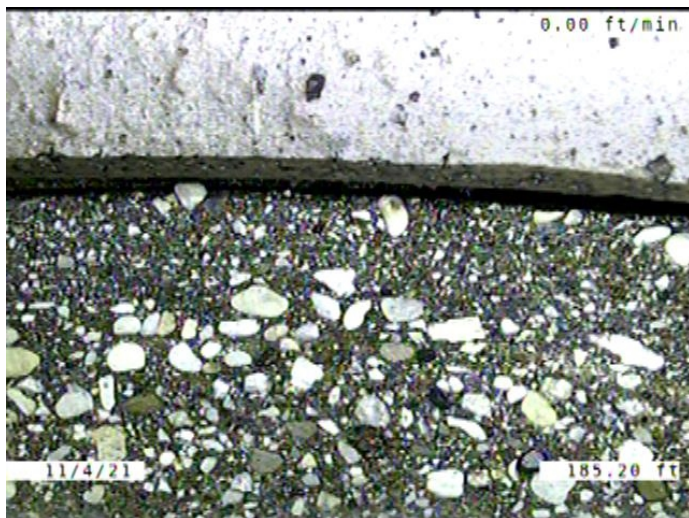
Code: **MMC**
 Description: **Miscellaneous Material Change**

Distance (ft): **185.2**
 Structural Grade: **0**
 O&M Grade: **0**
 Clock Start/From:
 Clock To:
 1st Value:
 2nd Value:
 Value Percent:
 Continuous Index:
 Within 8" of Joint: **NO**
 Remarks: **VCP TO CONCRETE**

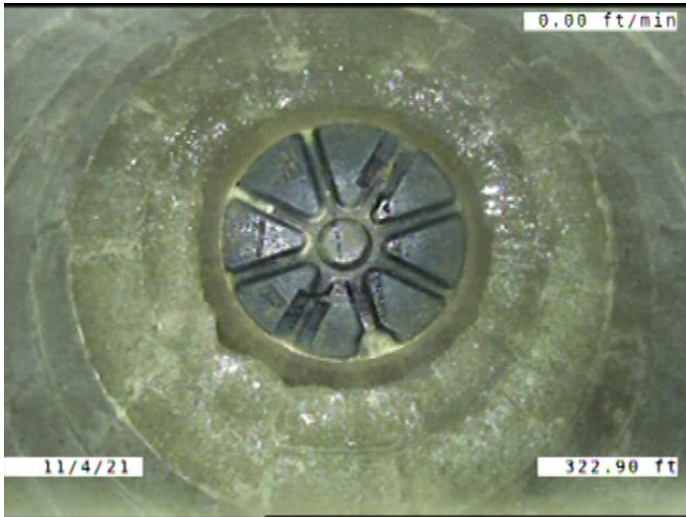
Code:	AMH
Description:	Manhole
Distance (ft):	322.9
Structural Grade:	0
O&M Grade:	0
Clock Start/From:	
Clock To:	
1st Value:	
2nd Value:	
Value Percent:	
Continuous Index:	
Within 8" of Joint:	NO
Remarks:	M-405-068
