Profile/Photo Observation Report

Profile/Prioto Observation Report									
Date:	10/22/2021	Weather:		Coding:	PACP 7.0				
Pipe Length (ft)	: 146.9	Owner:	City of Hobart	Pre Clean:	Heavy Cleaning				
P.O.#:	YES502259	Surveyor:	S. Bucklin	PSR:	P-503-005-004				
Customer:	City of Hobart	Clean Date:	10/21/2021	Shape:	С				
Street:	West 40th Place		Flow Control:	Not Controlle	d				
City:	Hobart, IN		Year Renewed:						
Location:	Alley		Tape/Media #:						
Purpose:	Routine Assessmen	nt	Dia/Height:	12"					
Use:	Sanitary Sewage Pi	pe	Material:	VCP					
Drain Area:			Lining:	None					
Category:	NA								
Comment:									
Location Details	s:		Direction of Surve	ey: Upstream					
US MH:	M-503-004	DS MH:	M-503-005	Total Length Surveyed (f	t): 146.9				
O&M Index:	1.73	O&M Quick:	3423	O&M Rating:	26.00				
Structural Index:	2.29	Structural Qu	ick: 4133		39.00				
Overall Index:	2.03	Overall Quick	442		65.00				
			·

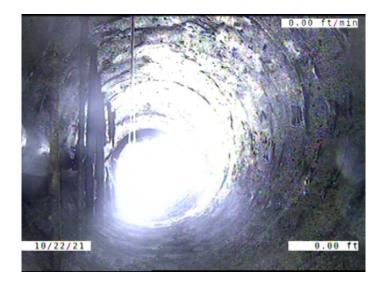
Code: AMH
Description: Manhole

Distance (ft): .0
Structural Grade: 0
O&M Grade: 0

Remarks: M-503-005

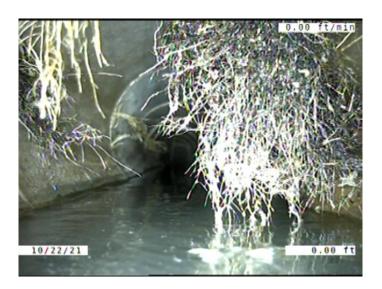
Code: MWL

Description: Miscellaneous Water Level

Distance (ft): .0
Structural Grade: 0
O&M Grade: 0

Value Percent: 10.000

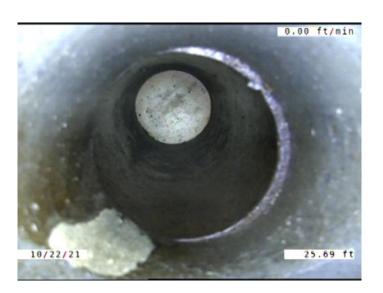
Code: **TFD**

Description: Tap Factory Defective

Distance (ft): 23.7
Structural Grade: 0

O&M Grade: 3

Clock Start/From: 1

1st Value: **4.000**

Remarks: CAPPED. LARGE OFFSET FIRST JOINT

BACK. SOIL VISIIBLE

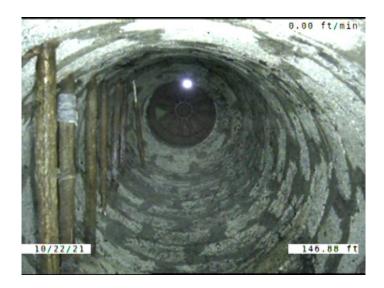
Code: AMH
Description: Manhole

Distance (ft): 146.9
Structural Grade: 0
O&M Grade: 0
