Profile/Photo Observation Report

Date:	04/12/2018	Weather:		Coding:	PACP 6.0
Pipe Length (ft):	219.9	Owner:	NA	Pre Clean:	Not Known
P.O.#:		Surveyor:	Jen Costello	PSR:	P-503-008-004
Customer:		Clean Date:	01/01/1900	Shape:	C

Street:	W 40TH AVE	Flow Control:	Not Controlled
City:	Hobart, IN	Year Renewed:	
Location:	Other	Tape/Media #:	
Purpose:	Not Known	Dia/Height:	12"
Use:	Sanitary	Material:	VCP
Drain Area:	NA	Lining:	
Category:	NA		
Comment:

Location Details:		Direction of Survey:	Downstream
US MH:	M-503-004	DS MH:	M-503-008
		Total Length Surveyed (ft):	204.0

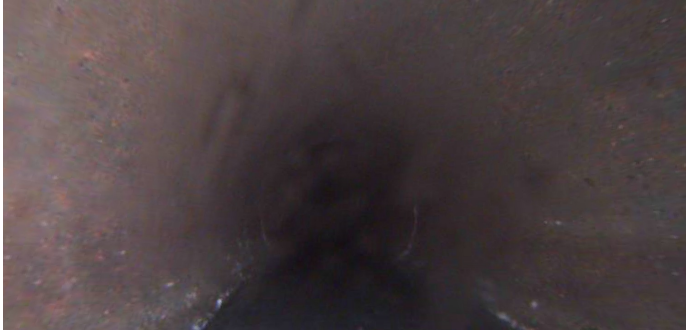
Code: **AMH**
Description: **Manhole**

Distance (ft): **.0**
Structural Grade: **0**
O&M Grade: **0**
Clock Start/From:
Clock To:
1st Value:
2nd Value:
Value Percent:
Continuous Index:
Within 8" of Joint: **NO**
Remarks: **M-503-004**

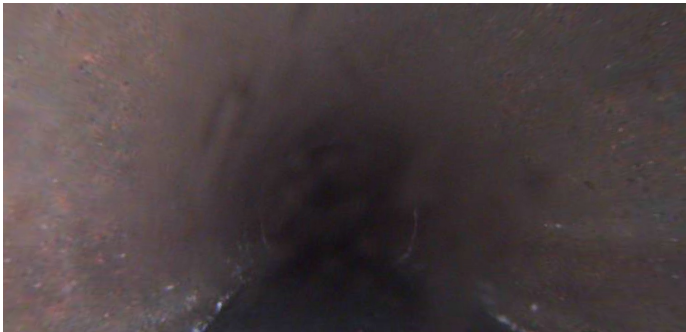
Code: **MWL**
Description: **Water Level**

Distance (ft): **.0**
Structural Grade: **0**
O&M Grade: **0**
Clock Start/From:
Clock To:
1st Value:
2nd Value:
Value Percent: **5.000**
Continuous Index:
Within 8" of Joint: **NO**
Remarks:

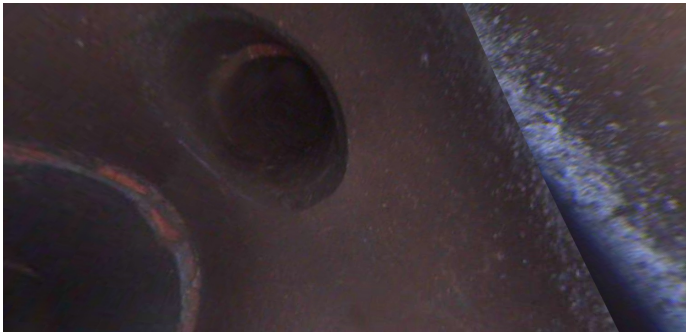
Code: **TF**
Description: **Tap Factory**

Distance (ft): **9.7**
Structural Grade: **0**
O&M Grade: **0**
Clock Start/From: **11**
Clock To:
1st Value: **4.000**
2nd Value:
Value Percent:
Continuous Index:
Within 8" of Joint:
Remarks:

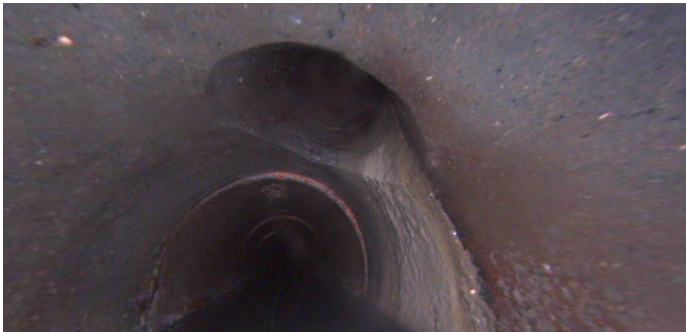
Code: **TF**
Description: **Tap Factory**

Distance (ft): **26.0**
Structural Grade: **0**
O&M Grade: **0**
Clock Start/From: **12**
Clock To:
1st Value: **4.000**
2nd Value:
Value Percent:
Continuous Index:
Within 8" of Joint:
Remarks:

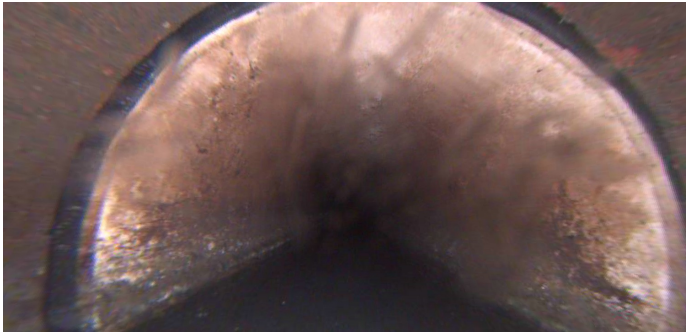
Code: **MMC**
Description: **Material Change**

Distance (ft): **46.8**
Structural Grade: **0**
O&M Grade: **0**
Clock Start/From:
Clock To:
1st Value:
2nd Value:
Value Percent:
Continuous Index:
Within 8" of Joint: **NO**
Remarks: **PVC**

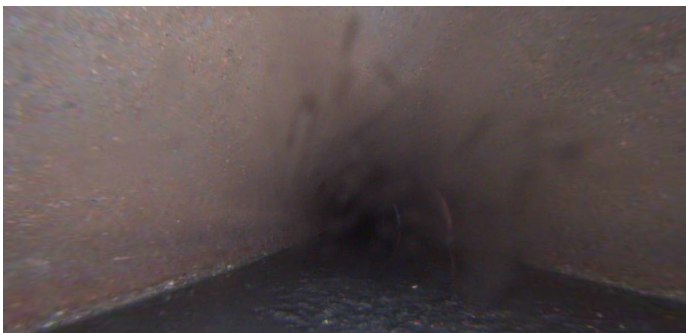
Code: **MMC**
Description: **Material Change**

Distance (ft): **57.9**
Structural Grade: **0**
O&M Grade: **0**
Clock Start/From:
Clock To:
1st Value:
2nd Value:
Value Percent:
Continuous Index:
Within 8" of Joint: **NO**
Remarks: **vcp**

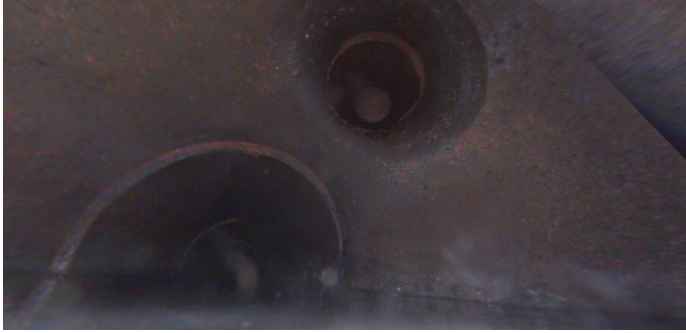
Code: **TF**
Description: **Tap Factory**

Distance (ft): **70.9**
Structural Grade: **0**
O&M Grade: **0**
Clock Start/From: **11**
Clock To:
1st Value: **4.000**
2nd Value:
Value Percent:
Continuous Index:
Within 8" of Joint:
Remarks:

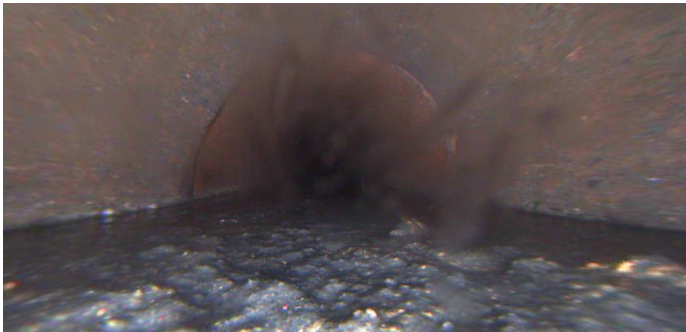
Code: **MWL**
Description: **Water Level**

Distance (ft): **70.9**
Structural Grade: **0**
O&M Grade: **0**
Clock Start/From:
Clock To:
1st Value:
2nd Value:
Value Percent: **40.000**
Continuous Index:
Within 8" of Joint: **NO**
Remarks:

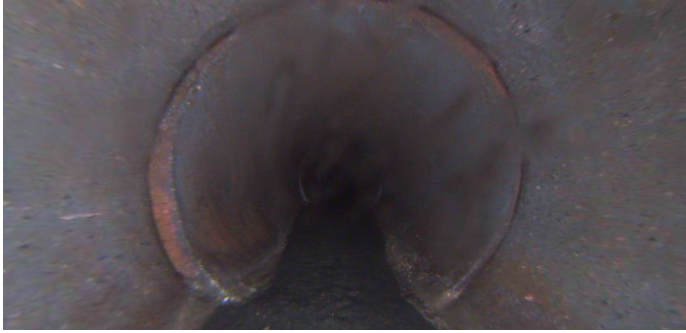
Code: **MWL**
Description: **Water Level**

Distance (ft): **91.6**
Structural Grade: **0**
O&M Grade: **0**
Clock Start/From:
Clock To:
1st Value:
2nd Value:
Value Percent: **5.000**
Continuous Index:
Within 8" of Joint: **NO**
Remarks:

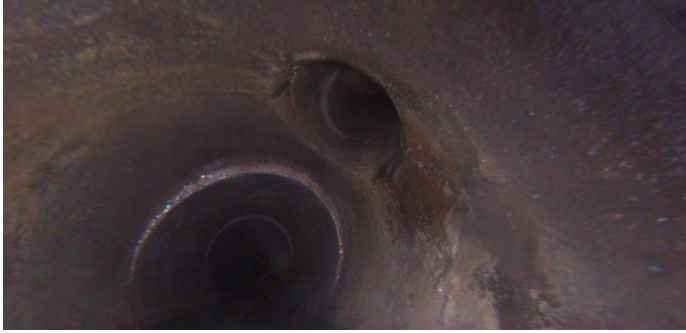
Code: **TF**
Description: **Tap Factory**

Distance (ft): **95.7**
Structural Grade: **0**
O&M Grade: **0**
Clock Start/From: **11**
Clock To:
1st Value: **4.000**
2nd Value:
Value Percent:
Continuous Index:
Within 8" of Joint:
Remarks:

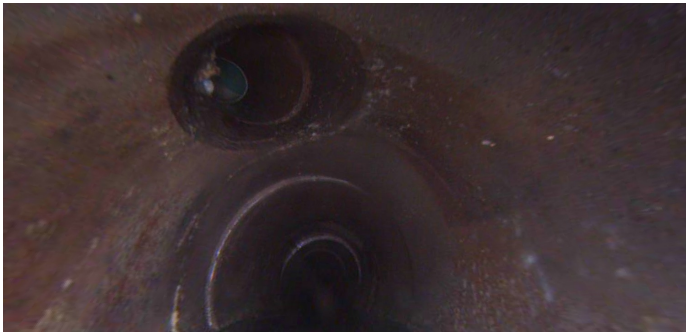
Code: **TF**
Description: **Tap Factory**

Distance (ft): **97.7**
Structural Grade: **0**
O&M Grade: **0**
Clock Start/From: **12**
Clock To:
1st Value: **4.000**
2nd Value:
Value Percent:
Continuous Index:
Within 8" of Joint:
Remarks:

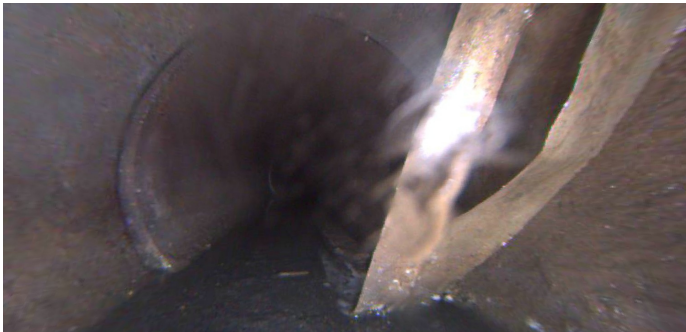
Code: **AMH**
Description: **Manhole**

Distance (ft): **204.0**
Structural Grade: **0**
O&M Grade: **0**
Clock Start/From:
Clock To:
1st Value:
2nd Value:
Value Percent:
Continuous Index:
Within 8" of Joint: **NO**
Remarks: **M-503-008**
