Profile/Photo Observation Report

Date:	04/12/2018	Weather:		Coding:	PACP 6.0
Pipe Length (ft):	219.9	Owner:	NA	Pre Clean:	Not Known
P.O.#:		Surveyor:	Jen Costello	PSR:	P-503-008-004
Customer:		Clean Date:	01/01/1900	Shape:	C

Street:	W 40th ave	Flow Control:	Not Controlled
City:	Hobart, IN	Year Renewed:	
Location:	Other	Tape/Media #:	
Purpose:	Not Known	Dia/Height:	12"
Use:	Sanitary	Material:	VCP
Drain Area:	NA	Lining:	
Category:	NA		
Comment:

Location Details:		Direction of Survey:	Downstream
US MH:	M-503-004	DS MH:	M-503-008
		Total Length Surveyed (ft):	204.0

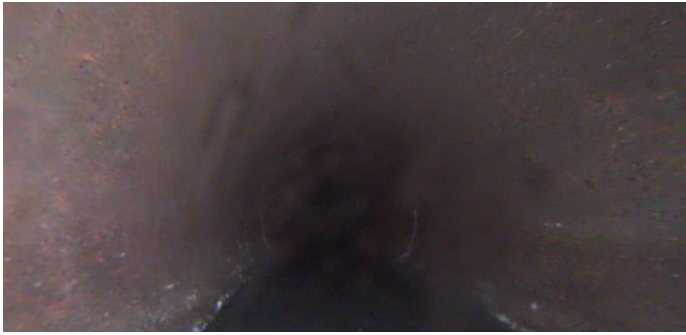
Code: **AMH**
Description: **Manhole**

Distance (ft): **.0**
Structural Grade: **0**
O&M Grade: **0**
Clock Start/From:
Clock To:
1st Value:
2nd Value:
Value Percent:
Continuous Index:
Within 8" of Joint: **NO**
Remarks: **M-503-004**

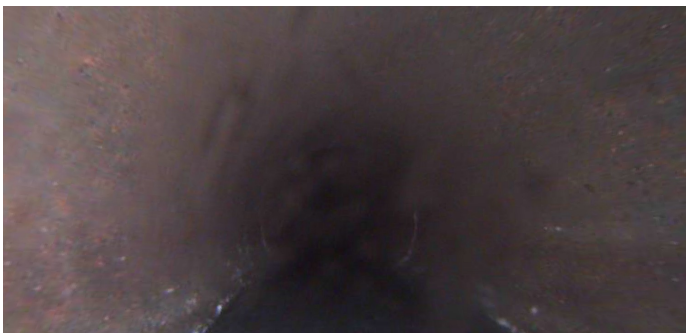
Code: **MWL**
Description: **Water Level**

Distance (ft): **.0**
Structural Grade: **0**
O&M Grade: **0**
Clock Start/From:
Clock To:
1st Value:
2nd Value:
Value Percent: **5.000**
Continuous Index:
Within 8" of Joint: **NO**
Remarks:

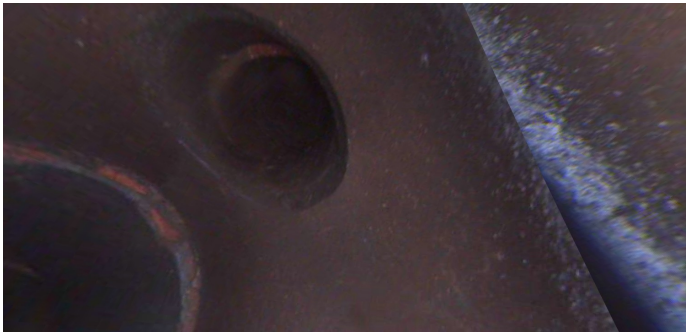
Code: **TF**
Description: **Tap Factory**

Distance (ft): **9.7**
Structural Grade: **0**
O&M Grade: **0**
Clock Start/From: **11**
Clock To:
1st Value: **4.000**
2nd Value:
Value Percent:
Continuous Index:
Within 8" of Joint:
Remarks:

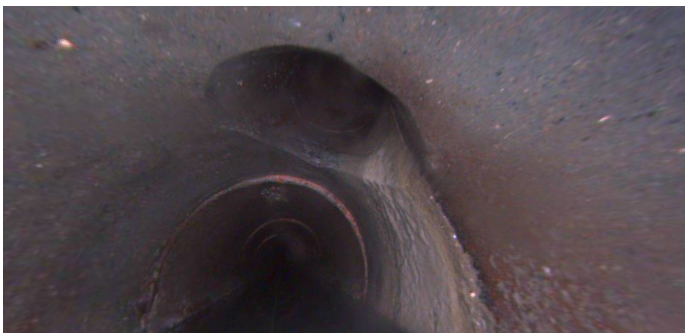
Code: **TF**
Description: **Tap Factory**

Distance (ft): **26.0**
Structural Grade: **0**
O&M Grade: **0**
Clock Start/From: **12**
Clock To:
1st Value: **4.000**
2nd Value:
Value Percent:
Continuous Index:
Within 8" of Joint:
Remarks:

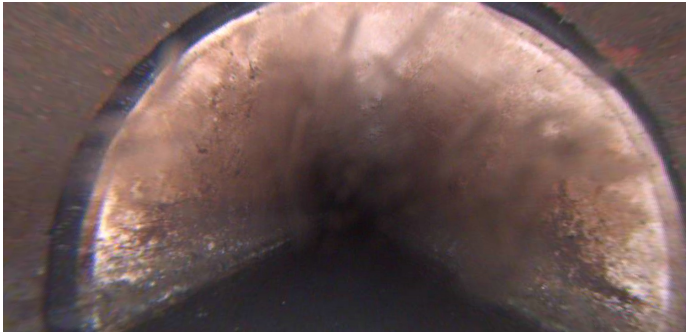
Code: **MMC**
Description: **Material Change**

Distance (ft): **46.8**
Structural Grade: **0**
O&M Grade: **0**
Clock Start/From:
Clock To:
1st Value:
2nd Value:
Value Percent:
Continuous Index:
Within 8" of Joint: **NO**
Remarks: **PVC**

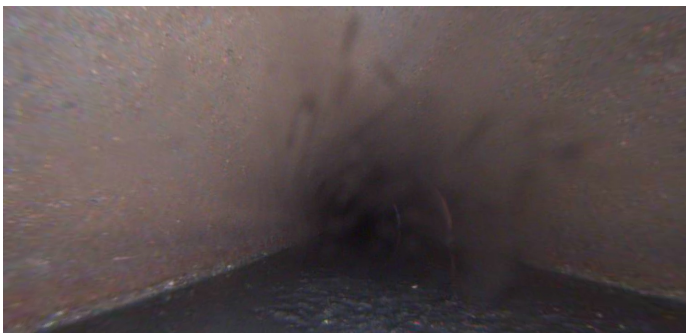
Code: **MMC**
Description: **Material Change**

Distance (ft): **57.9**
Structural Grade: **0**
O&M Grade: **0**
Clock Start/From:
Clock To:
1st Value:
2nd Value:
Value Percent:
Continuous Index:
Within 8" of Joint: **NO**
Remarks: **vcp**

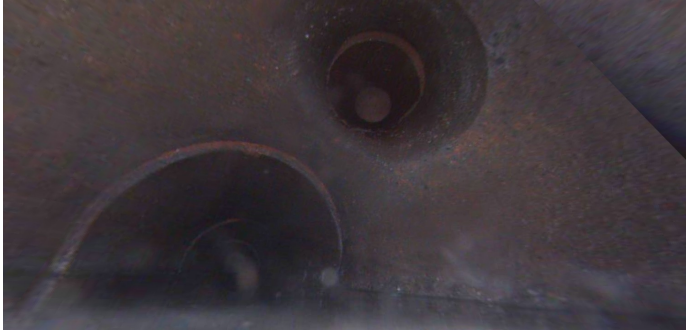
Code: **TF**
Description: **Tap Factory**

Distance (ft): **70.9**
Structural Grade: **0**
O&M Grade: **0**
Clock Start/From: **11**
Clock To:
1st Value: **4.000**
2nd Value:
Value Percent:
Continuous Index:
Within 8" of Joint:
Remarks:

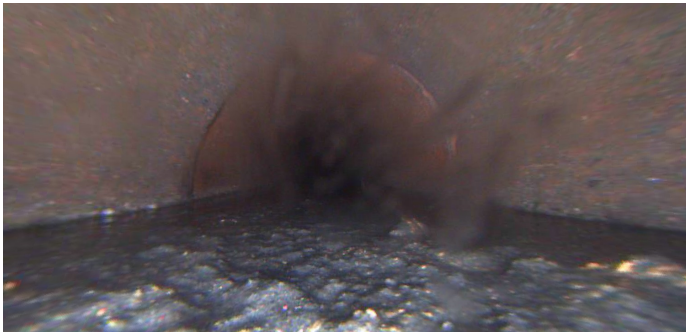
Code: **MWL**
Description: **Water Level**

Distance (ft): **70.9**
Structural Grade: **0**
O&M Grade: **0**
Clock Start/From:
Clock To:
1st Value:
2nd Value:
Value Percent: **40.000**
Continuous Index:
Within 8" of Joint: **NO**
Remarks:

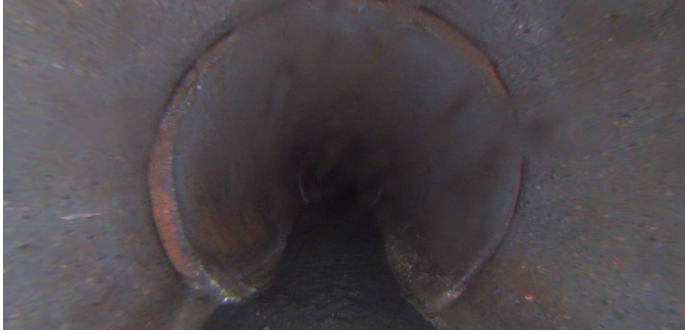
Code: **MWL**
Description: **Water Level**

Distance (ft): **91.6**
Structural Grade: **0**
O&M Grade: **0**
Clock Start/From:
Clock To:
1st Value:
2nd Value:
Value Percent: **5.000**
Continuous Index:
Within 8" of Joint: **NO**
Remarks:

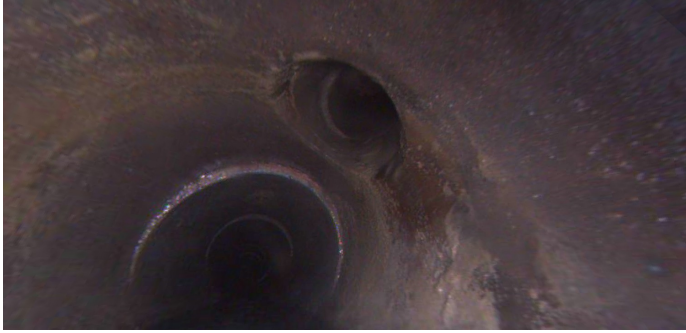
Code: **TF**
Description: **Tap Factory**

Distance (ft): **95.7**
Structural Grade: **0**
O&M Grade: **0**
Clock Start/From: **11**
Clock To:
1st Value: **4.000**
2nd Value:
Value Percent:
Continuous Index:
Within 8" of Joint:
Remarks:

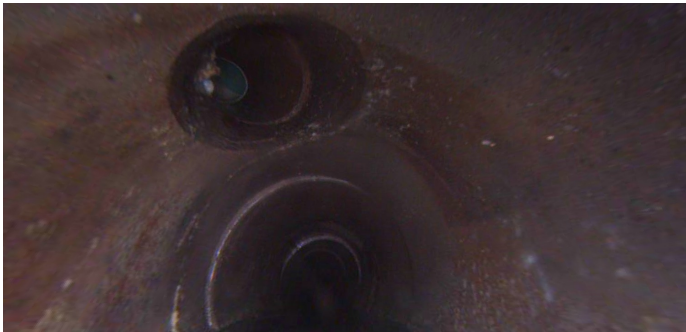
Code: **TF**
Description: **Tap Factory**

Distance (ft): **97.7**
Structural Grade: **0**
O&M Grade: **0**
Clock Start/From: **12**
Clock To:
1st Value: **4.000**
2nd Value:
Value Percent:
Continuous Index:
Within 8" of Joint:
Remarks:

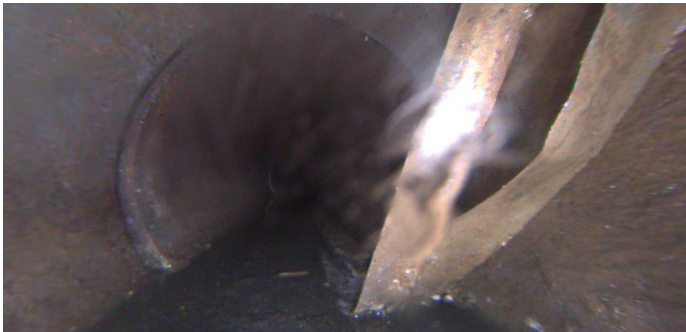
Code: **AMH**
Description: **Manhole**

Distance (ft): **204.0**
Structural Grade: **0**
O&M Grade: **0**
Clock Start/From:
Clock To:
1st Value:
2nd Value:
Value Percent:
Continuous Index:
Within 8" of Joint: **NO**
Remarks: **M-503-008**
