# Profile/Photo Observation Report

Date:	09/19/2021	Weather:		Coding:	PACP 7.0
Pipe Length (ft):	185.8	Owner:	City of Hobart	Pre Clean:	Light Cleaning
P.O.#:	YES502259	Surveyor:	S. Bucklin	PSR:	P-503-010-009
Customer:	City of Hobart	Clean Date:	09/06/2021	Shape:	C

Street:	West 39th Place	Flow Control:	Not Controlled
City:	Hobart, IN	Year Renewed:	
Location:	Alley	Tape/Media #:	
Purpose:	Routine Assessment	Dia/Height:	10"
Use:	Sanitary Sewage Pipe	Material:	VCP
Drain Area:		Lining:	None
Category:	NA		
Comment:			
Location Details:		Direction of Survey:	Downstream
US MH:	M-503-009	DS MH:	M-503-010
		Total Length Surveyed (ft):	185.8

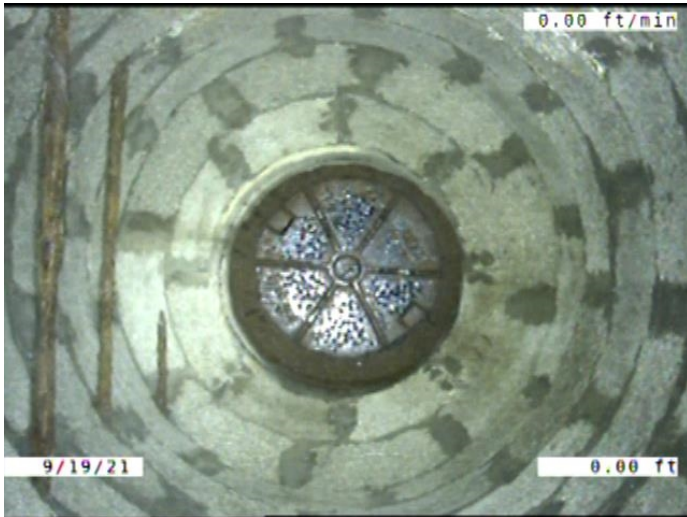
Code: **AMH**  
 Description: **Manhole**

Distance (ft): **.0**  
 Structural Grade: **0**  
 O&M Grade: **0**  
 Clock Start/From:  
 Clock To:  
 1st Value:  
 2nd Value:  
 Value Percent:  
 Continuous Index:  
 Within 8" of Joint: **NO**  
 Remarks: **M-503-009**

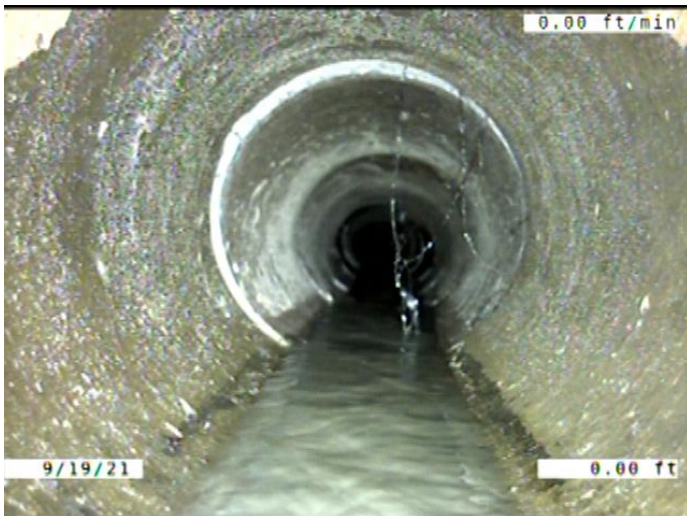
Code: **MWL**  
 Description: **Miscellaneous Water Level**

Distance (ft): **.0**  
 Structural Grade: **0**  
 O&M Grade: **0**  
 Clock Start/From:  
 Clock To:  
 1st Value:  
 2nd Value:  
 Value Percent: **5.000**  
 Continuous Index:  
 Within 8" of Joint: **NO**  
 Remarks:

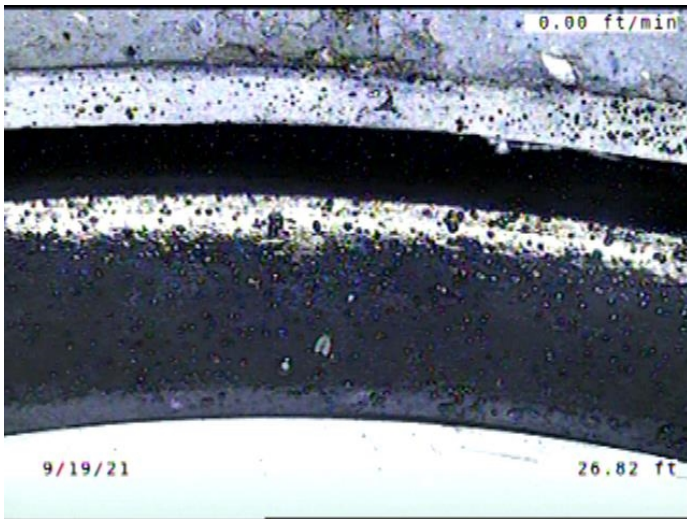
Code: **MMC**  
Description: **Miscellaneous Material Change**

Distance (ft): **26.8**  
Structural Grade: **0**  
O&M Grade: **0**  
Clock Start/From:  
Clock To:  
1st Value:  
2nd Value:  
Value Percent:  
Continuous Index:  
Within 8" of Joint: **NO**  
Remarks: **VCP TO PVC**

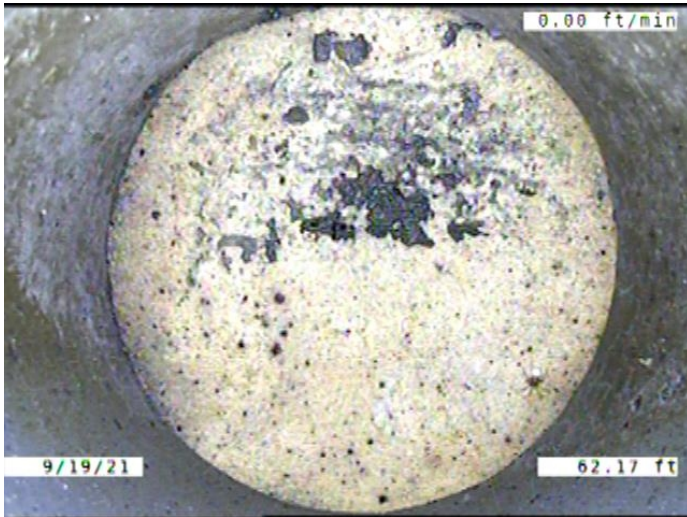
Code: **TFC**  
 Description: **Tap Factory Capped**

Distance (ft): **62.2**  
 Structural Grade: **0**  
 O&M Grade: **0**  
 Clock Start/From: **11**  
 Clock To:  
 1st Value: **4.000**  
 2nd Value:  
 Value Percent:  
 Continuous Index:  
 Within 8" of Joint: **YES**  
 Remarks:

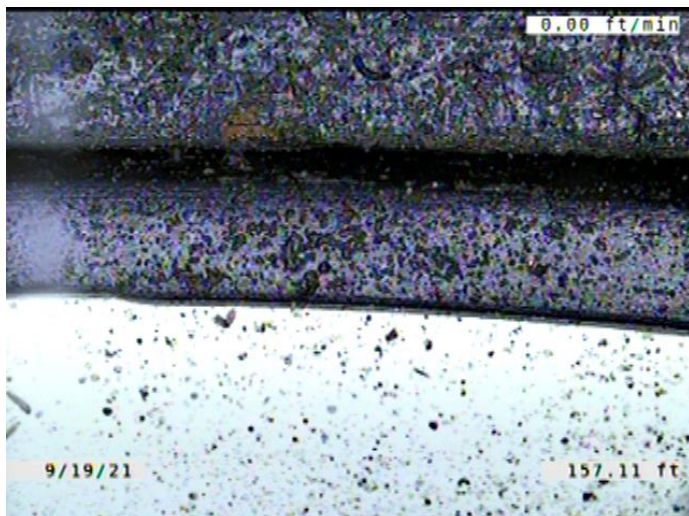
Code: **MMC**  
Description: **Miscellaneous Material Change**

Distance (ft): **157.1**  
Structural Grade: **0**  
O&M Grade: **0**  
Clock Start/From:  
Clock To:  
1st Value:  
2nd Value:  
Value Percent:  
Continuous Index:  
Within 8" of Joint: **NO**  
Remarks: **VCP TO PVC**

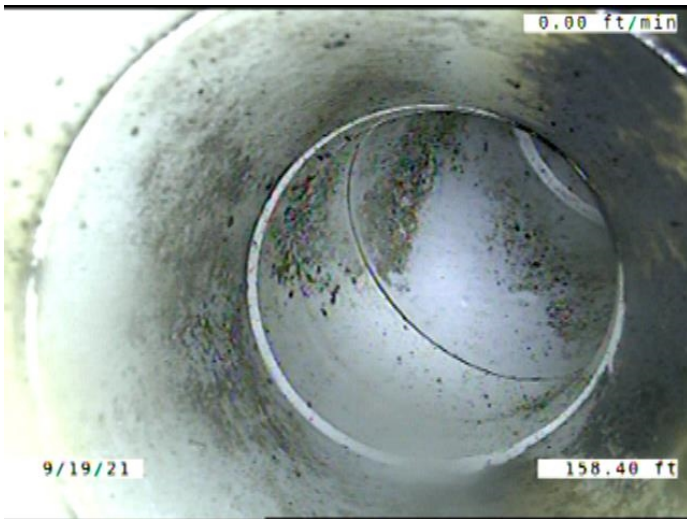
Code: **TF**  
Description: **Tap Factory**

Distance (ft): **158.4**  
Structural Grade: **0**  
O&M Grade: **0**  
Clock Start/From: **12**  
Clock To:  
1st Value: **4.000**  
2nd Value:  
Value Percent:  
Continuous Index:  
Within 8" of Joint: **YES**  
Remarks:
