Profile/Photo Observation Report

Date:	09/19/2021	Weather:		Coding:	PACP 7.0
Pipe Length (ft):	185.8	Owner:	City of Hobart	Pre Clean:	Light Cleaning
P.O.#:	YES502259	Surveyor:	S. Bucklin	PSR:	P-503-010-009
Customer:	City of Hobart	Clean Date:	09/06/2021	Shape:	C

Street:	West 39th Place	Flow Control:	Not Controlled
City:	Hobart, IN	Year Renewed:	
Location:	Alley	Tape/Media #:	
Purpose:	Routine Assessment	Dia/Height:	10"
Use:	Sanitary Sewage Pipe	Material:	VCP
Drain Area:		Lining:	None
Category:	NA		
Comment:			
Location Details:		Direction of Survey:	Downstream
US MH:	M-503-009	DS MH:	M-503-010
		Total Length Surveyed (ft):	185.8

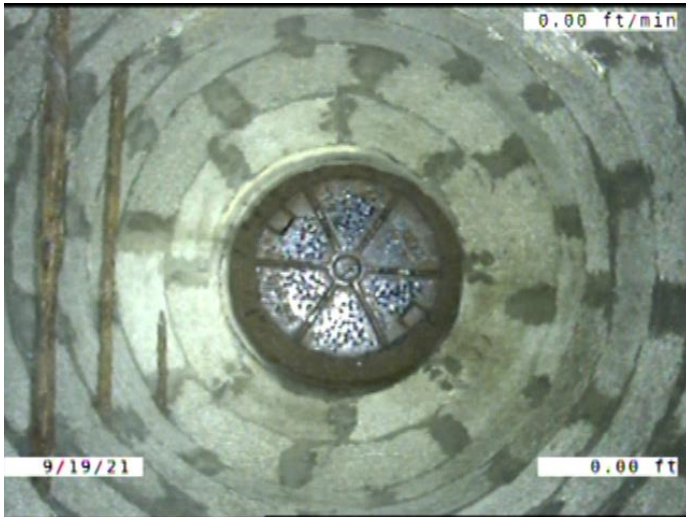
Code: **AMH**
 Description: **Manhole**

Distance (ft): **.0**
 Structural Grade: **0**
 O&M Grade: **0**
 Clock Start/From:
 Clock To:
 1st Value:
 2nd Value:
 Value Percent:
 Continuous Index:
 Within 8" of Joint: **NO**
 Remarks: **M-503-009**

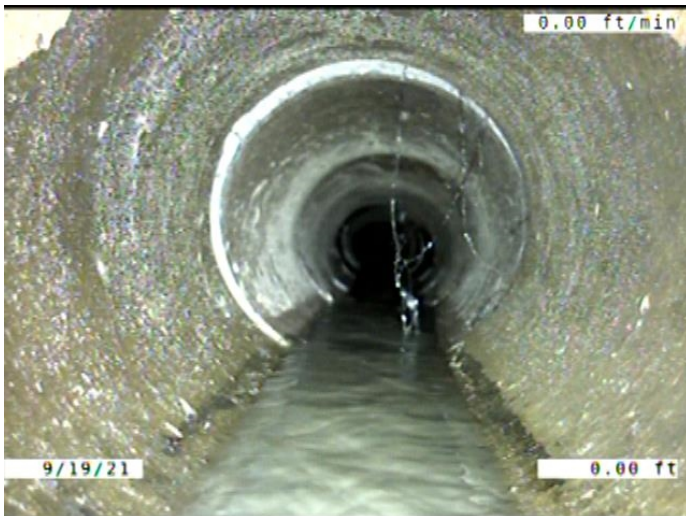
Code: **MWL**
 Description: **Miscellaneous Water Level**

Distance (ft): **.0**
 Structural Grade: **0**
 O&M Grade: **0**
 Clock Start/From:
 Clock To:
 1st Value:
 2nd Value:
 Value Percent: **5.000**
 Continuous Index:
 Within 8" of Joint: **NO**
 Remarks:

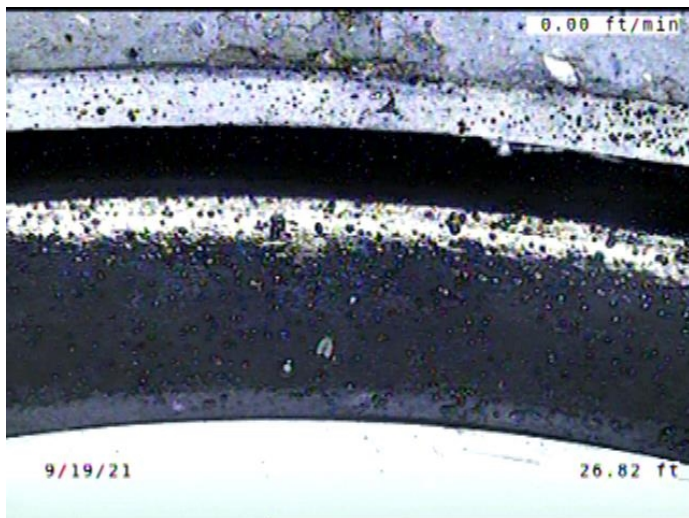
Code: **MMC**
 Description: **Miscellaneous Material Change**

Distance (ft): **26.8**
 Structural Grade: **0**
 O&M Grade: **0**
 Clock Start/From:
 Clock To:
 1st Value:
 2nd Value:
 Value Percent:
 Continuous Index:
 Within 8" of Joint: **NO**
 Remarks: **VCP TO PVC**

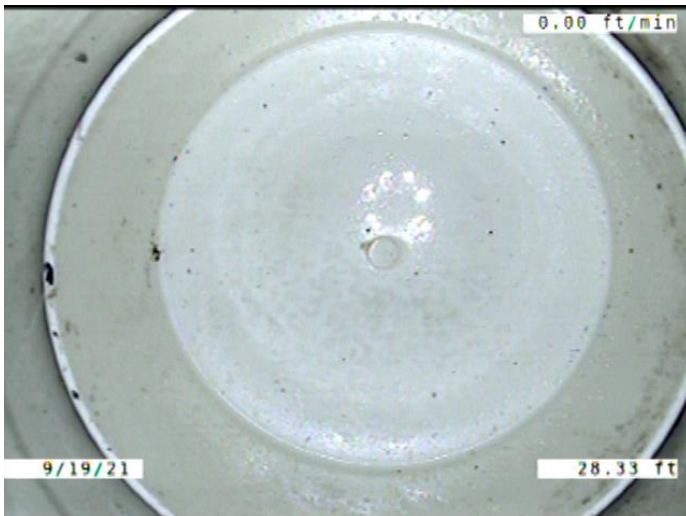
Code: **TFC**
 Description: **Tap Factory Capped**

Distance (ft): **28.3**
 Structural Grade: **0**
 O&M Grade: **0**
 Clock Start/From: **1**
 Clock To:
 1st Value: **4.000**
 2nd Value:
 Value Percent:
 Continuous Index:
 Within 8" of Joint: **YES**
 Remarks:

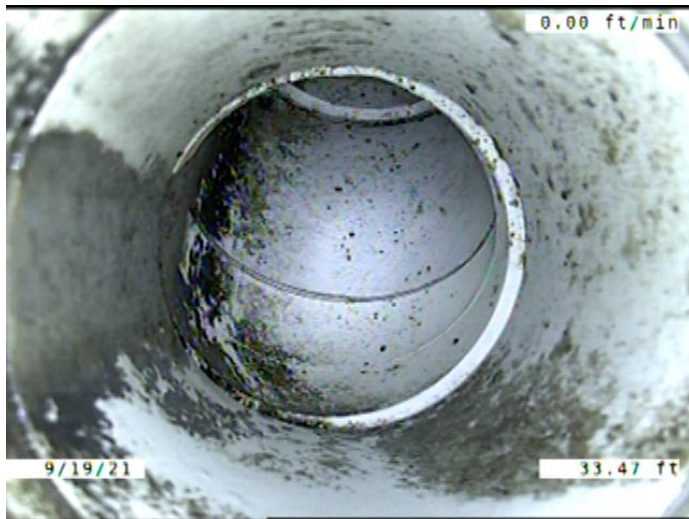
Code: **TF**
 Description: **Tap Factory**

Distance (ft): **33.5**
 Structural Grade: **0**
 O&M Grade: **0**
 Clock Start/From: **10**
 Clock To:
 1st Value: **4.000**
 2nd Value:
 Value Percent:
 Continuous Index:
 Within 8" of Joint: **YES**
 Remarks:

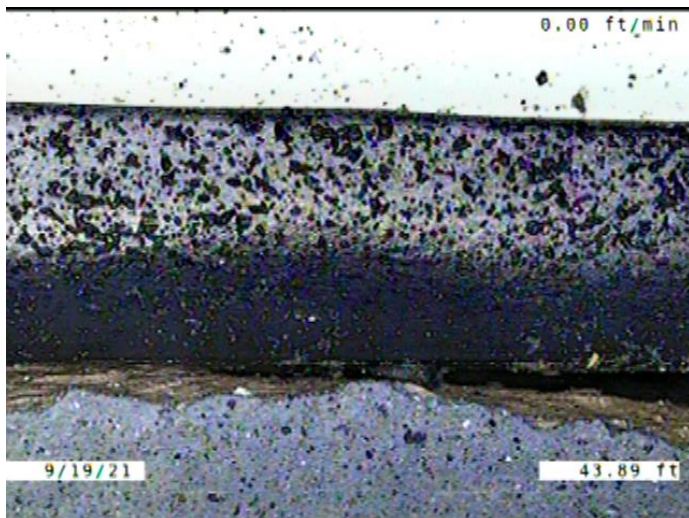
Code: **MMC**
 Description: **Miscellaneous Material Change**

Distance (ft): **43.9**
 Structural Grade: **0**
 O&M Grade: **0**
 Clock Start/From:
 Clock To:
 1st Value:
 2nd Value:
 Value Percent:
 Continuous Index:
 Within 8" of Joint: **NO**
 Remarks: **PVC TO VCP**

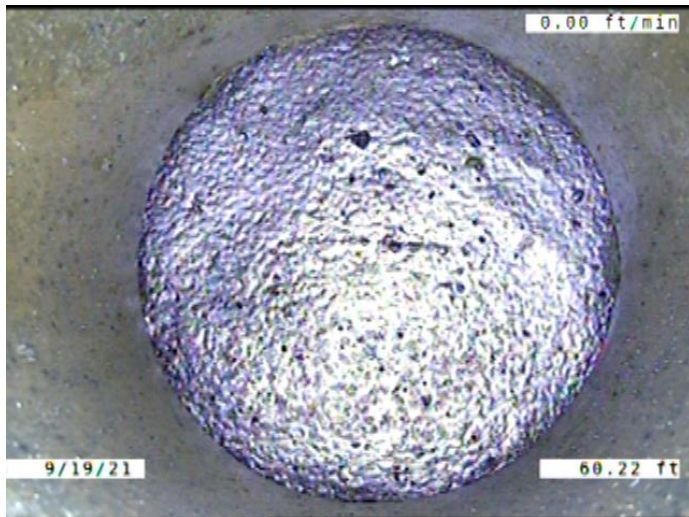
Code: **TFC**
 Description: **Tap Factory Capped**

Distance (ft): **60.2**
 Structural Grade: **0**
 O&M Grade: **0**
 Clock Start/From: **1**
 Clock To:
 1st Value: **4.000**
 2nd Value:
 Value Percent:
 Continuous Index:
 Within 8" of Joint: **YES**
 Remarks:

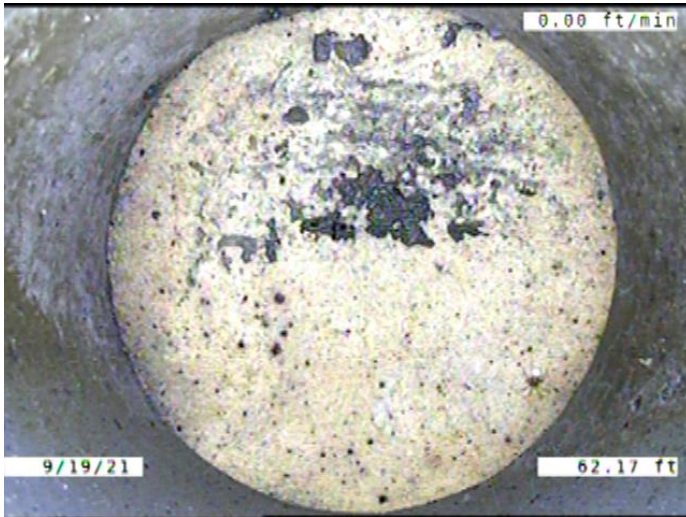
Code: **TFC**
 Description: **Tap Factory Capped**

Distance (ft): **62.2**
 Structural Grade: **0**
 O&M Grade: **0**
 Clock Start/From: **11**
 Clock To:
 1st Value: **4.000**
 2nd Value:
 Value Percent:
 Continuous Index:
 Within 8" of Joint: **YES**
 Remarks:

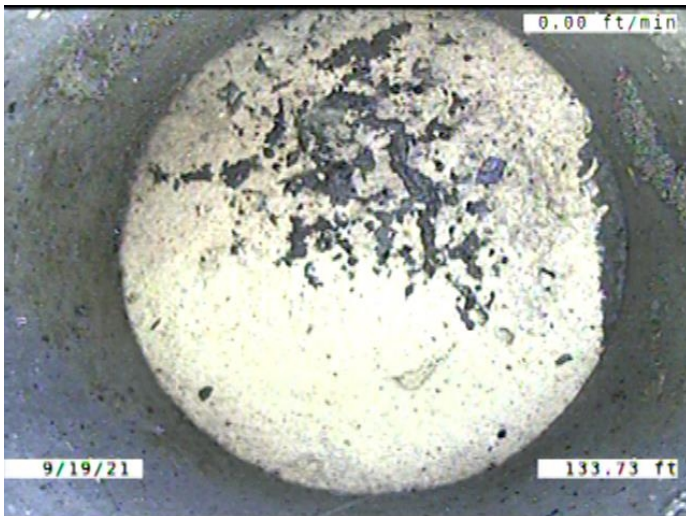
Code: **TFC**
 Description: **Tap Factory Capped**

Distance (ft): **133.7**
 Structural Grade: **0**
 O&M Grade: **0**
 Clock Start/From: **1**
 Clock To:
 1st Value: **4.000**
 2nd Value:
 Value Percent:
 Continuous Index:
 Within 8" of Joint: **YES**
 Remarks:

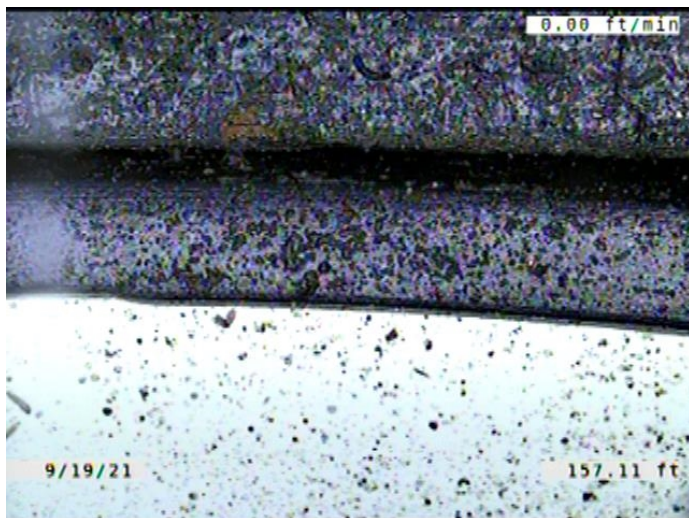
Code: **MMC**
 Description: **Miscellaneous Material Change**

Distance (ft): **157.1**
 Structural Grade: **0**
 O&M Grade: **0**
 Clock Start/From:
 Clock To:
 1st Value:
 2nd Value:
 Value Percent:
 Continuous Index:
 Within 8" of Joint: **NO**
 Remarks: **VCP TO PVC**

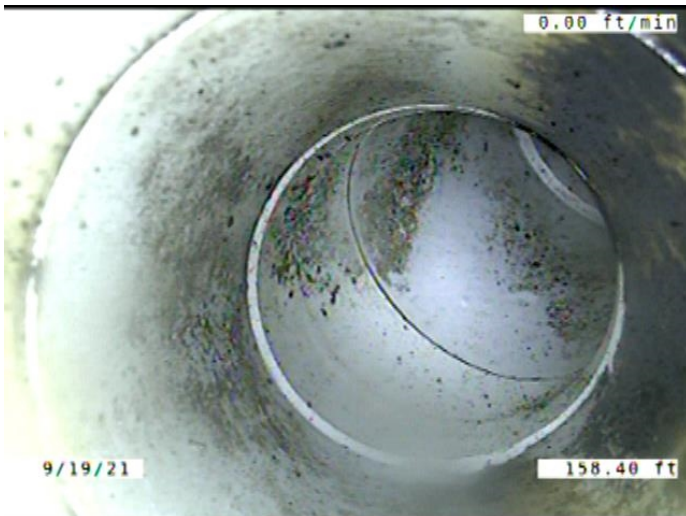
Code: **TF**
Description: **Tap Factory**

Distance (ft): **158.4**
Structural Grade: **0**
O&M Grade: **0**
Clock Start/From: **12**
Clock To:
1st Value: **4.000**
2nd Value:
Value Percent:
Continuous Index:
Within 8" of Joint: **YES**
Remarks:

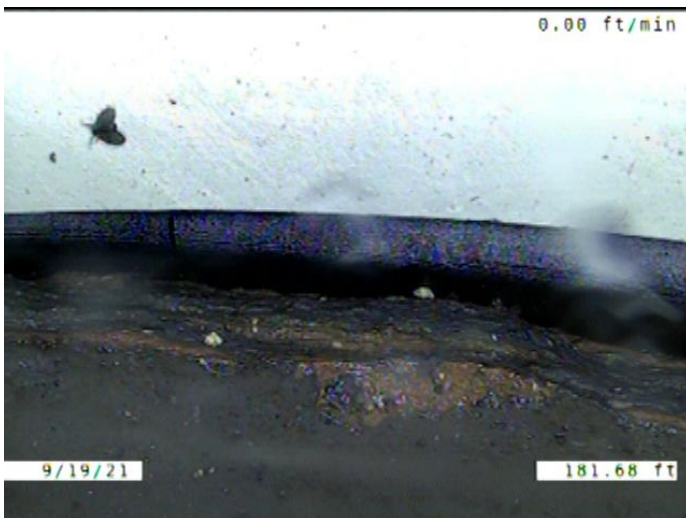
Code: **MMC**
Description: **Miscellaneous Material Change**

Distance (ft): **181.7**
Structural Grade: **0**
O&M Grade: **0**
Clock Start/From:
Clock To:
1st Value:
2nd Value:
Value Percent:
Continuous Index:
Within 8" of Joint: **NO**
Remarks: **PVC TO VCP**

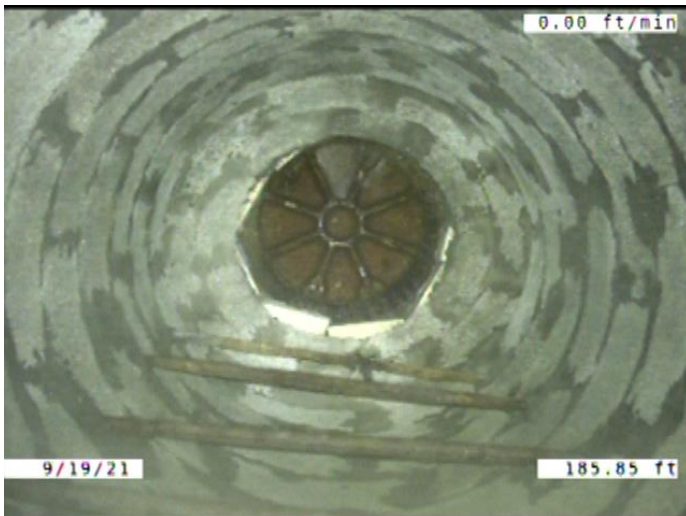
Code: **AMH**
 Description: **Manhole**

Distance (ft): **185.8**
 Structural Grade: **0**
 O&M Grade: **0**
 Clock Start/From:
 Clock To:
 1st Value:
 2nd Value:
 Value Percent:
 Continuous Index:
 Within 8" of Joint: **NO**
 Remarks: **M-503-010**
