Profile/Photo Observation Report

Street:	W 39TH PL	Flow Control:	Not Controlled
City:	Hobart, IN	Year Renewed:	
Location:	Other	Tape/Media #:	
Purpose:	Not Known	Dia/Height:	12"
Use:	Sanitary	Material:	VCP
Drain Area:	NA	Lining:	
Category:	NA		
Comment:

Location Details:		Direction of Survey:	Upstream
US MH:	M-503-009	DS MH:	M-503-016
		Total Length Surveyed (ft):	124.7

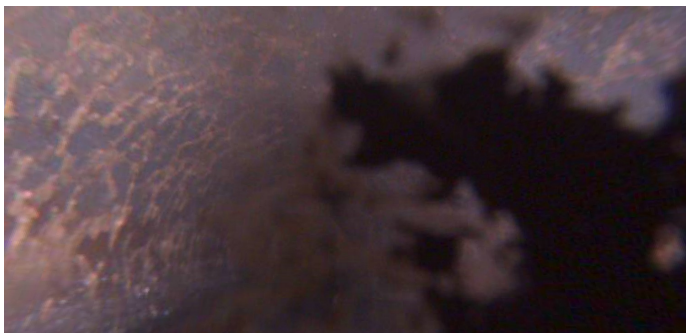
Code: **AMH**
 Description: **Manhole**

Distance (ft): **.0**
 Structural Grade: **0**
 O&M Grade: **0**
 Clock Start/From:
 Clock To:
 1st Value:
 2nd Value:
 Value Percent:
 Continuous Index:
 Within 8" of Joint: **NO**
 Remarks: **M-503-009**

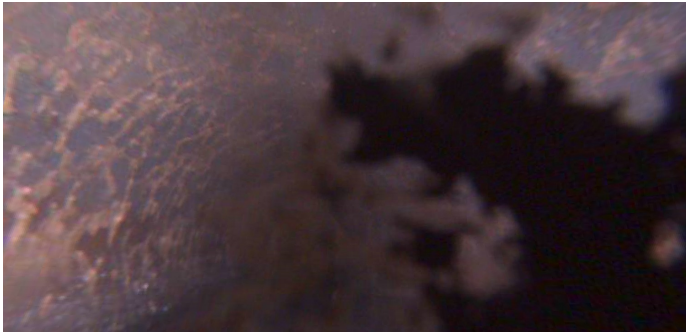
Code:	MWL
Description:	Water Level

Distance (ft):	.0
Structural Grade:	0
O&M Grade:	0
Clock Start/From:	
Clock To:	
1st Value:	
2nd Value:	
Value Percent:	20.000
Continuous Index:	
Within 8" of Joint:	NO
Remarks:

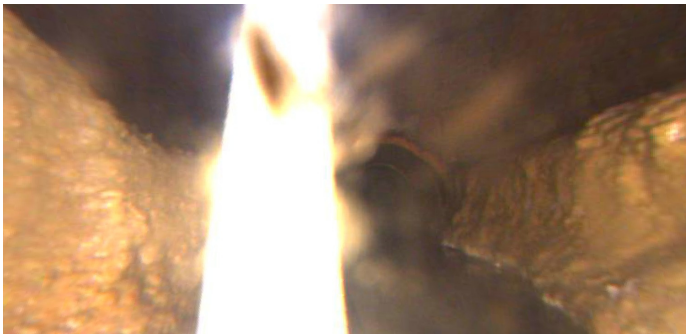
Code:	MGO
Description:	General Observation

Distance (ft):	.0
Structural Grade:	0
O&M Grade:	0
Clock Start/From:	
Clock To:	
1st Value:	
2nd Value:	
Value Percent:	
Continuous Index:	
Within 8" of Joint:	NO
Remarks:	rear camera

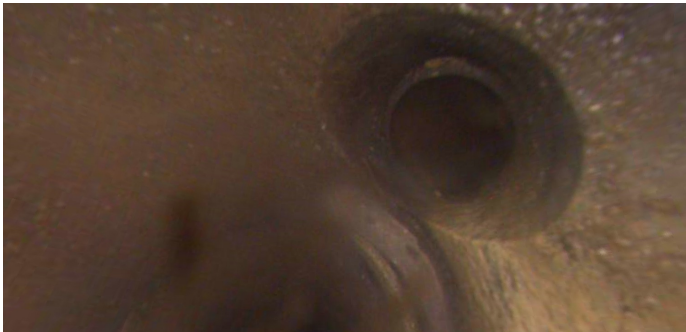
Code: **TF**
Description: **Tap Factory**

Distance (ft): **62.6**
Structural Grade: **0**
O&M Grade: **0**
Clock Start/From: **10**
Clock To:
1st Value: **4.000**
2nd Value:
Value Percent:
Continuous Index:
Within 8" of Joint:
Remarks:

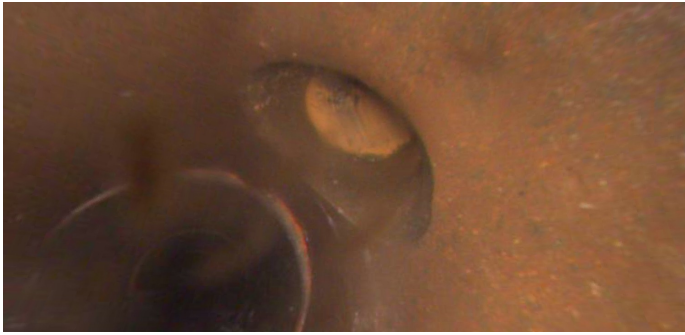
Code: **TFC**
Description: **Tap Factory Capped**

Distance (ft): **84.9**
Structural Grade: **0**
O&M Grade: **0**
Clock Start/From: **10**
Clock To:
1st Value: **4.000**
2nd Value:
Value Percent:
Continuous Index:
Within 8" of Joint:
Remarks:
