Profile/Photo Observation Report

Date:	10/19/2021	Weather:		Coding:	PACP 7.0
Pipe Length (ft):	167.1	Owner:	City of Hobart	Pre Clean:	Heavy Cleaning
P.O.#:	YES502259	Surveyor:	S. Bucklin	PSR:	P-503-016-009
Customer:	City of Hobart	Clean Date:	09/06/2021	Shape:	C

Street:	West 39th Place	Flow Control:	Not Controlled
City:	Hobart, IN	Year Renewed:	
Location:	Alley	Tape/Media #:	
Purpose:	Routine Assessment	Dia/Height:	12"
Use:	Sanitary Sewage Pipe	Material:	VCP
Drain Area:		Lining:	
Category:	NA		
Comment:			
Location Details:		Direction of Survey:	Downstream
US MH:	M-503-009	DS MH:	M-503-016
		Total Length Surveyed (ft):	167.1

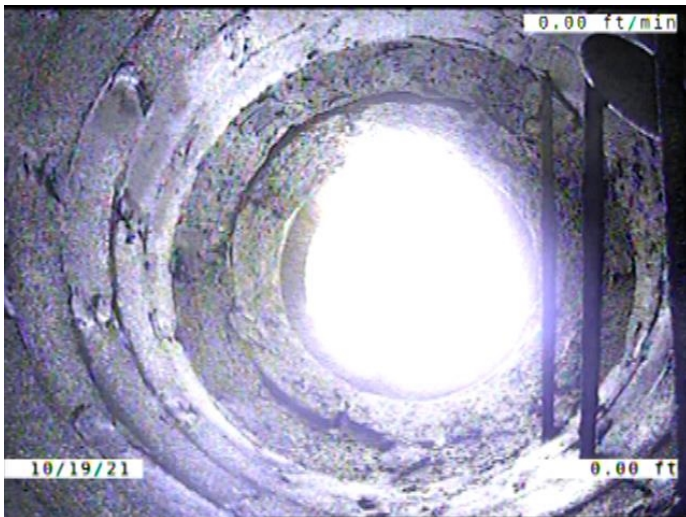
Code: **AMH**
Description: **Manhole**

Distance (ft): **.0**
Structural Grade: **0**
O&M Grade: **0**
Clock Start/From:
Clock To:
1st Value:
2nd Value:
Value Percent:
Continuous Index:
Within 8" of Joint: **NO**
Remarks: **M-503-009**

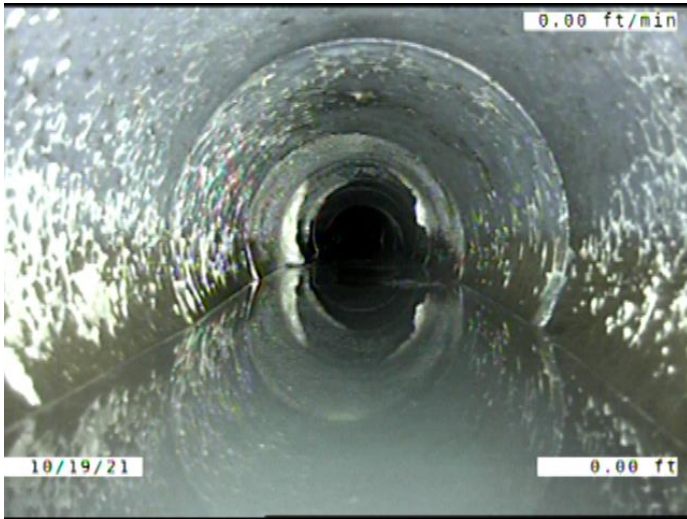
Code: **MWL**
Description: **Miscellaneous Water Level**

Distance (ft): **.0**
Structural Grade: **0**
O&M Grade: **0**
Clock Start/From:
Clock To:
1st Value:
2nd Value:
Value Percent: **10.000**
Continuous Index:
Within 8" of Joint: **NO**
Remarks:

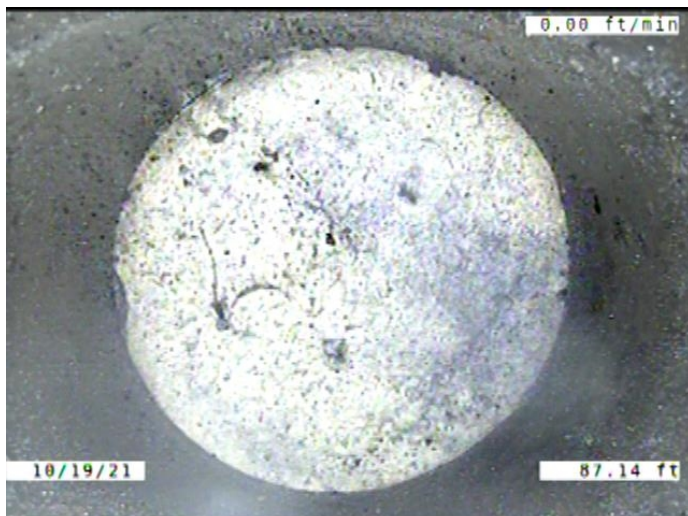
Code: **TFC**
Description: **Tap Factory Capped**

Distance (ft): **87.1**
Structural Grade: **0**
O&M Grade: **0**
Clock Start/From: **11**
Clock To:
1st Value: **4.000**
2nd Value:
Value Percent:
Continuous Index:
Within 8" of Joint: **YES**
Remarks:

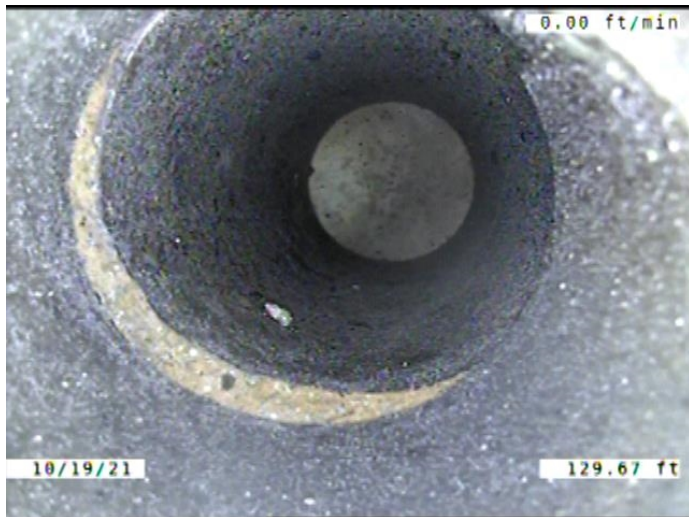
Code: **TFC**
 Description: **Tap Factory Capped**

Distance (ft): **129.7**
 Structural Grade: **0**
 O&M Grade: **0**
 Clock Start/From: **1**
 Clock To:
 1st Value: **4.000**
 2nd Value:
 Value Percent:
 Continuous Index:
 Within 8" of Joint: **YES**
 Remarks:

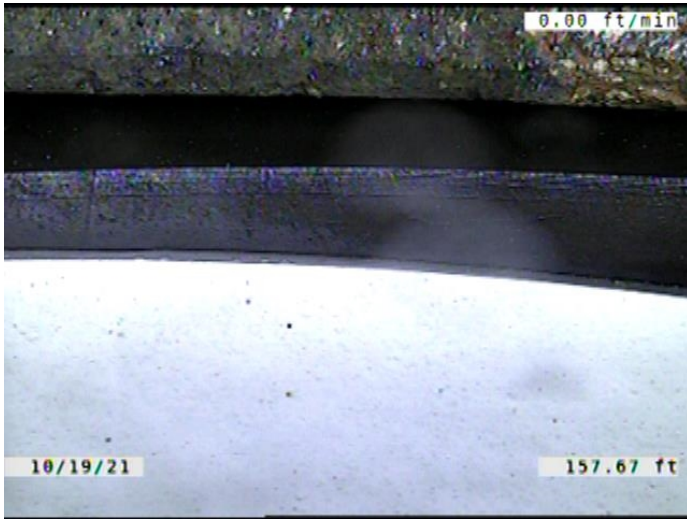
Code: **MMC**
Description: **Miscellaneous Material Change**

Distance (ft): **157.7**
Structural Grade: **0**
O&M Grade: **0**
Clock Start/From:
Clock To:
1st Value:
2nd Value:
Value Percent:
Continuous Index:
Within 8" of Joint: **NO**
Remarks: **VCP TO PVC**

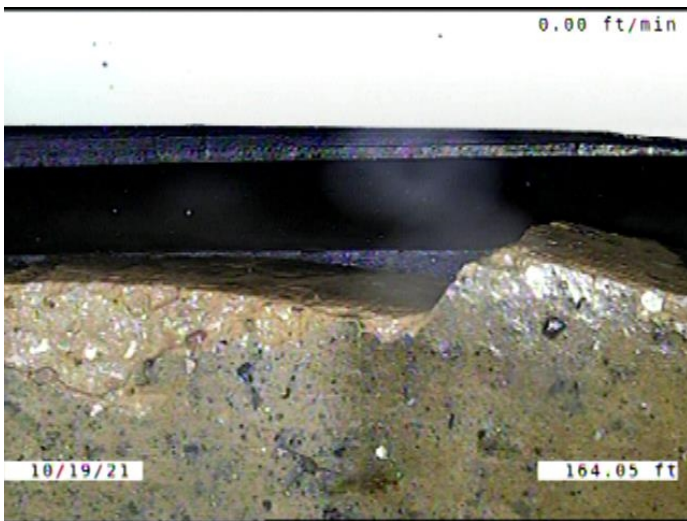
Code: **MMC**
Description: **Miscellaneous Material Change**

Distance (ft): **164.0**
Structural Grade: **0**
O&M Grade: **0**
Clock Start/From:
Clock To:
1st Value:
2nd Value:
Value Percent:
Continuous Index:
Within 8" of Joint: **NO**
Remarks: **PVC TO VCP**

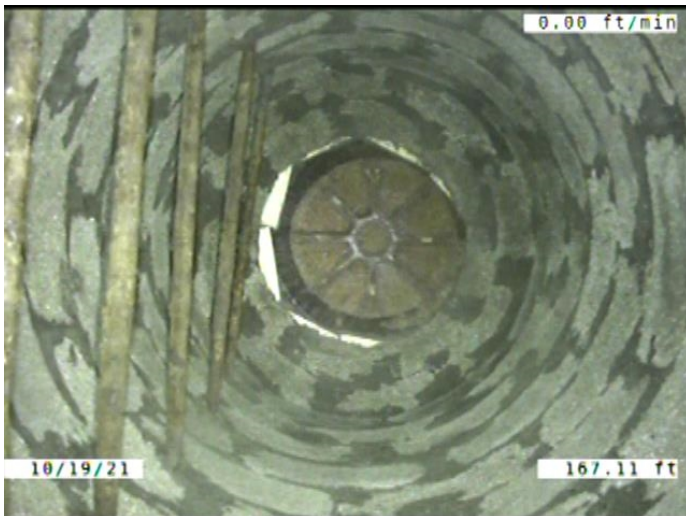
Code: **AMH**
 Description: **Manhole**

Distance (ft): **167.1**
 Structural Grade: **0**
 O&M Grade: **0**
 Clock Start/From:
 Clock To:
 1st Value:
 2nd Value:
 Value Percent:
 Continuous Index:
 Within 8" of Joint: **NO**
 Remarks: **M-503-016**
