Profile/Photo Observation Report

Date:	10/19/2021	Weather:		Coding:	PACP 7.0
Pipe Length (ft):	167.1	Owner:	City of Hobart	Pre Clean:	Heavy Cleaning
P.O.#:	YES502259	Surveyor:	S. Bucklin	PSR:	P-503-016-009
Customer:	City of Hobart	Clean Date:	09/06/2021	Shape:	C

Street:	West 39th Place	Flow Control:	Not Controlled
City:	Hobart, IN	Year Renewed:	
Location:	Alley	Tape/Media #:	
Purpose:	Routine Assessment	Dia/Height:	12"
Use:	Sanitary Sewage Pipe	Material:	VCP
Drain Area:		Lining:	
Category:	NA		
Comment:			
Location Details:		Direction of Survey:	Downstream
US MH:	M-503-009	DS MH:	M-503-016
		Total Length Surveyed (ft):	167.1

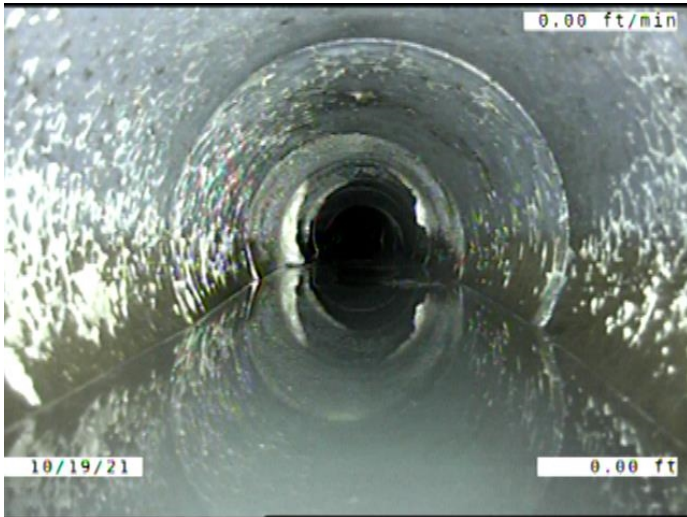
Code: **MWL**
 Description: **Miscellaneous Water Level**

Distance (ft): **.0**
 Structural Grade: **0**
 O&M Grade: **0**
 Clock Start/From:
 Clock To:
 1st Value:
 2nd Value:
 Value Percent: **10.000**
 Continuous Index:
 Within 8" of Joint: **NO**
 Remarks:

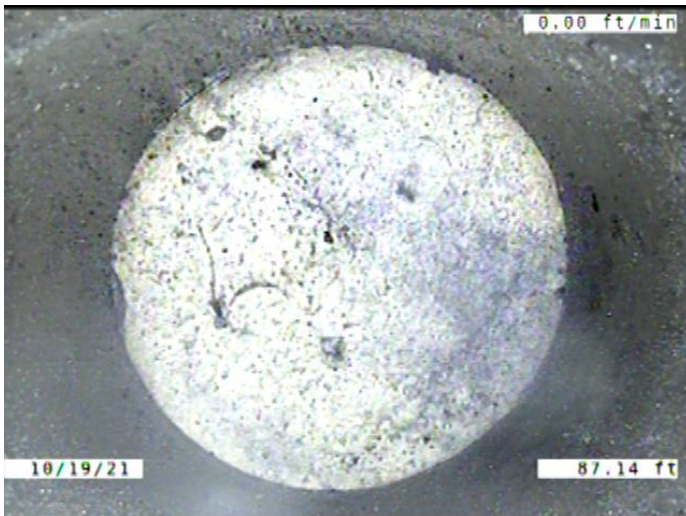
Code: **B**
Description: **Broken**

Distance (ft): **84.7**
Structural Grade: **4**
O&M Grade: **0**
Clock Start/From: **8**
Clock To: **11**
1st Value:
2nd Value:
Value Percent:
Continuous Index:
Within 8" of Joint: **YES**
Remarks:

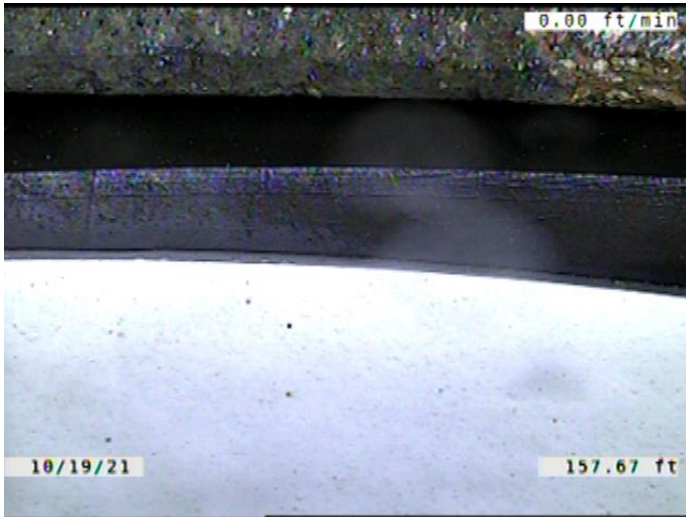
Code: **CM**
 Description: **Crack Multiple**

Distance (ft): **153.7**
 Structural Grade: **3**
 O&M Grade: **0**
 Clock Start/From: **10**
 Clock To: **1**
 1st Value:
 2nd Value:
 Value Percent:
 Continuous Index: **F07**
 Within 8" of Joint: **YES**
 Remarks: **Wandering**

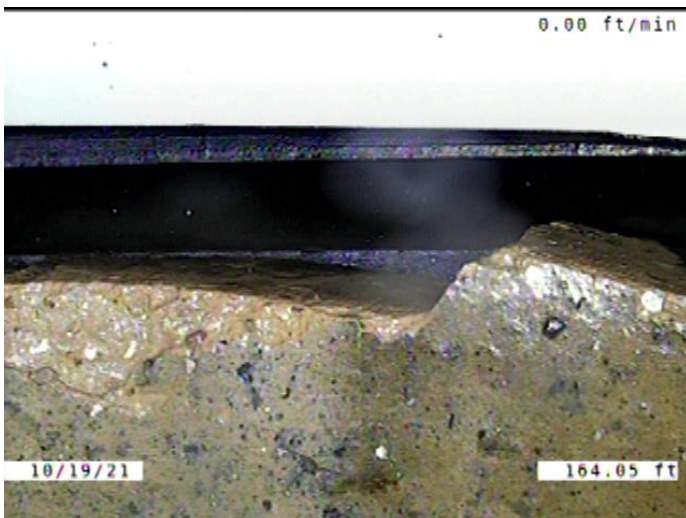
Code: **MMC**
Description: **Miscellaneous Material Change**

Distance (ft): **157.7**
Structural Grade: **0**
O&M Grade: **0**
Clock Start/From:
Clock To:
1st Value:
2nd Value:
Value Percent:
Continuous Index:
Within 8" of Joint: **NO**
Remarks: **VCP TO PVC**
