Profile/Photo Observation Report

Date:	09/19/2021	Weather:		Coding:	PACP 7.0
Pipe Length (ft):	194.3	Owner:	City of Hobart	Pre Clean:	Light Cleaning
P.O.#:	YES502259	Surveyor:	S. Bucklin	PSR:	P-503-011-010
Customer:	City of Hobart	Clean Date:	09/06/2021	Shape:	C

Street:	West 39th Place	Flow Control:	Not Controlled
City:	Hobart, IN	Year Renewed:	
Location:	Alley	Tape/Media #:	
Purpose:	Routine Assessment	Dia/Height:	10"
Use:	Sanitary Sewage Pipe	Material:	VCP
Drain Area:		Lining:	None
Category:	NA		
Comment:			
Location Details:		Direction of Survey:	Downstream
US MH:	M-503-010	DS MH:	M-503-011
		Total Length Surveyed (ft):	194.3

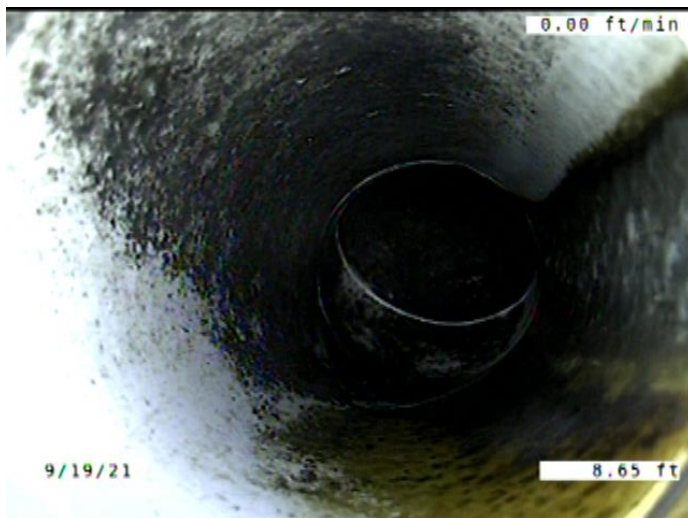
Code: **JOM**
 Description: **Joint Offset Medium**

Distance (ft): **6.9**
 Structural Grade: **3**
 O&M Grade: **0**
 Clock Start/From:
 Clock To:
 1st Value:
 2nd Value:
 Value Percent:
 Continuous Index:
 Within 8" of Joint: **NO**
 Remarks:

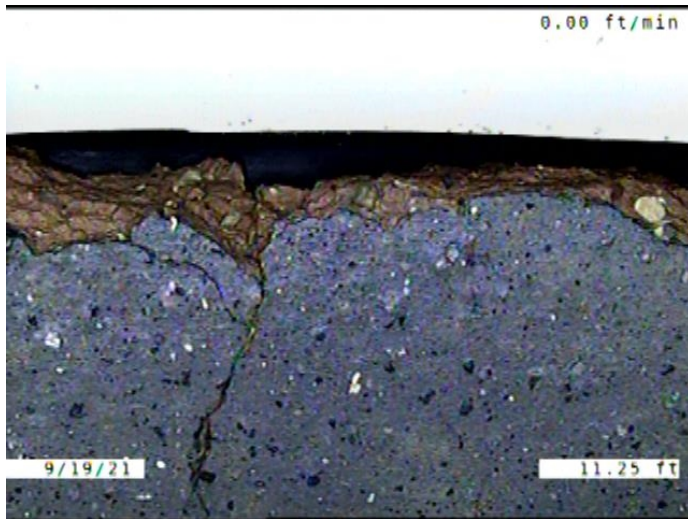
Code: **TF**
 Description: **Tap Factory**

Distance (ft): **8.6**
 Structural Grade: **0**
 O&M Grade: **0**
 Clock Start/From: **1**
 Clock To:
 1st Value: **4.000**
 2nd Value:
 Value Percent:
 Continuous Index:
 Within 8" of Joint: **YES**
 Remarks:

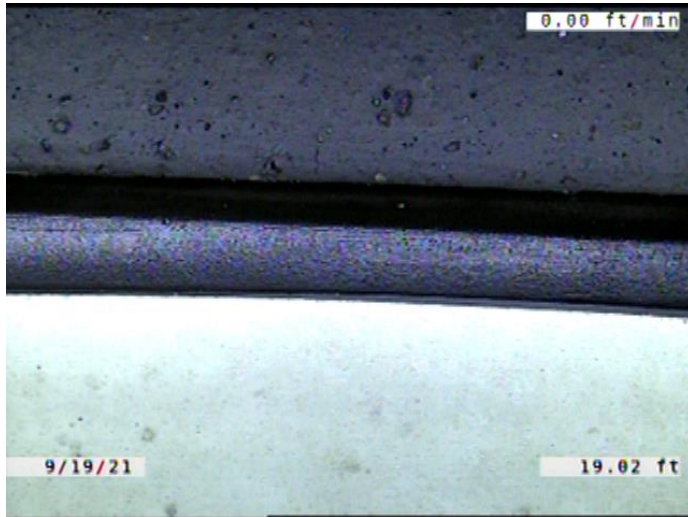
Code: **TFC**
 Description: **Tap Factory Capped**

Distance (ft): **17.8**
 Structural Grade: **0**
 O&M Grade: **0**
 Clock Start/From: **11**
 Clock To:
 1st Value: **4.000**
 2nd Value:
 Value Percent:
 Continuous Index:
 Within 8" of Joint: **YES**
 Remarks:

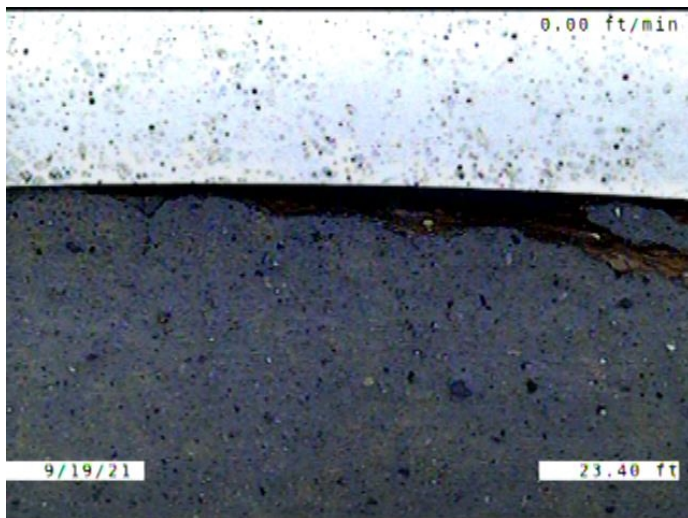
Code: **MMC**
 Description: **Miscellaneous Material Change**

Distance (ft): **19.0**
 Structural Grade: **0**
 O&M Grade: **0**
 Clock Start/From:
 Clock To:
 1st Value:
 2nd Value:
 Value Percent:
 Continuous Index:
 Within 8" of Joint: **NO**
 Remarks: **VCP TO PVC**

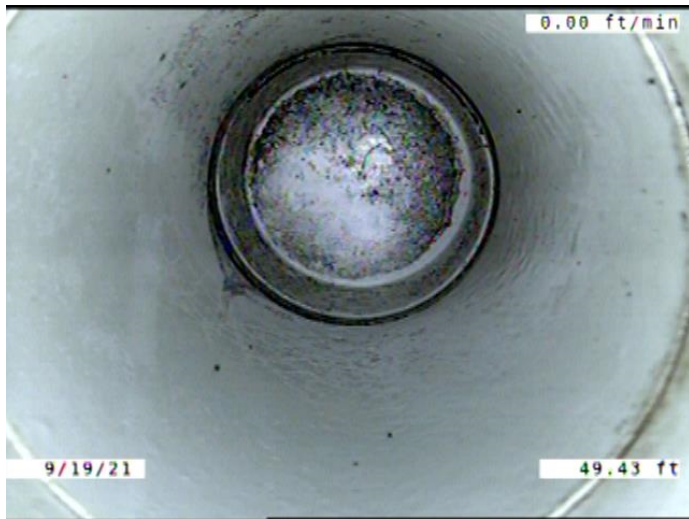
Code: **MWLS**
 Description: **Miscellaneous Water Level Sag**

Distance (ft): **44.5**
 Structural Grade: **2**
 O&M Grade: **0**
 Clock Start/From:
 Clock To:
 1st Value:
 2nd Value:
 Value Percent: **5.000**
 Continuous Index: **S03**
 Within 8" of Joint: **NO**
 Remarks:

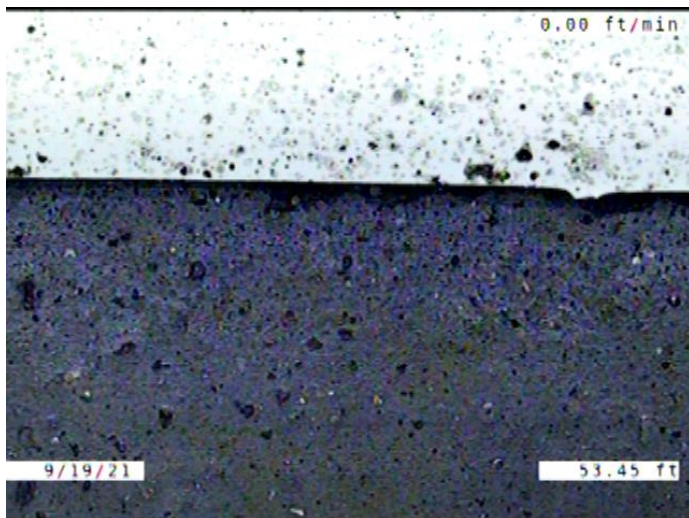
Code: **TFC**
 Description: **Tap Factory Capped**

Distance (ft): **49.4**
 Structural Grade: **0**
 O&M Grade: **0**
 Clock Start/From: **1**
 Clock To:
 1st Value: **4.000**
 2nd Value:
 Value Percent:
 Continuous Index:
 Within 8" of Joint: **YES**
 Remarks:

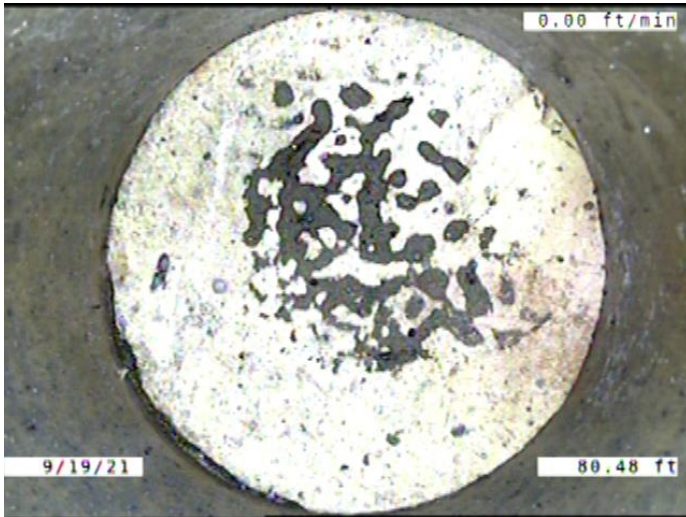
Code: **SSS**
Description: **Surface Damage Surface Spalling**

Distance (ft): **74.6**
Structural Grade: **2**
O&M Grade: **0**
Clock Start/From: **2**
Clock To:
1st Value:
2nd Value:
Value Percent:
Continuous Index:
Within 8" of Joint: **YES**
Remarks:

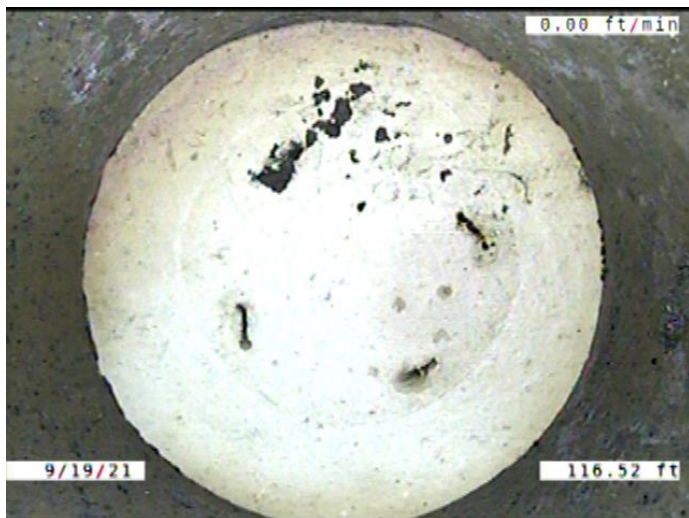
Code: **SSS**
 Description: **Surface Damage Surface Spalling**

Distance (ft): **113.9**
 Structural Grade: **2**
 O&M Grade: **0**
 Clock Start/From: **10**
 Clock To:
 1st Value:
 2nd Value:
 Value Percent:
 Continuous Index:
 Within 8" of Joint: **YES**
 Remarks:

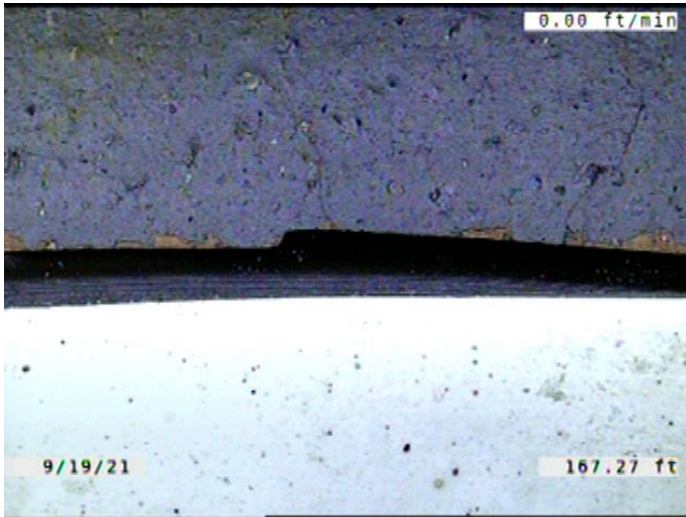
Code: **DAE**
 Description: **Deposits Attached Encrustation**

Distance (ft): **165.7**
 Structural Grade: **0**
 O&M Grade: **2**
 Clock Start/From: **7**
 Clock To: **9**
 1st Value:
 2nd Value:
 Value Percent: **5.000**
 Continuous Index:
 Within 8" of Joint: **YES**
 Remarks:
