Profile/Photo Observation Report

Street:	N VIRGINIA ST	Flow Control:	Not Controlled
City:	Hobart, IN	Year Renewed:	
Location:	Other	Tape/Media #:	
Purpose:	Not Known	Dia/Height:	10"
Use:	Sanitary	Material:	VCP
Drain Area:	NA	Lining:	
Category:	NA		
Comment:

Location Details:		Direction of Survey:	Downstream
US MH:	M-503-012	DS MH:	M-503-013
		Total Length Surveyed (ft):	71.5

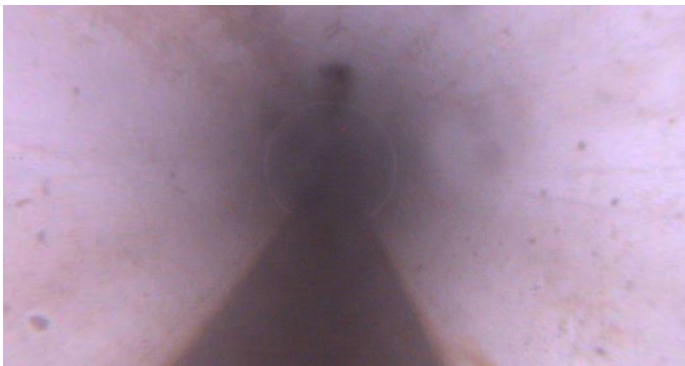
Code: **MMC**
Description: **Material Change**

Distance (ft): **50.4**
Structural Grade: **0**
O&M Grade: **0**
Clock Start/From:
Clock To:
1st Value:
2nd Value:
Value Percent:
Continuous Index:
Within 8" of Joint: **NO**
Remarks: **PVC**
