Profile/Photo Observation Report

Date:	10/19/2021	Weather:		Coding:	PACP 7.0
Pipe Length (ft):	165.3	Owner:	City of Hobart	Pre Clean:	Heavy Cleaning
P.O.#:	YES502259	Surveyor:	S. Bucklin	PSR:	P-503-017-016
Customer:	City of Hobart	Clean Date:	09/06/2021	Shape:	C

Street:	West 39th Place	Flow Control:	Not Controlled
City:	Hobart, IN	Year Renewed:	
Location:	Alley	Tape/Media #:	
Purpose:	Routine Assessment	Dia/Height:	12"
Use:	Sanitary Sewage Pipe	Material:	VCP
Drain Area:		Lining:	
Category:	NA		
Comment:			
Location Details:		Direction of Survey:	Downstream
US MH:	M-503-016	DS MH:	M-503-017
		Total Length Surveyed (ft):	165.3

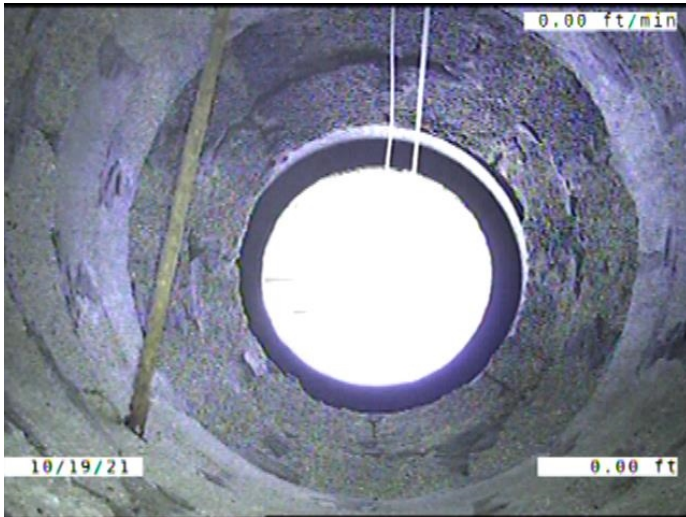
Code: **AMH**
 Description: **Manhole**

Distance (ft): **.0**
 Structural Grade: **0**
 O&M Grade: **0**
 Clock Start/From:
 Clock To:
 1st Value:
 2nd Value:
 Value Percent:
 Continuous Index:
 Within 8" of Joint: **NO**
 Remarks: **M-503-016**

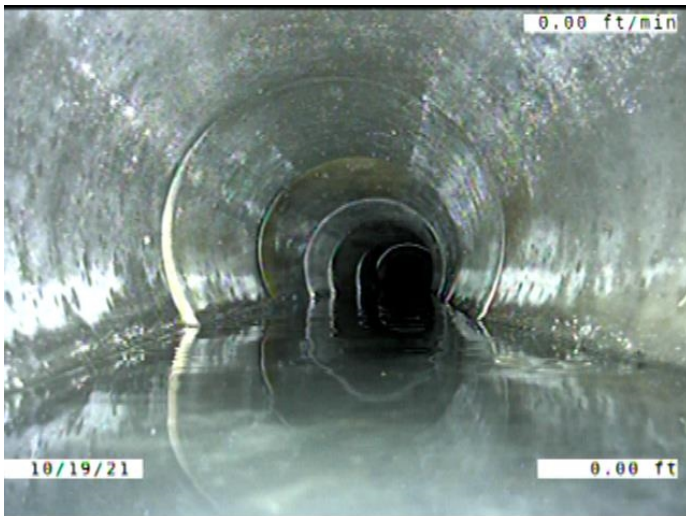
Code: **MWL**
 Description: **Miscellaneous Water Level**

Distance (ft): **.0**
 Structural Grade: **0**
 O&M Grade: **0**
 Clock Start/From:
 Clock To:
 1st Value:
 2nd Value:
 Value Percent: **10.000**
 Continuous Index:
 Within 8" of Joint: **NO**
 Remarks:

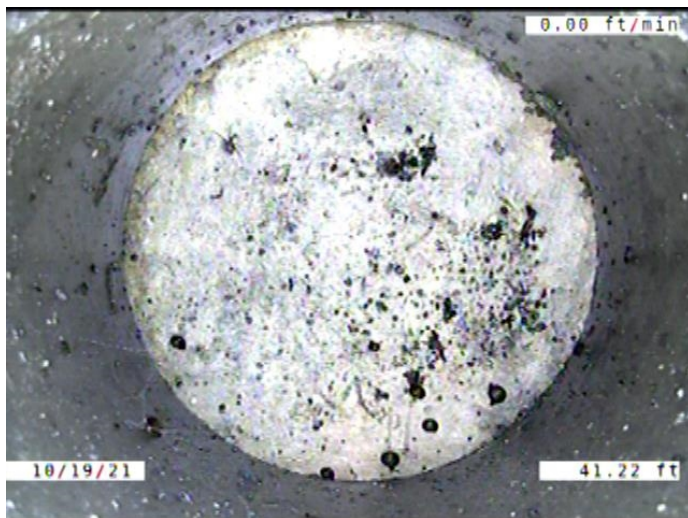
Code: **TFC**
Description: **Tap Factory Capped**

Distance (ft): **41.2**
Structural Grade: **0**
O&M Grade: **0**
Clock Start/From: **12**
Clock To:
1st Value: **4.000**
2nd Value:
Value Percent:
Continuous Index:
Within 8" of Joint: **YES**
Remarks:

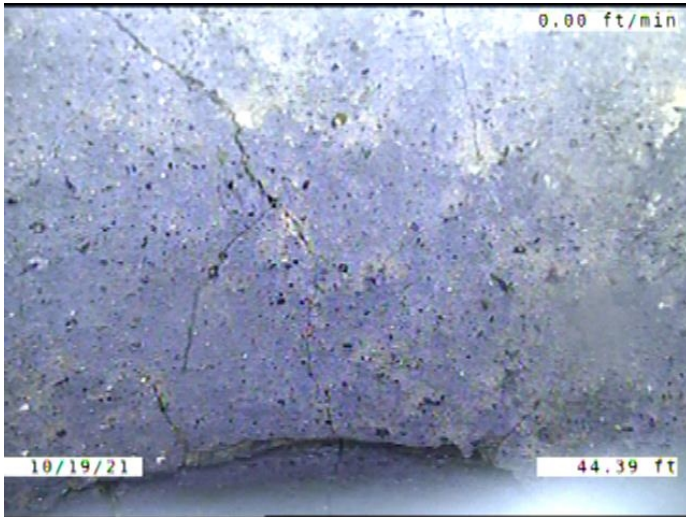
Code: **MWL**
 Description: **Miscellaneous Water Level**

Distance (ft): **44.4**
 Structural Grade: **0**
 O&M Grade: **0**
 Clock Start/From:
 Clock To:
 1st Value:
 2nd Value:
 Value Percent: **20.000**
 Continuous Index:
 Within 8" of Joint: **NO**
 Remarks:
