Profile/Photo Observation Report

Date:	10/19/2021	Weather:		Coding:	PACP 7.0
Pipe Length (ft):	165.3	Owner:	City of Hobart	Pre Clean:	Heavy Cleaning
P.O.#:	YES502259	Surveyor:	S. Bucklin	PSR:	P-503-017-016
Customer:	City of Hobart	Clean Date:	09/06/2021	Shape:	C

Street:	West 39th Place	Flow Control:	Not Controlled
City:	Hobart, IN	Year Renewed:	
Location:	Alley	Tape/Media #:	
Purpose:	Routine Assessment	Dia/Height:	12"
Use:	Sanitary Sewage Pipe	Material:	VCP
Drain Area:		Lining:	
Category:	NA		
Comment:			
Location Details:		Direction of Survey:	Downstream
US MH:	M-503-016	DS MH:	M-503-017
		Total Length Surveyed (ft):	165.3

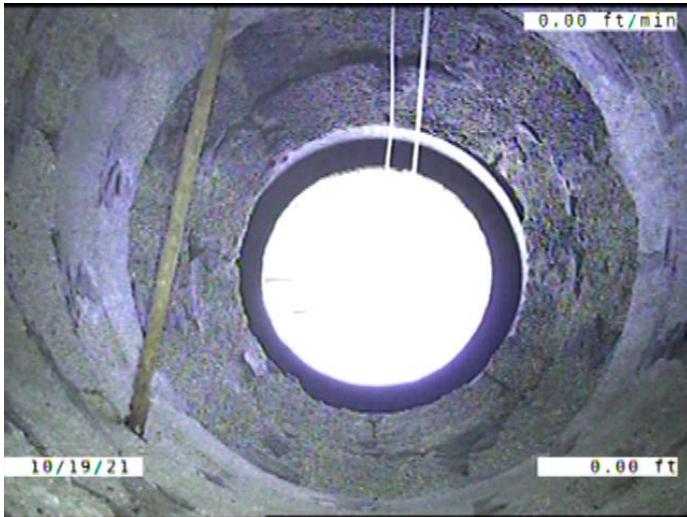
Code: **AMH**
Description: **Manhole**

Distance (ft): **.0**
Structural Grade: **0**
O&M Grade: **0**
Clock Start/From:
Clock To:
1st Value:
2nd Value:
Value Percent:
Continuous Index:
Within 8" of Joint: **NO**
Remarks: **M-503-016**

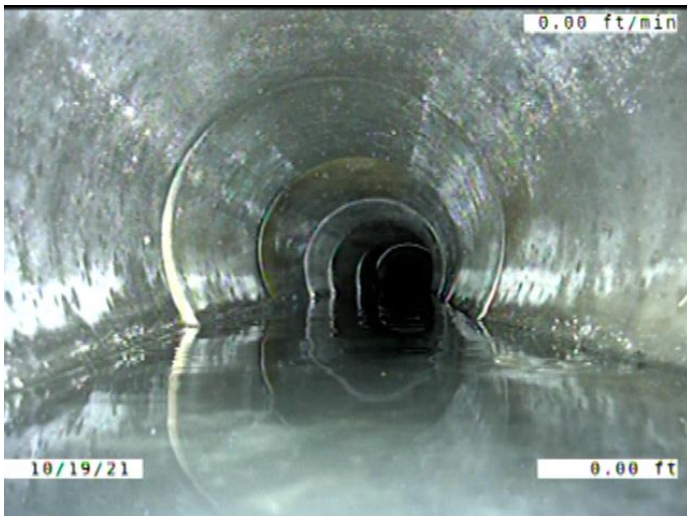
Code: **MWL**
Description: **Miscellaneous Water Level**

Distance (ft): **.0**
Structural Grade: **0**
O&M Grade: **0**
Clock Start/From:
Clock To:
1st Value:
2nd Value:
Value Percent: **10.000**
Continuous Index:
Within 8" of Joint: **NO**
Remarks:

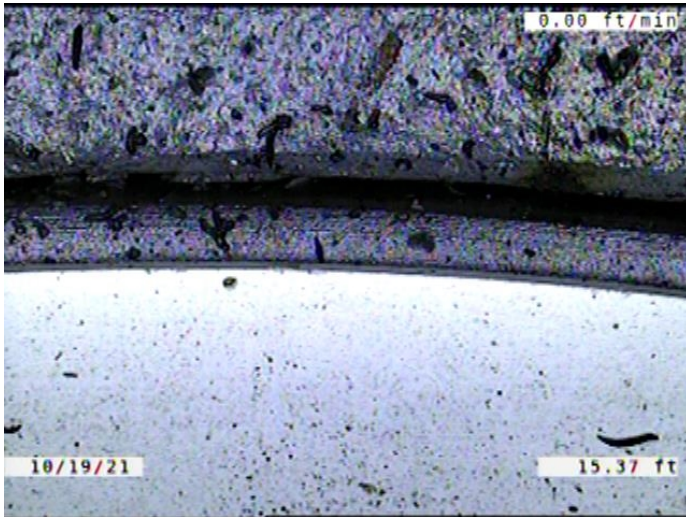
Code: **MMC**
 Description: **Miscellaneous Material Change**

Distance (ft): **15.4**
 Structural Grade: **0**
 O&M Grade: **0**
 Clock Start/From:
 Clock To:
 1st Value:
 2nd Value:
 Value Percent:
 Continuous Index:
 Within 8" of Joint: **NO**
 Remarks: **VCP TO PVC**

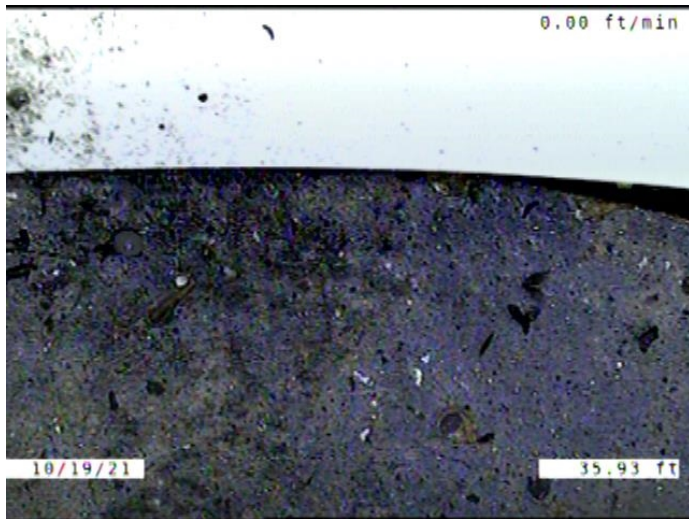
Code: **MMC**
 Description: **Miscellaneous Material Change**

Distance (ft): **35.9**
 Structural Grade: **0**
 O&M Grade: **0**
 Clock Start/From:
 Clock To:
 1st Value:
 2nd Value:
 Value Percent:
 Continuous Index:
 Within 8" of Joint: **NO**
 Remarks: **PVC TO VCP**

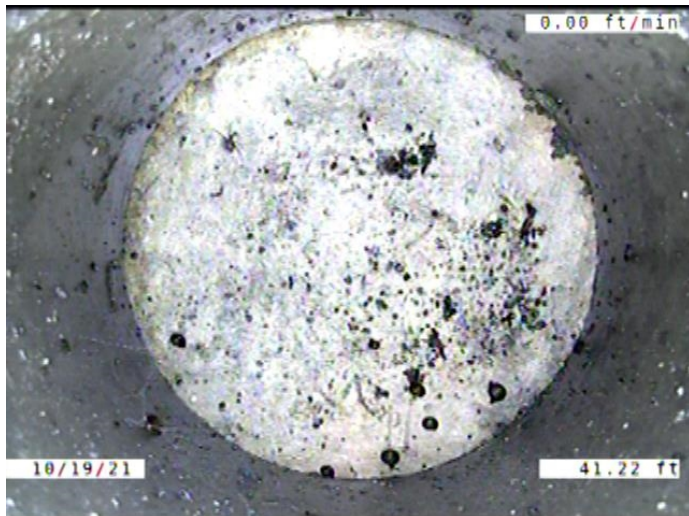
Code: **TFC**
 Description: **Tap Factory Capped**

Distance (ft): **41.2**
 Structural Grade: **0**
 O&M Grade: **0**
 Clock Start/From: **12**
 Clock To:
 1st Value: **4.000**
 2nd Value:
 Value Percent:
 Continuous Index:
 Within 8" of Joint: **YES**
 Remarks:

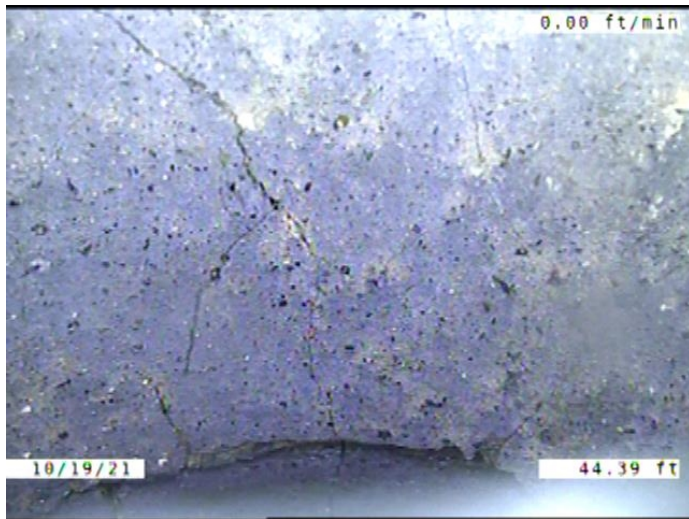
Code: **MWL**
 Description: **Miscellaneous Water Level**

Distance (ft): **44.4**
 Structural Grade: **0**
 O&M Grade: **0**
 Clock Start/From:
 Clock To:
 1st Value:
 2nd Value:
 Value Percent: **20.000**
 Continuous Index:
 Within 8" of Joint: **NO**
 Remarks:

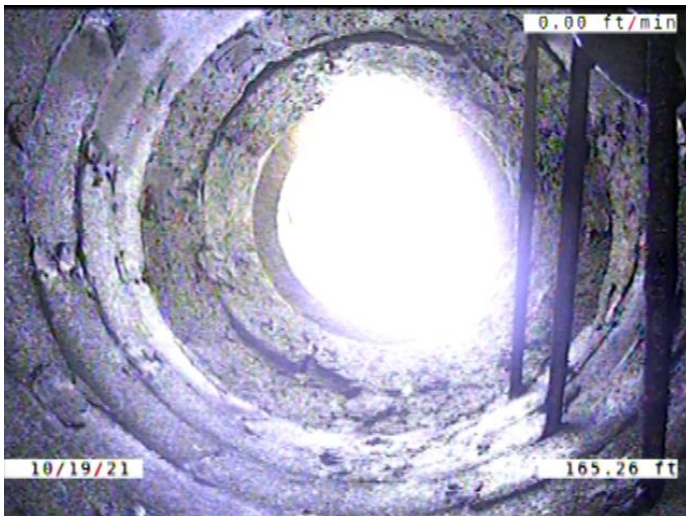
Code: **AMH**
 Description: **Manhole**

Distance (ft): **165.3**
 Structural Grade: **0**
 O&M Grade: **0**
 Clock Start/From:
 Clock To:
 1st Value:
 2nd Value:
 Value Percent:
 Continuous Index:
 Within 8" of Joint: **NO**
 Remarks: **M-503-017**
