Profile/Photo Observation Report

Date:	10/20/2021	Weather:		Coding:	PACP 7.0
Pipe Length (ft):	161.5	Owner:	City of Hobart	Pre Clean:	Heavy Cleaning
P.O.#:	YES502259	Surveyor:	S. Bucklin	PSR:	P-503-019-017
Customer:	City of Hobart	Clean Date:	09/05/2021	Shape:	C

Street:	West 39th Avenue	Flow Control:	Not Controlled
City:	Hobart, IN	Year Renewed:	
Location:	Alley	Tape/Media #:	
Purpose:	Routine Assessment	Dia/Height:	10"
Use:	Sanitary Sewage Pipe	Material:	VCP
Drain Area:		Lining:	
Category:	NA		
Comment:			
Location Details:		Direction of Survey:	Upstream
US MH:	M-503-017	DS MH:	M-503-019
		Total Length Surveyed (ft):	161.5

O&M Index:	2.38	O&M Quick:	5131	O&M Rating:	19.00
Structural Index:	2.63	Structural Quick:	534A	Structural Rating:	163.00
Overall Index:	2.60	Overall Quick:	544A	Overall Rating:	182.00

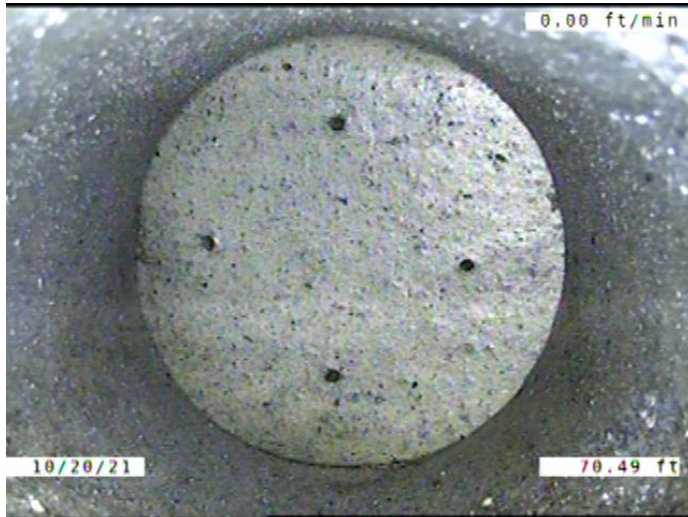
Code: **MWLS**
 Description: **Miscellaneous Water Level Sag**

Distance (ft): **68.4**
 Structural Grade: **2**
 O&M Grade: **0**
 Clock Start/From:
 Clock To:
 1st Value:
 2nd Value:
 Value Percent: **10.000**
 Continuous Index: **S03**
 Within 8" of Joint: **NO**
 Remarks:

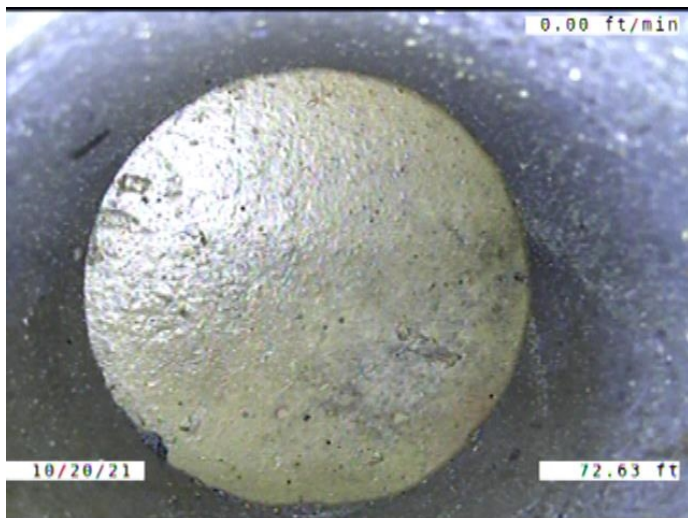
Code: **TFC**
 Description: **Tap Factory Capped**

Distance (ft): **70.5**
 Structural Grade: **0**
 O&M Grade: **0**
 Clock Start/From: **1**
 Clock To:
 1st Value: **4.000**
 2nd Value:
 Value Percent:
 Continuous Index:
 Within 8" of Joint: **YES**
 Remarks:

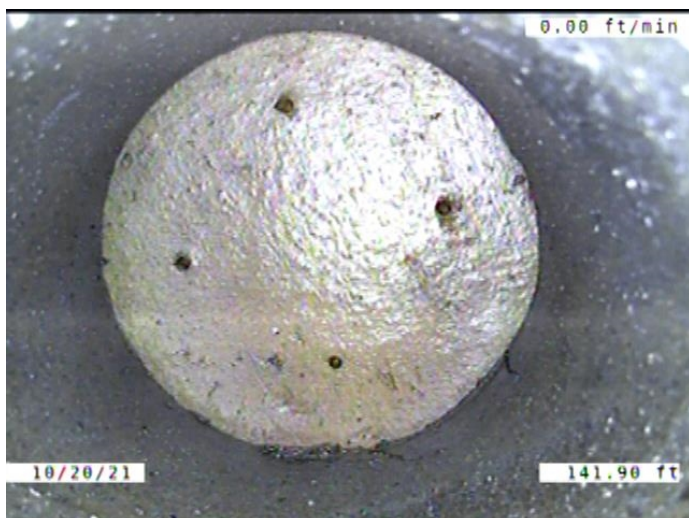
Code: **DAE**
 Description: **Deposits Attached Encrustation**

Distance (ft): **133.7**
 Structural Grade: **0**
 O&M Grade: **2**
 Clock Start/From: **3**
 Clock To: **5**
 1st Value:
 2nd Value:
 Value Percent: **5.000**
 Continuous Index: **F06**
 Within 8" of Joint: **YES**
 Remarks:

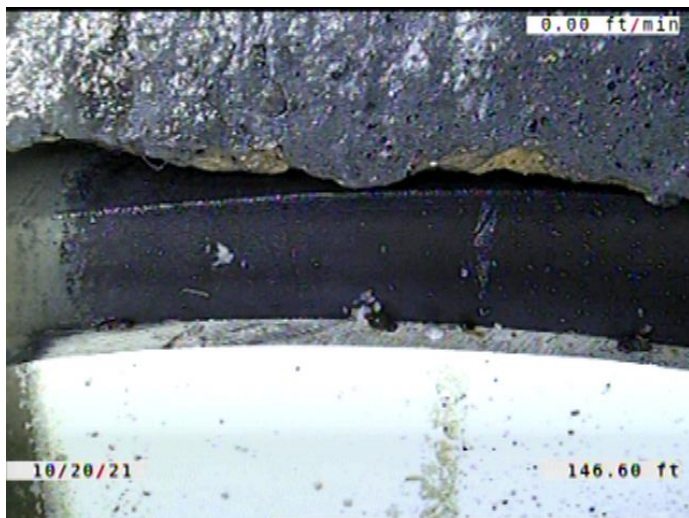
Code: **TFD**
 Description: **Tap Factory Defective**

Distance (ft): **144.0**
 Structural Grade: **0**
 O&M Grade: **3**
 Clock Start/From: **11**
 Clock To:
 1st Value: **4.000**
 2nd Value:
 Value Percent:
 Continuous Index:
 Within 8" of Joint: **YES**
 Remarks: **CAP BROKEN. SOIL VISIBLE**

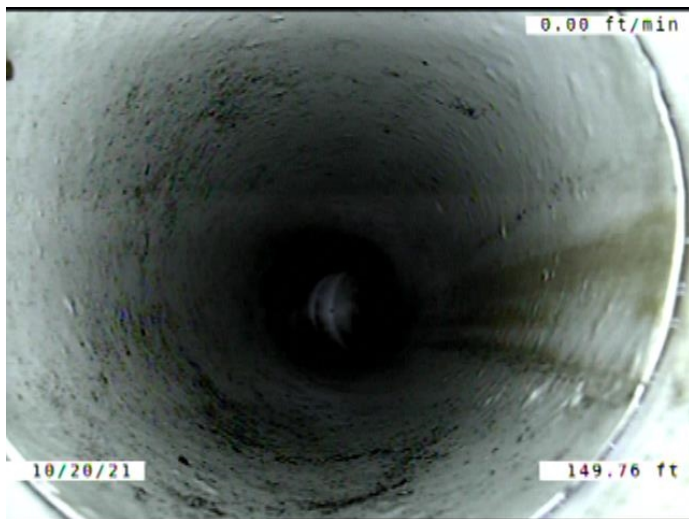
Code: **FM**
 Description: **Fracture Multiple**

Distance (ft): **147.2**
 Structural Grade: **4**
 O&M Grade: **0**
 Clock Start/From: **12**
 Clock To: **12**
 1st Value:
 2nd Value:
 Value Percent:
 Continuous Index: **F05**
 Within 8" of Joint: **YES**
 Remarks:

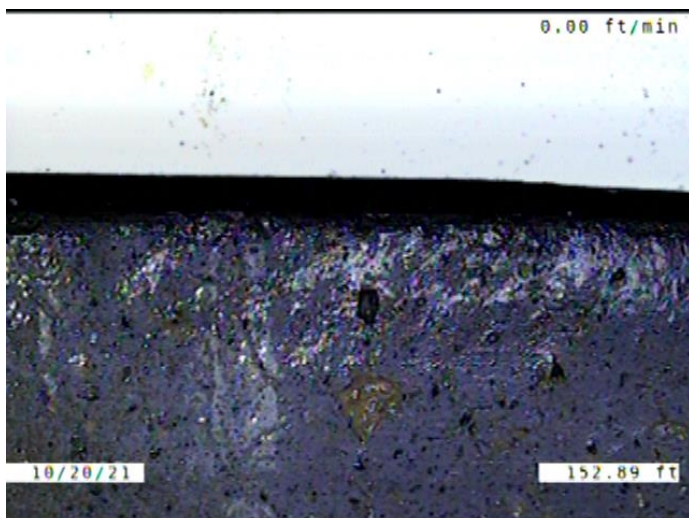
Code: **TF**
 Description: **Tap Factory**

Distance (ft): **149.8**
 Structural Grade: **0**
 O&M Grade: **0**
 Clock Start/From: **1**
 Clock To:
 1st Value: **4.000**
 2nd Value:
 Value Percent:
 Continuous Index:
 Within 8" of Joint: **YES**
 Remarks:
