Profile/Photo Observation Report

Date:	04/10/2018	Weather:		Coding:	PACP 6.0
Pipe Length (ft):	194.5	Owner:	NA	Pre Clean:	Not Known
P.O.#:		Surveyor:	Byrd Fitzgerald	PSR:	P-503-020-019
Customer:		Clean Date:	01/01/1900	Shape:	C

Street:	W 40th ave	Flow Control:	Not Controlled
City:	Hobart, IN	Year Renewed:	
Location:	Other	Tape/Media #:	
Purpose:	Not Known	Dia/Height:	10"
Use:	Sanitary	Material:	VCP
Drain Area:	NA	Lining:	
Category:	NA		
Comment:

Location Details:		Direction of Survey:	Downstream
US MH:	M-503-019	DS MH:	M-503-020
		Total Length Surveyed (ft):	42.9

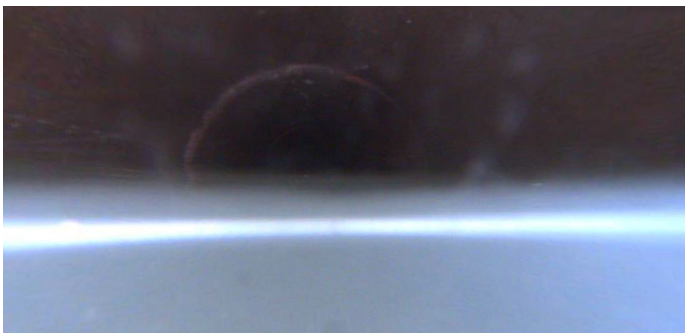
Code: **MWL**
Description: **Water Level**

Distance (ft): **6.9**
Structural Grade: **0**
O&M Grade: **0**
Clock Start/From:
Clock To:
1st Value:
2nd Value:
Value Percent: **50.000**
Continuous Index:
Within 8" of Joint: **NO**
Remarks:

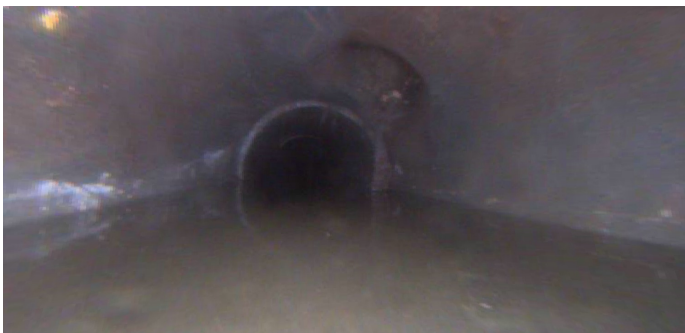
Code: **MWL**
Description: **Water Level**

Distance (ft): **23.1**
Structural Grade: **0**
O&M Grade: **0**
Clock Start/From:
Clock To:
1st Value:
2nd Value:
Value Percent: **25.000**
Continuous Index:
Within 8" of Joint: **NO**
Remarks:

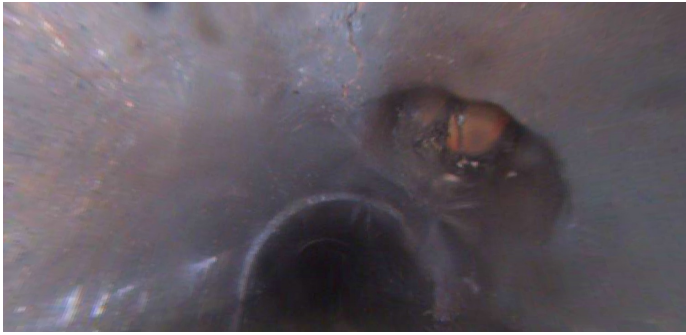
Code: **TFC**
Description: **Tap Factory Capped**

Distance (ft): **23.5**
Structural Grade: **0**
O&M Grade: **0**
Clock Start/From: **1**
Clock To:
1st Value: **4.000**
2nd Value:
Value Percent:
Continuous Index:
Within 8" of Joint: **YES**
Remarks:

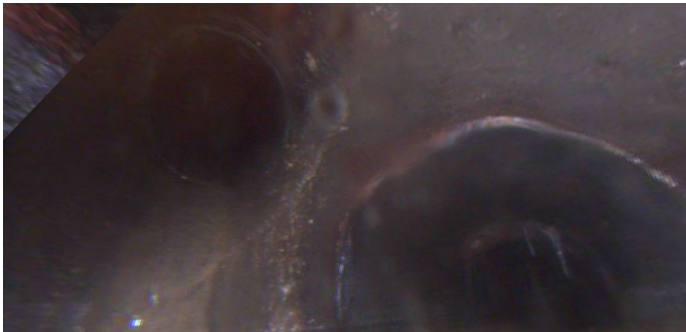
Code: **TF**
Description: **Tap Factory**

Distance (ft): **26.0**
Structural Grade: **0**
O&M Grade: **0**
Clock Start/From: **11**
Clock To:
1st Value: **4.000**
2nd Value:
Value Percent:
Continuous Index:
Within 8" of Joint: **YES**
Remarks:

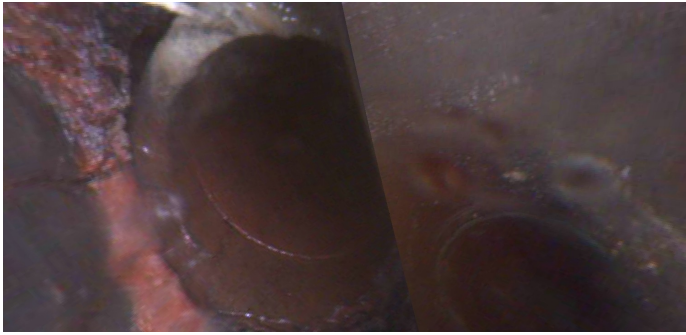
Code: **TB**
Description: **Tap Break-in**

Distance (ft): **26.0**
Structural Grade: **0**
O&M Grade: **0**
Clock Start/From: **12**
Clock To:
1st Value: **6.000**
2nd Value:
Value Percent:
Continuous Index:
Within 8" of Joint:
Remarks:

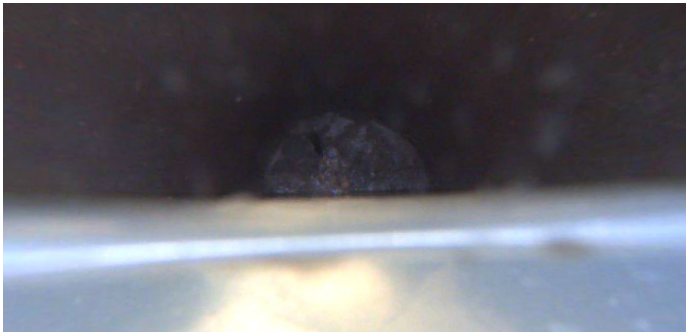
Code: **MWL**
Description: **Water Level**

Distance (ft): **42.7**
Structural Grade: **0**
O&M Grade: **0**
Clock Start/From:
Clock To:
1st Value:
2nd Value:
Value Percent: **50.000**
Continuous Index:
Within 8" of Joint: **NO**
Remarks:
