Profile/Photo Observation Report

Date:	09/19/2021	Weather:		Coding:	PACP 7.0
Pipe Length (ft):	194.0	Owner:	City of Hobart	Pre Clean:	Heavy Cleaning
P.O.#:	YES502259	Surveyor:	S. Bucklin	PSR:	P-503-020-019
Customer:	City of Hobart	Clean Date:	09/05/2021	Shape:	C

Street:	West 39th Avenue	Flow Control:	Not Controlled
City:	Hobart, IN	Year Renewed:	
Location:	Alley	Tape/Media #:	
Purpose:	Routine Assessment	Dia/Height:	10"
Use:	Sanitary Sewage Pipe	Material:	VCP
Drain Area:		Lining:	None
Category:	NA		
Comment:			
Location Details:		Direction of Survey:	Downstream
US MH:	M-503-019	DS MH:	M-503-020
		Total Length Surveyed (ft):	133.5

M-503-020

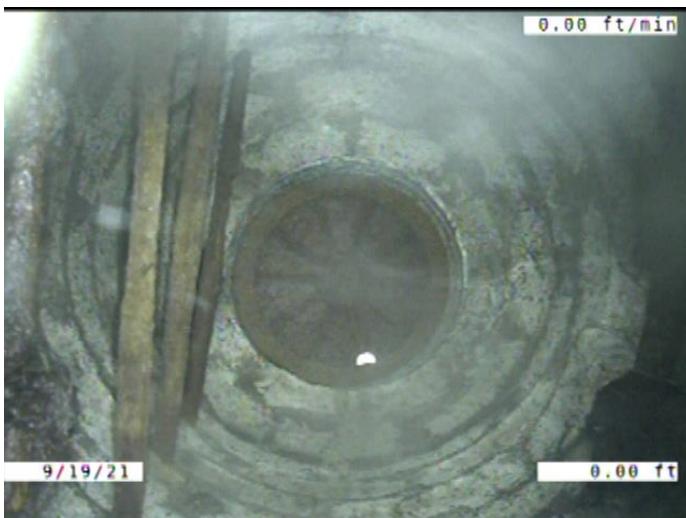
Code: **AMH**
Description: **Manhole**

Distance (ft): **.0**
Structural Grade: **0**
O&M Grade: **0**
Clock Start/From:
Clock To:
1st Value:
2nd Value:
Value Percent:
Continuous Index:
Within 8" of Joint: **NO**
Remarks: **M-503-019**

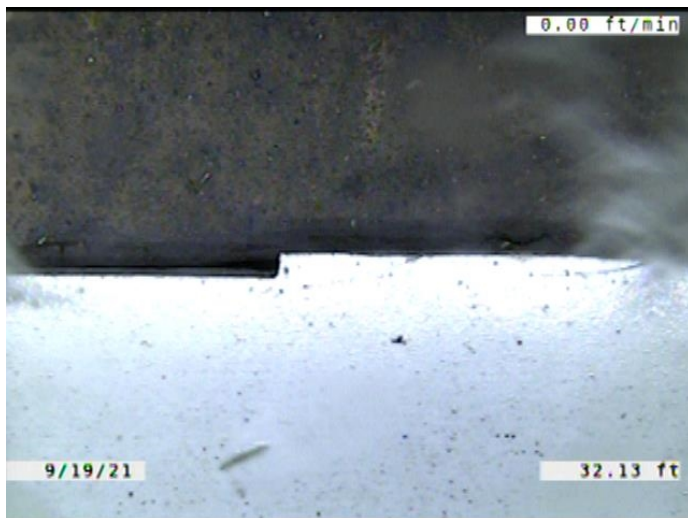
Code: **JOM**
 Description: **Joint Offset Medium**

Distance (ft): **31.6**
 Structural Grade: **3**
 O&M Grade: **0**
 Clock Start/From:
 Clock To:
 1st Value:
 2nd Value:
 Value Percent:
 Continuous Index:
 Within 8" of Joint: **NO**
 Remarks:

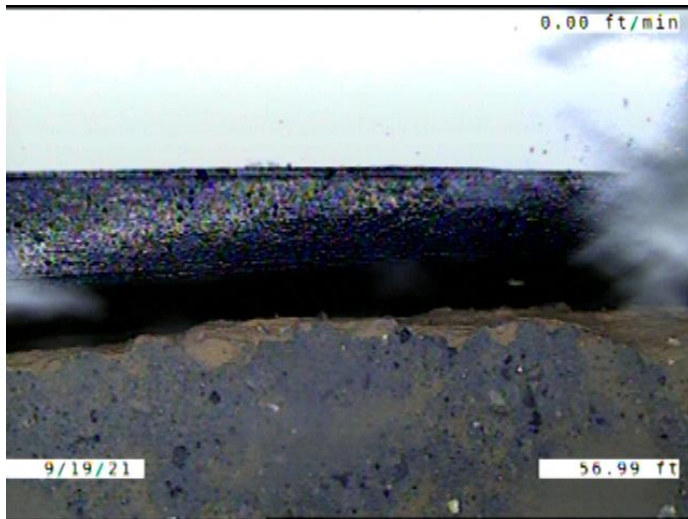
Code: **MWL**
 Description: **Miscellaneous Water Level**

Distance (ft): **56.5**
 Structural Grade: **0**
 O&M Grade: **0**
 Clock Start/From:
 Clock To:
 1st Value:
 2nd Value:
 Value Percent: **5.000**
 Continuous Index:
 Within 8" of Joint: **NO**
 Remarks:

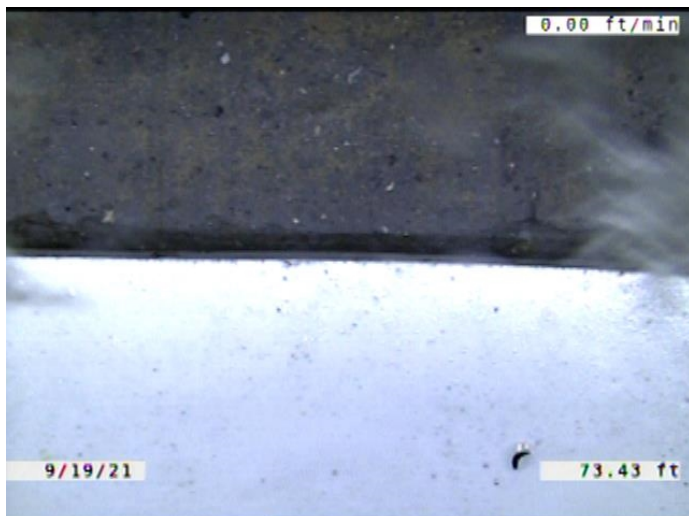
Code: **JOM**
 Description: **Joint Offset Medium**

Distance (ft): **73.0**
 Structural Grade: **3**
 O&M Grade: **0**
 Clock Start/From:
 Clock To:
 1st Value:
 2nd Value:
 Value Percent:
 Continuous Index:
 Within 8" of Joint: **NO**
 Remarks:

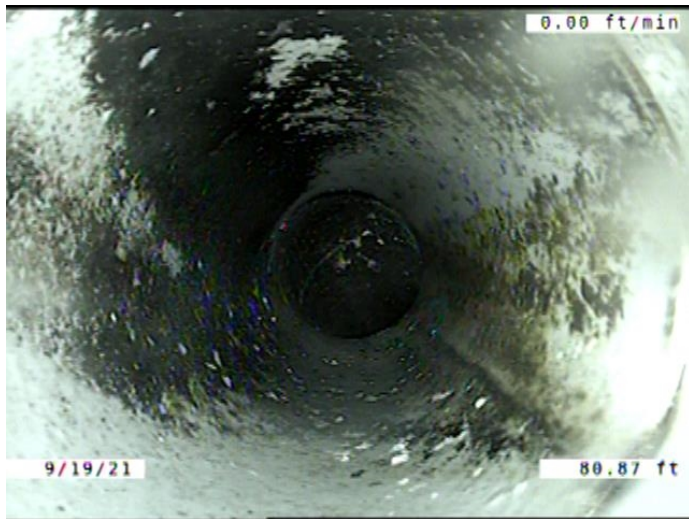
Code: **TF**
 Description: **Tap Factory**

Distance (ft): **76.7**
 Structural Grade: **0**
 O&M Grade: **0**
 Clock Start/From: **11**
 Clock To:
 1st Value: **4.000**
 2nd Value:
 Value Percent:
 Continuous Index:
 Within 8" of Joint: **YES**
 Remarks: **CONSTANTLY RUNNING WATER**

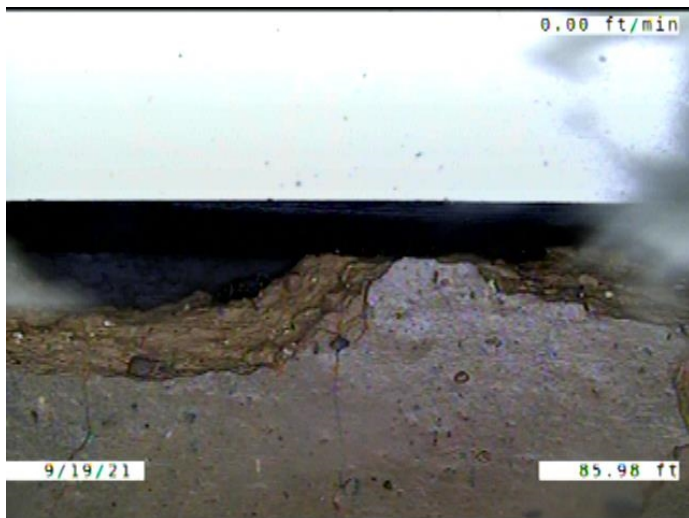
Code: **TF**
 Description: **Tap Factory**

Distance (ft): **80.9**
 Structural Grade: **0**
 O&M Grade: **0**
 Clock Start/From: **1**
 Clock To:
 1st Value: **4.000**
 2nd Value:
 Value Percent:
 Continuous Index:
 Within 8" of Joint: **YES**
 Remarks:

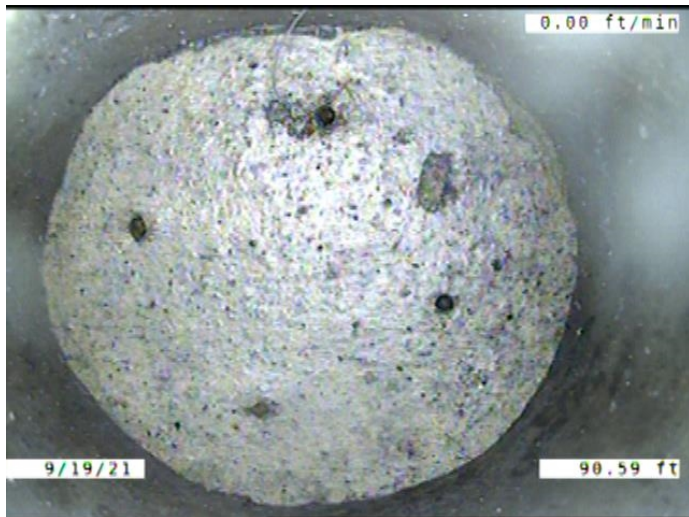
Code: **TFD**
 Description: **Tap Factory Defective**

Distance (ft): **88.7**
 Structural Grade: **0**
 O&M Grade: **3**
 Clock Start/From: **2**
 Clock To:
 1st Value: **4.000**
 2nd Value:
 Value Percent:
 Continuous Index:
 Within 8" of Joint: **YES**
 Remarks: **CAPPED**
