Profile/Photo Observation Report

Date:	10/20/2021	Weather:		Coding:	PACP 7.0
Pipe Length (ft):	194.0	Owner:	City of Hobart	Pre Clean:	Heavy Cleaning
P.O.#:	YES502259	Surveyor:	S. Bucklin	PSR:	P-503-020-019
Customer:	City of Hobart	Clean Date:	09/05/2021	Shape:	C

Street:	West 39th Avenue	Flow Control:	Not Controlled
City:	Hobart, IN	Year Renewed:	
Location:	Alley	Tape/Media #:	
Purpose:	Routine Assessment	Dia/Height:	10"
Use:	Sanitary Sewage Pipe	Material:	VCP
Drain Area:		Lining:	None
Category:	NA		
Comment:

Location Details:		Direction of Survey:	Upstream
US MH:	M-503-019	DS MH:	M-503-020
		Total Length Surveyed (ft):	50.0

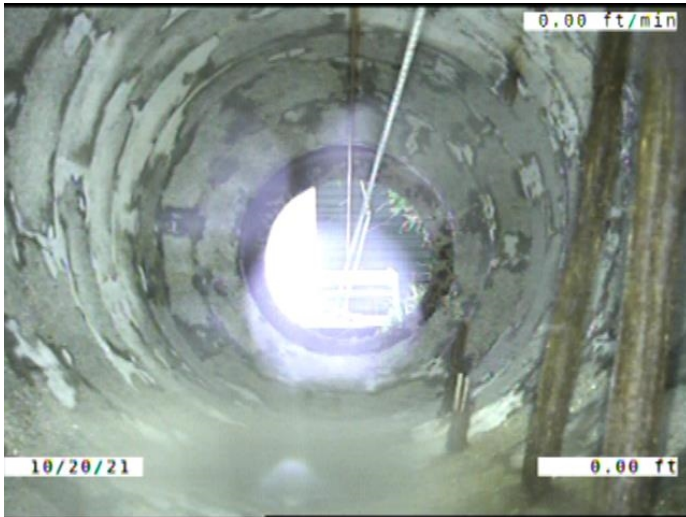
Code: **AMH**
 Description: **Manhole**

Distance (ft): **.0**
 Structural Grade: **0**
 O&M Grade: **0**
 Clock Start/From:
 Clock To:
 1st Value:
 2nd Value:
 Value Percent:
 Continuous Index:
 Within 8" of Joint: **NO**
 Remarks: **M-503-020**

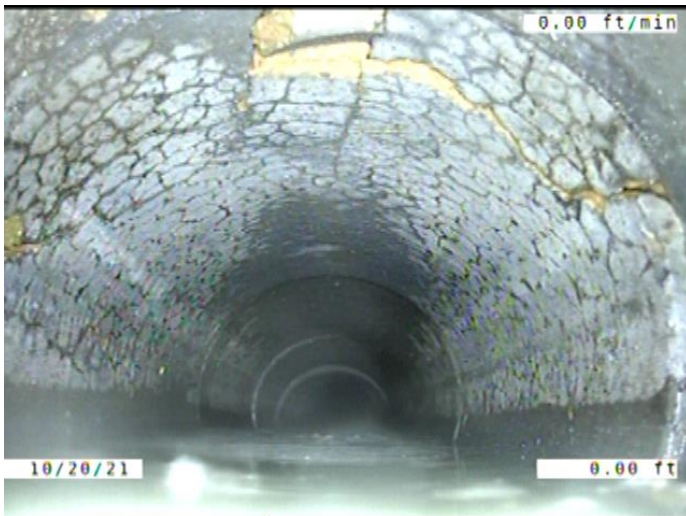
Code: **MWL**
 Description: **Miscellaneous Water Level**

Distance (ft): **.0**
 Structural Grade: **0**
 O&M Grade: **0**
 Clock Start/From:
 Clock To:
 1st Value:
 2nd Value:
 Value Percent: **15.000**
 Continuous Index:
 Within 8" of Joint: **NO**
 Remarks:

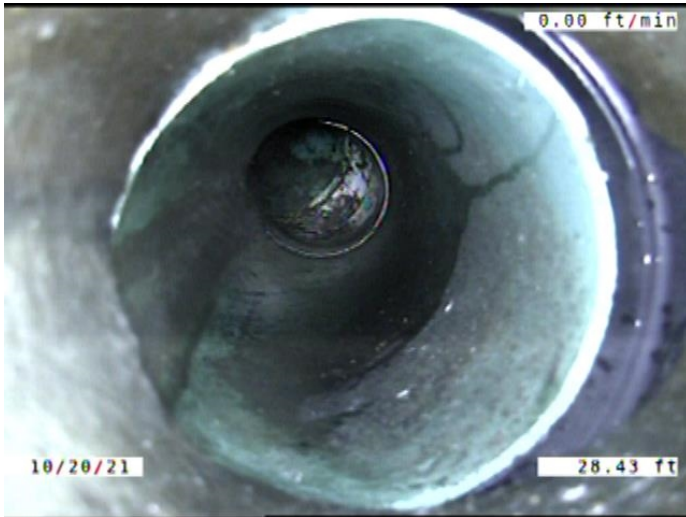
Code: **TFA**
 Description: **Tap Factory Activity**

Distance (ft): **28.4**
 Structural Grade: **0**
 O&M Grade: **0**
 Clock Start/From: **10**
 Clock To:
 1st Value: **4.000**
 2nd Value:
 Value Percent:
 Continuous Index:
 Within 8" of Joint: **YES**
 Remarks:
