Profile/Photo Observation Report

Date:	04/10/2018	Weather:		Coding:	PACP 6.0
Pipe Length (ft):	178.0	Owner:	NA	Pre Clean:	Not Known
P.O.#:		Surveyor:	Mark Ruby	PSR:	P-503-021-020
Customer:		Clean Date:	01/01/1900	Shape:	C

Street:	N VIRGINIA ST	Flow Control:	Not Controlled
City:	Hobart, IN	Year Renewed:	
Location:	Other	Tape/Media #:	
Purpose:	Not Known	Dia/Height:	10"
Use:	Sanitary	Material:	VCP
Drain Area:	NA	Lining:	
Category:	NA		
Comment:

Location Details:		Direction of Survey:	Downstream
US MH:	M-503-020	DS MH:	M-503-021
		Total Length Surveyed (ft):	105.7

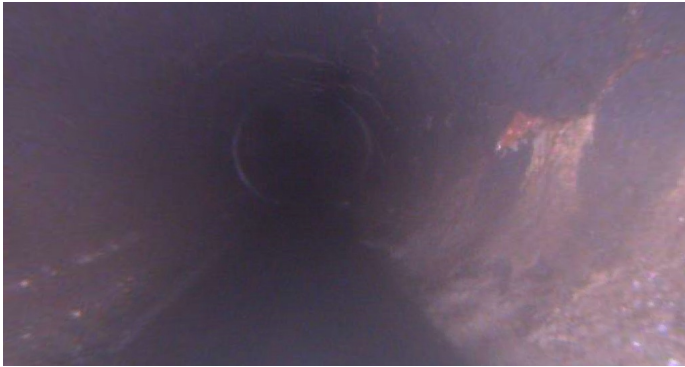
Code:	AMH
Description:	Manhole

Distance (ft):	.0
Structural Grade:	0
O&M Grade:	0
Clock Start/From:	
Clock To:	
1st Value:	
2nd Value:	
Value Percent:	
Continuous Index:	
Within 8" of Joint:	NO
Remarks:	M-503-020

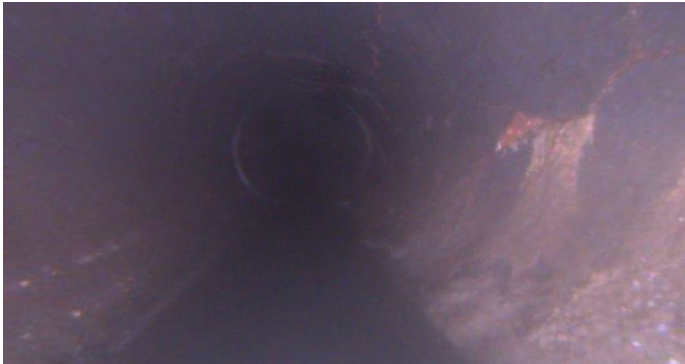
Code:	MWL
Description:	Water Level

Distance (ft):	.0
Structural Grade:	0
O&M Grade:	0
Clock Start/From:	
Clock To:	
1st Value:	
2nd Value:	
Value Percent:	10.000
Continuous Index:	
Within 8" of Joint:	NO
Remarks:

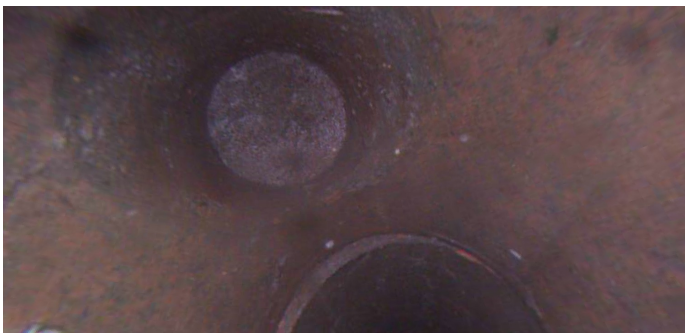
Code: **TFC**
Description: **Tap Factory Capped**

Distance (ft): **44.3**
Structural Grade: **0**
O&M Grade: **0**
Clock Start/From: **1**
Clock To:
1st Value: **4.000**
2nd Value:
Value Percent:
Continuous Index:
Within 8" of Joint:
Remarks:

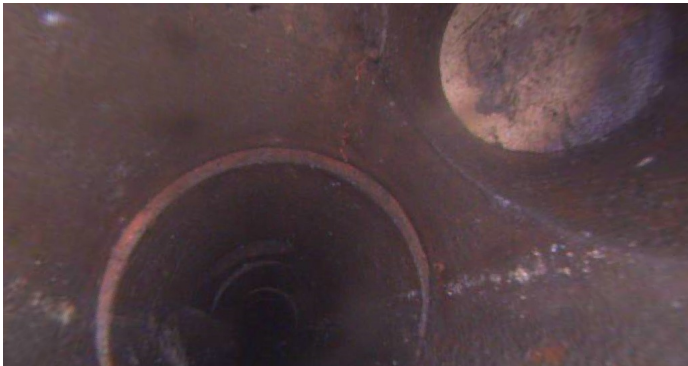
Code: **FM**
Description: **Fracture Multiple**

Distance (ft): **45.7**
Structural Grade: **4**
O&M Grade: **0**
Clock Start/From: **11**
Clock To: **9**
1st Value:
2nd Value:
Value Percent:
Continuous Index:
Within 8" of Joint: **YES**
Remarks:

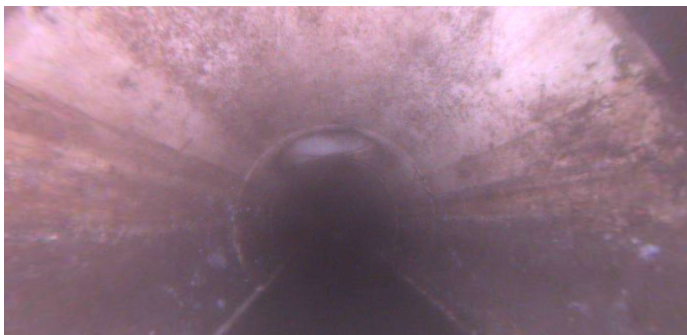
Code:	FL
Description:	Fracture Longitudinal
Distance (ft):	51.0
Structural Grade:	3
O&M Grade:	0
Clock Start/From:	12
Clock To:	
1st Value:	
2nd Value:	
Value Percent:	
Continuous Index:	
Within 8" of Joint:	YES
Remarks:

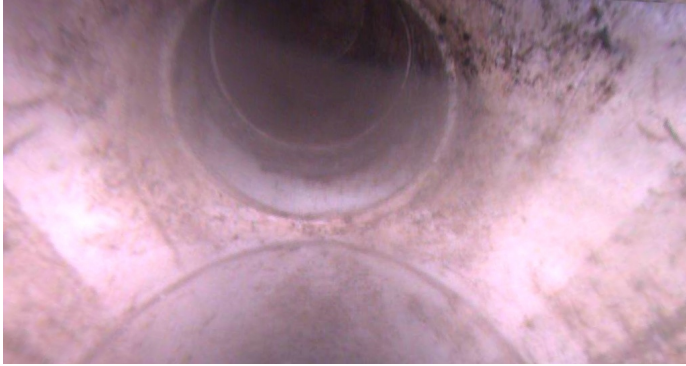
Code: **TF**
Description: **Tap Factory**

Distance (ft): **54.3**
Structural Grade: **0**
O&M Grade: **0**
Clock Start/From: **12**
Clock To:
1st Value: **4.000**
2nd Value:
Value Percent:
Continuous Index:
Within 8" of Joint:
Remarks:

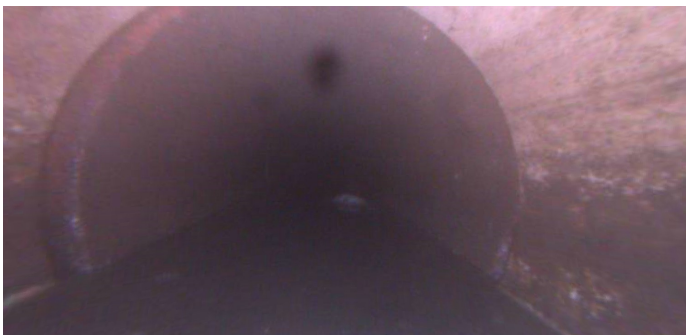
Code: **MMC**
Description: **Material Change**

Distance (ft): **59.0**
Structural Grade: **0**
O&M Grade: **0**
Clock Start/From:
Clock To:
1st Value:
2nd Value:
Value Percent:
Continuous Index:
Within 8" of Joint: **NO**
Remarks: **vcp**

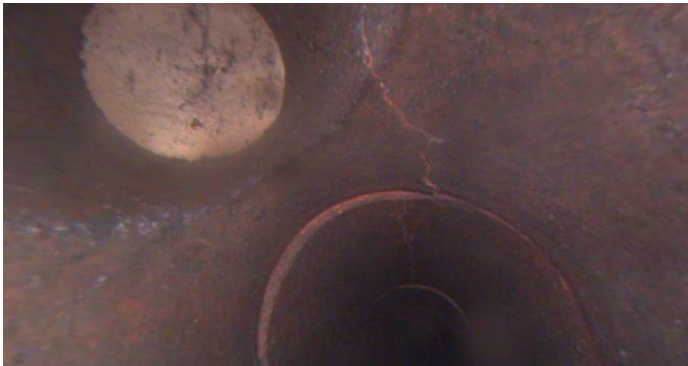
Code: **FL**
Description: **Fracture Longitudinal**

Distance (ft): **65.8**
Structural Grade: **3**
O&M Grade: **0**
Clock Start/From: **1**
Clock To:
1st Value:
2nd Value:
Value Percent:
Continuous Index: **S01**
Within 8" of Joint:
Remarks:

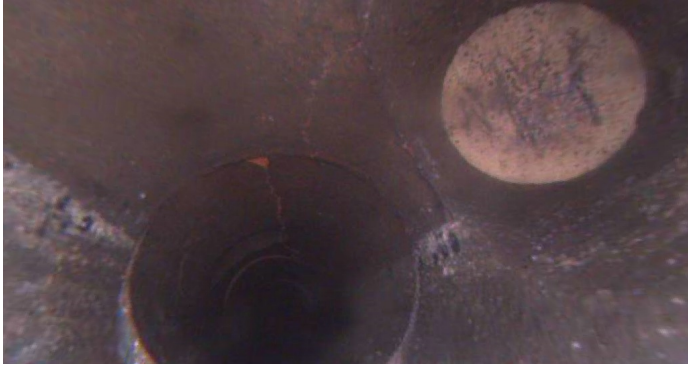
Code: **TFC**
Description: **Tap Factory Capped**

Distance (ft): **76.4**
Structural Grade: **0**
O&M Grade: **0**
Clock Start/From: **2**
Clock To:
1st Value: **4.000**
2nd Value:
Value Percent:
Continuous Index:
Within 8" of Joint:
Remarks:

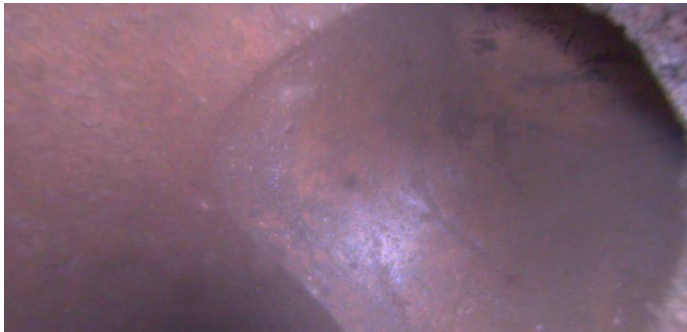
Code: **FL**
Description: **Fracture Longitudinal**

Distance (ft): **85.9**
Structural Grade: **3**
O&M Grade: **0**
Clock Start/From: **1**
Clock To:
1st Value:
2nd Value:
Value Percent:
Continuous Index: **F01**
Within 8" of Joint:
Remarks:
