Profile/Photo Observation Report

RUBUIICS
Date:	09/19/2021	Weather:		Coding:	PACP 7.0
Pipe Length (ft):	187.5	Owner:	City of Hobart	Pre Clean:	Heavy Cleaning
P.O.#:	YES502259	Surveyor:	S. Bucklin	PSR:	P-503-021-020
Customer:	City of Hobart	Clean Date	e: 09/05/2021	Shape:	С
Street:	North Virginia Stre	et	Flow Control:	Not Controlled	ł
City:	Hobart, IN		Year Renewed:		
Location:	Local rural streets	with light traffi	c, t Tape/Media #:		
Purpose:	Routine Assessme	nt	Dia/Height:	10"	
Use:	Sanitary Sewage P	ipe	Material:	VCP	
Drain Area:			Lining:	None	
Category:	NA				
Comment:					
Location Details	:		Direction of Surv	ey: Downstream	
US MH:	M-503-020	DS MH:	M-503-021	Total Length Surveyed (ft): 187.5
0&M Index:	1.71	O&M Quick		GO&M Rating:	116.00
structural Index:	3.21	Structural C	Quick: 534	B Structural Rating	125.00
Overall Index:	2.25	Overall Qui	ck: 534I	B Overall Rating:	241.00

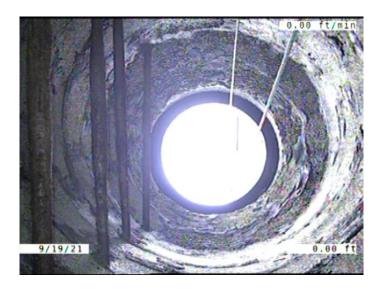
Code: Description:	AMH Manhole
Distance (ft):	.0
Structural Grade:	0
O&M Grade:	0
Clock Start/From:	
Clock To:	
1st Value:	
2nd Value:	
Value Percent:	
Continuous Index:	
Within 8" of Joint:	NO
Remarks:	M-503-020

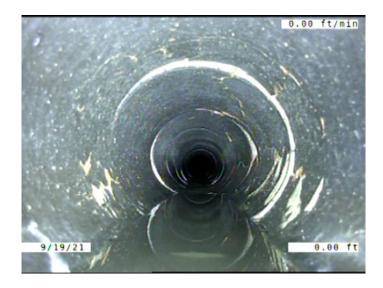
Code: Description:	MWL Miscellaneous Water Level
Distance (ft):	.0
Structural Grade:	0
O&M Grade:	0
Clock Start/From:	
Clock To:	
1st Value:	
2nd Value:	
Value Percent:	5.000
Continuous Index:	
Within 8" of Joint:	NO
Remarks:

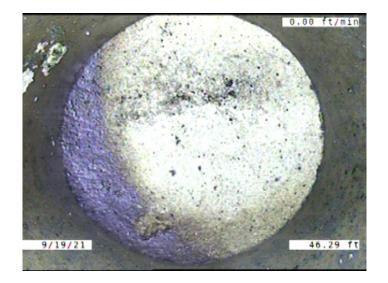
Code:	TFC
Description:	Tap Factory Capped
Distance (ft):	46.3
Structural Grade:	0
O&M Grade:	0
Clock Start/From:	11
Clock To:	
1st Value:	4.000
2nd Value:	
Value Percent:	
Continuous Index:	
Within 8" of Joint:	YES
Remarks:

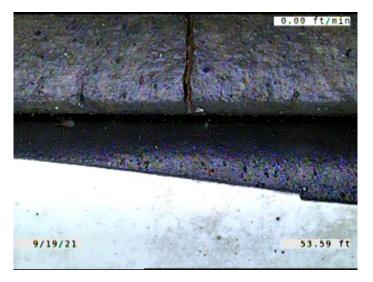
MMC Miscellaneous Material Change
53.6
0
0
NO
VCP TO PVC

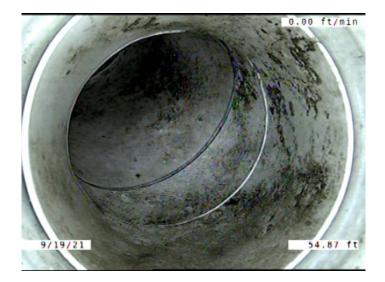
Code:	TF
Description:	Tap Factory
Distance (ft):	54.9
Structural Grade:	0
O&M Grade:	0
Clock Start/From:	12
Clock To:	
1st Value:	4.000
2nd Value:	
Value Percent:	
Continuous Index:	
Within 8" of Joint:	YES
Remarks:

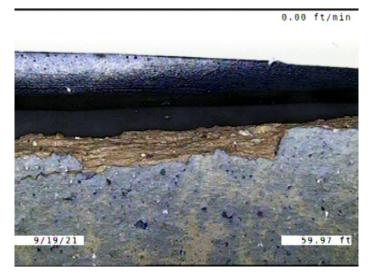
Code:	ММС
Description:	Miscellaneous Material Change
Distance (ft):	60.0
Structural Grade:	0
O&M Grade:	0
Clock Start/From:	
Clock To:	
1st Value:	
2nd Value:	
Value Percent:	
Continuous Index:	
Within 8" of Joint:	NO
Remarks:	ΡVC ΤΟ VCP

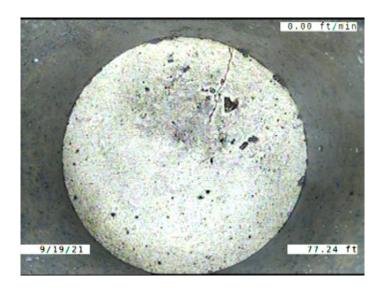
Code: Description:	TFC Tap Factory Capped
Distance (ft): Structural Grade: O&M Grade: Clock Start/From: Clock To: 1st Value: 2nd Value: Value Percent: Continuous Index: Within 8" of Joint: Remarks:	77.2 0 0 1 4.000 YES
nemarks.

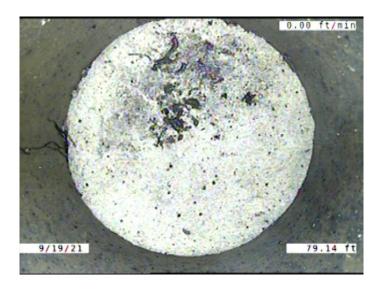
Code: Description:	TFC Tap Factory Capped
Distance (ft): Structural Grade: O&M Grade: Clock Start/From: Clock To: 1st Value: 2nd Value: Value Percent:	79.1 0 0 10 4.000
Continuous Index: Within 8" of Joint: Remarks:	YES

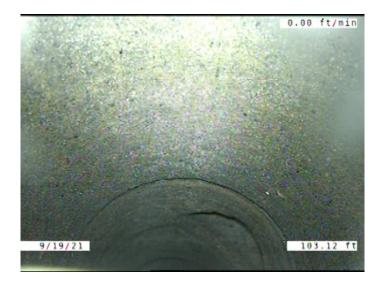
Code:	MWL
Description:	Miscellaneous Water Level
Distance (ft):	103.1
Structural Grade:	0
O&M Grade:	0
Clock Start/From:	
Clock To:	
1st Value:	
2nd Value:	
Value Percent:	15.000
Continuous Index:	
Within 8" of Joint:	NO
Remarks:

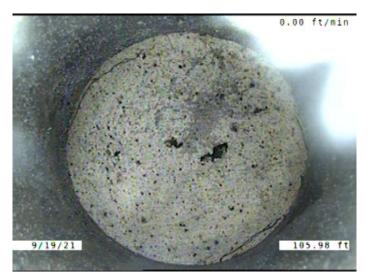
Code: Description:	TFC Tap Factory Capped
Distance (ft): Structural Grade: O&M Grade: Clock Start/From: Clock To: 1st Value: 2nd Value: Value Percent: Continuous Index: Within 8" of Joint: Remarks:	106.0 0 1 4.000 YES

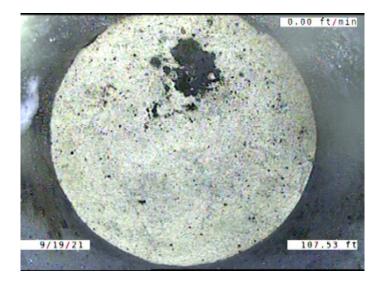
Code:	TFC
Description:	Tap Factory Capped
Distance (ft):	107.5
Structural Grade:	0
O&M Grade:	0
Clock Start/From:	11
Clock To:	
1st Value:	4.000
2nd Value:	
Value Percent:	
Continuous Index:	
Within 8" of Joint:	YES
Remarks:

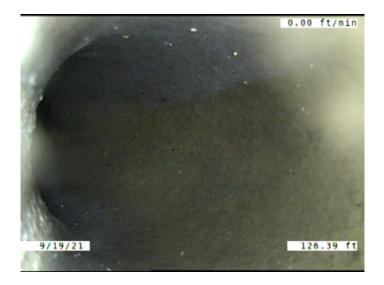
Code: Description:	TB Tap Break-in/Hammer
Distance (ft):	126.4
Structural Grade:	0
O&M Grade:	0
Clock Start/From:	12
Clock To:	
1st Value:	4.000
2nd Value:	
Value Percent:	
Continuous Index:	
Within 8" of Joint:	YES
Remarks:

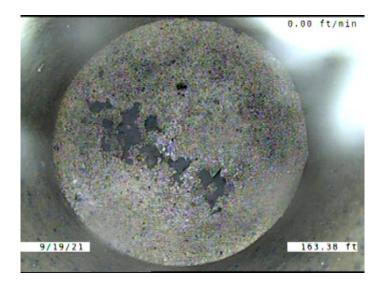
Code: Description:	TFC Tap Factory Capped
Distance (ft):	163.4
Structural Grade:	0
O&M Grade:	0
Clock Start/From:	1
Clock To:	
1st Value:	4.000
2nd Value:	
Value Percent:	
Continuous Index:	
Within 8" of Joint:	YES
Remarks:

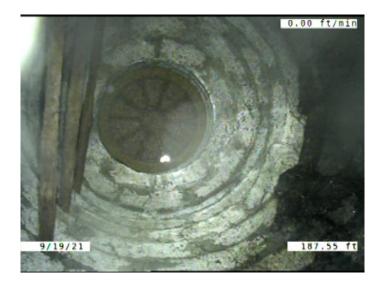
Code: Description:	AMH Manhole
Distance (ft):	187.5
Structural Grade:	0
O&M Grade:	0
Clock Start/From:	
Clock To:	
1st Value:	
2nd Value:	
Value Percent:	
Continuous Index:	
Within 8" of Joint:	NO
Remarks:	M-503-021
