Profile/Photo Observation Report

Date:	09/19/2021	Weather:		Coding:	PACP 7.0
Pipe Length (ft):	187.5	Owner:	City of Hobart	Pre Clean:	Heavy Cleaning
P.O.#:	YES502259	Surveyor:	S. Bucklin	PSR:	P-503-021-020
Customer:	City of Hobart	Clean Date:	09/05/2021	Shape:	C

Street:	North Virginia Street	Flow Control:	Not Controlled
City:	Hobart, IN	Year Renewed:	
Location:	Local rural streets with light traffic, t	Tape/Media #:	
Purpose:	Routine Assessment	Dia/Height:	10"
Use:	Sanitary Sewage Pipe	Material:	VCP
Drain Area:		Lining:	None
Category:	NA		
Comment:			
Location Details:		Direction of Survey:	Downstream
US MH:	M-503-020	DS MH:	M-503-021
		Total Length Surveyed (ft):	187.5

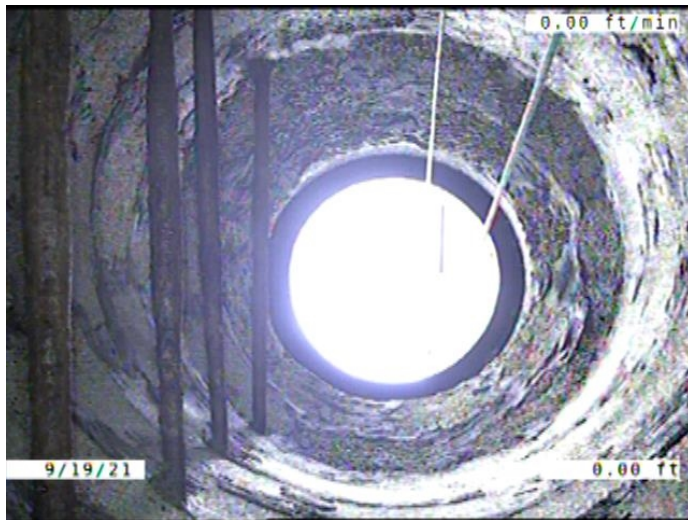
Code: **AMH**
 Description: **Manhole**

Distance (ft): **.0**
 Structural Grade: **0**
 O&M Grade: **0**
 Clock Start/From:
 Clock To:
 1st Value:
 2nd Value:
 Value Percent:
 Continuous Index:
 Within 8" of Joint: **NO**
 Remarks: **M-503-020**

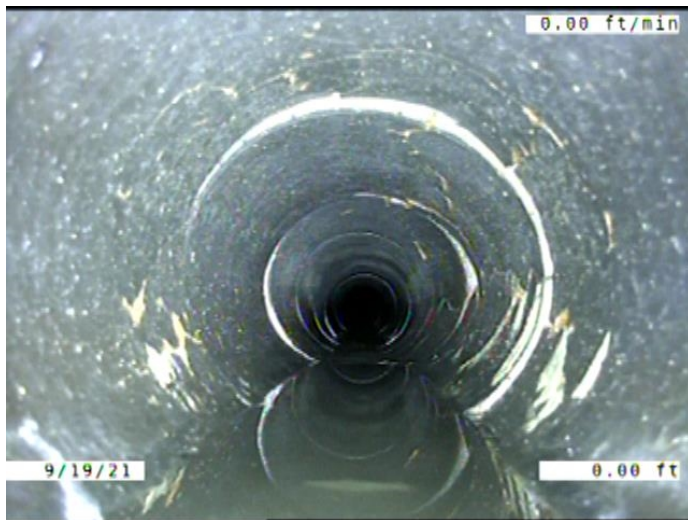
Code: **MWL**
 Description: **Miscellaneous Water Level**

Distance (ft): **.0**
 Structural Grade: **0**
 O&M Grade: **0**
 Clock Start/From:
 Clock To:
 1st Value:
 2nd Value:
 Value Percent: **5.000**
 Continuous Index:
 Within 8" of Joint: **NO**
 Remarks:

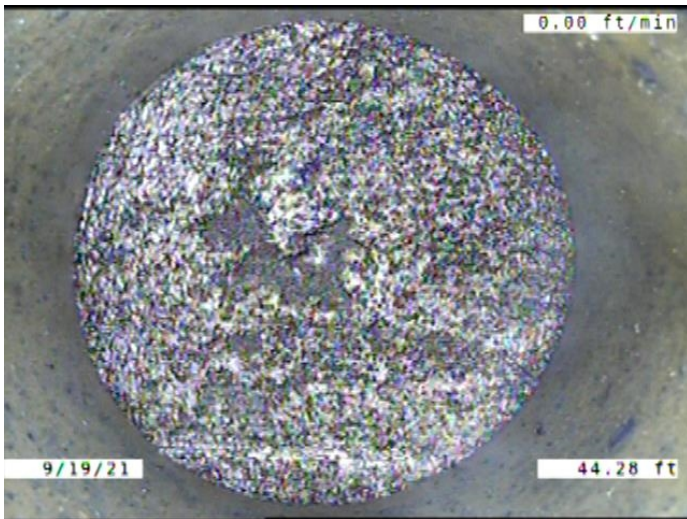
Code: **TFC**
 Description: **Tap Factory Capped**

Distance (ft): **44.3**
 Structural Grade: **0**
 O&M Grade: **0**
 Clock Start/From: **1**
 Clock To:
 1st Value: **4.000**
 2nd Value:
 Value Percent:
 Continuous Index:
 Within 8" of Joint: **YES**
 Remarks:

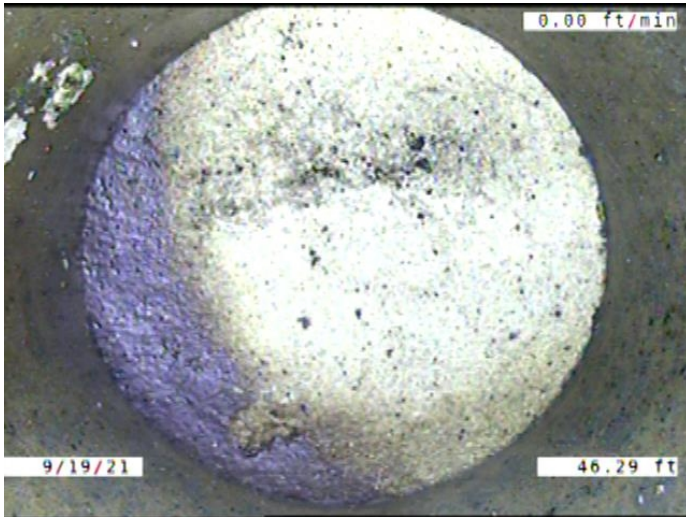
Code: **TFC**
 Description: **Tap Factory Capped**

Distance (ft): **46.3**
 Structural Grade: **0**
 O&M Grade: **0**
 Clock Start/From: **11**
 Clock To:
 1st Value: **4.000**
 2nd Value:
 Value Percent:
 Continuous Index:
 Within 8" of Joint: **YES**
 Remarks:

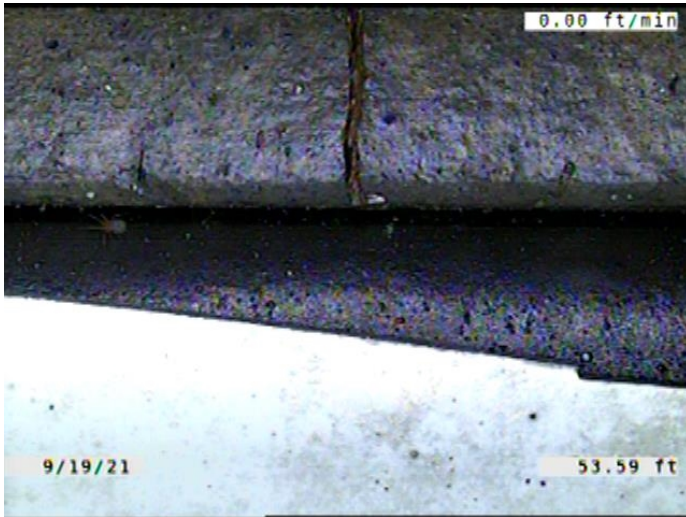
Code: **MMC**
 Description: **Miscellaneous Material Change**

Distance (ft): **53.6**
 Structural Grade: **0**
 O&M Grade: **0**
 Clock Start/From:
 Clock To:
 1st Value:
 2nd Value:
 Value Percent:
 Continuous Index:
 Within 8" of Joint: **NO**
 Remarks: **VCP TO PVC**

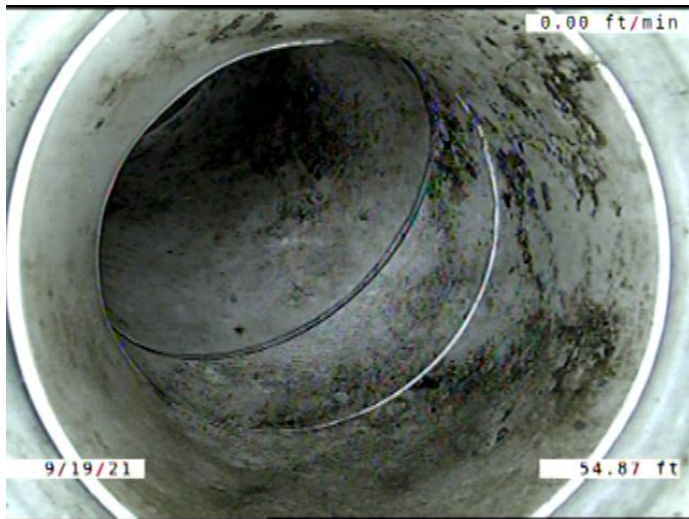
Code: **TF**
 Description: **Tap Factory**

Distance (ft): **54.9**
 Structural Grade: **0**
 O&M Grade: **0**
 Clock Start/From: **12**
 Clock To:
 1st Value: **4.000**
 2nd Value:
 Value Percent:
 Continuous Index:
 Within 8" of Joint: **YES**
 Remarks:

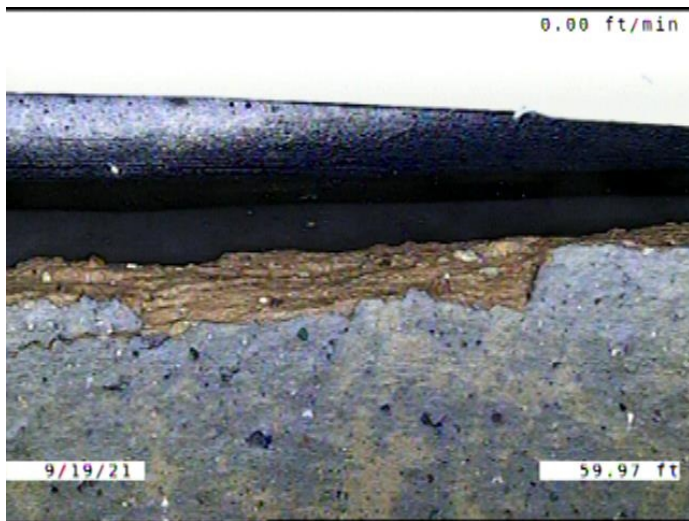
Code: **MMC**
 Description: **Miscellaneous Material Change**

Distance (ft): **60.0**
 Structural Grade: **0**
 O&M Grade: **0**
 Clock Start/From:
 Clock To:
 1st Value:
 2nd Value:
 Value Percent:
 Continuous Index:
 Within 8" of Joint: **NO**
 Remarks: **PVC TO VCP**

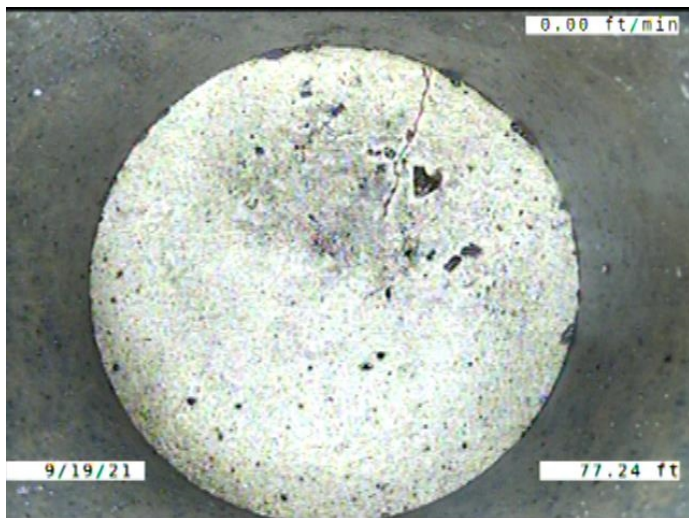
Code: **TFC**
 Description: **Tap Factory Capped**

Distance (ft): **77.2**
 Structural Grade: **0**
 O&M Grade: **0**
 Clock Start/From: **1**
 Clock To:
 1st Value: **4.000**
 2nd Value:
 Value Percent:
 Continuous Index:
 Within 8" of Joint: **YES**
 Remarks:

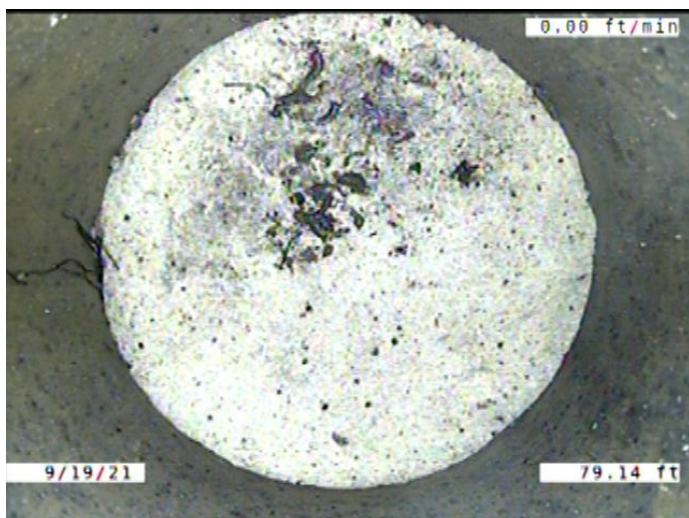
Code: **TFC**
 Description: **Tap Factory Capped**

Distance (ft): **79.1**
 Structural Grade: **0**
 O&M Grade: **0**
 Clock Start/From: **10**
 Clock To:
 1st Value: **4.000**
 2nd Value:
 Value Percent:
 Continuous Index:
 Within 8" of Joint: **YES**
 Remarks:

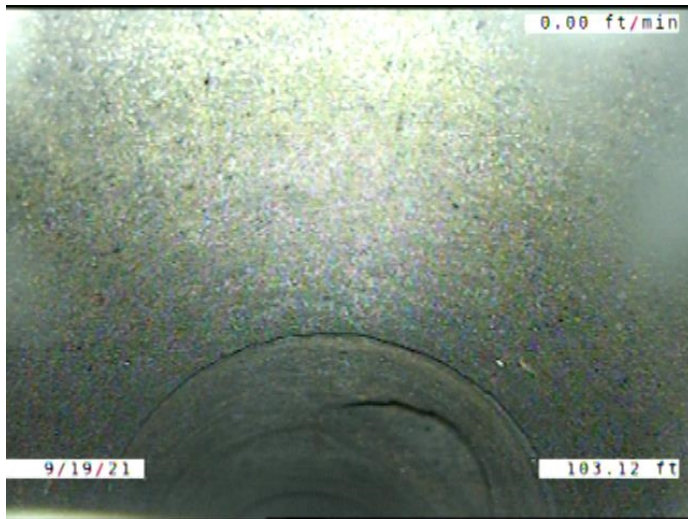
Code: **MWL**
 Description: **Miscellaneous Water Level**

Distance (ft): **103.1**
 Structural Grade: **0**
 O&M Grade: **0**
 Clock Start/From:
 Clock To:
 1st Value:
 2nd Value:
 Value Percent: **15.000**
 Continuous Index:
 Within 8" of Joint: **NO**
 Remarks:

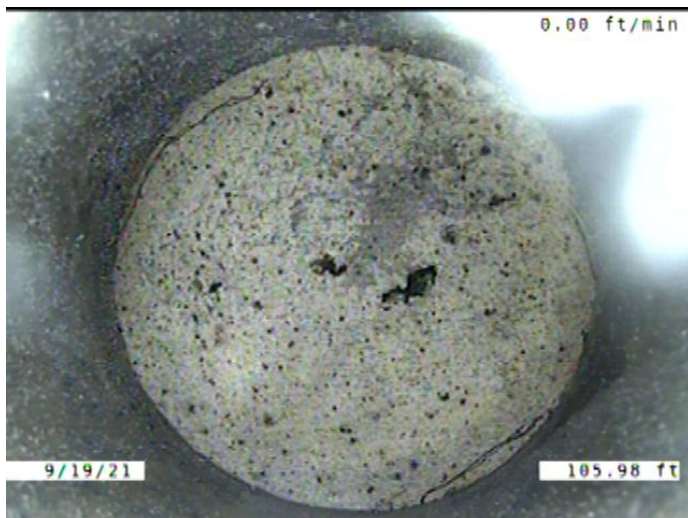
Code: **TFC**
 Description: **Tap Factory Capped**

Distance (ft): **106.0**
 Structural Grade: **0**
 O&M Grade: **0**
 Clock Start/From: **1**
 Clock To:
 1st Value: **4.000**
 2nd Value:
 Value Percent:
 Continuous Index:
 Within 8" of Joint: **YES**
 Remarks:

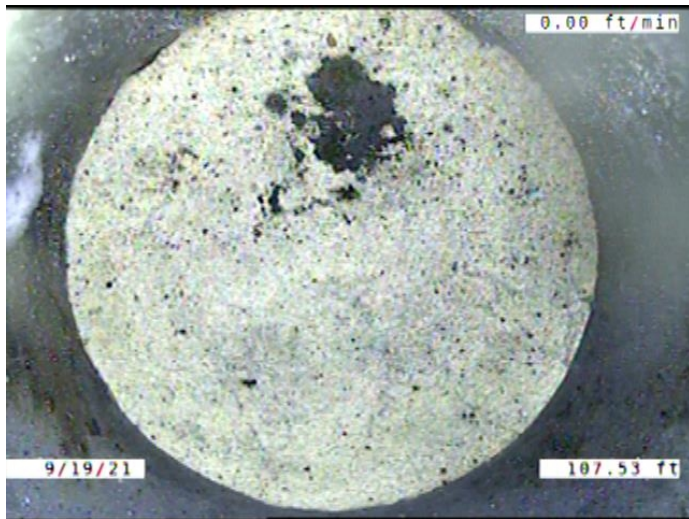
Code: **TFC**
 Description: **Tap Factory Capped**

Distance (ft): **107.5**
 Structural Grade: **0**
 O&M Grade: **0**
 Clock Start/From: **11**
 Clock To:
 1st Value: **4.000**
 2nd Value:
 Value Percent:
 Continuous Index:
 Within 8" of Joint: **YES**
 Remarks:

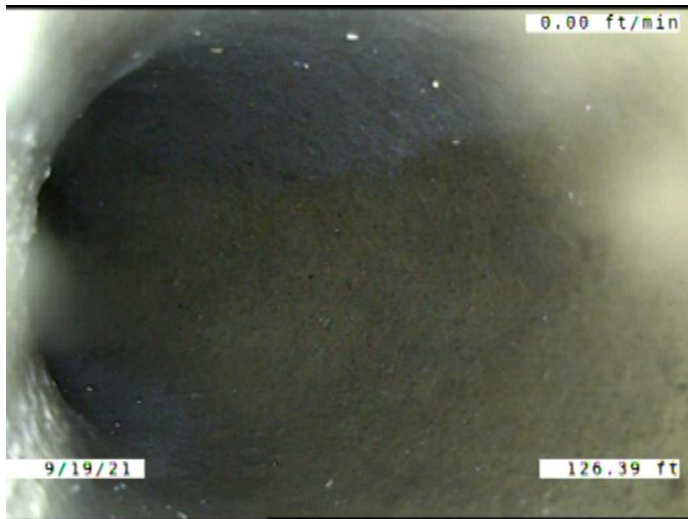
Code: **TB**
Description: **Tap Break-in/Hammer**

Distance (ft): **126.4**
Structural Grade: **0**
O&M Grade: **0**
Clock Start/From: **12**
Clock To:
1st Value: **4.000**
2nd Value:
Value Percent:
Continuous Index:
Within 8" of Joint: **YES**
Remarks:

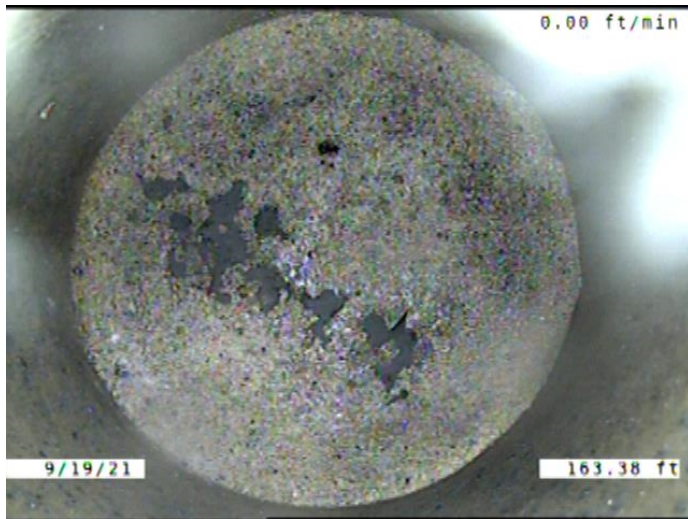
Code: **TFC**
Description: **Tap Factory Capped**

Distance (ft): **163.4**
Structural Grade: **0**
O&M Grade: **0**
Clock Start/From: **1**
Clock To:
1st Value: **4.000**
2nd Value:
Value Percent:
Continuous Index:
Within 8" of Joint: **YES**
Remarks:

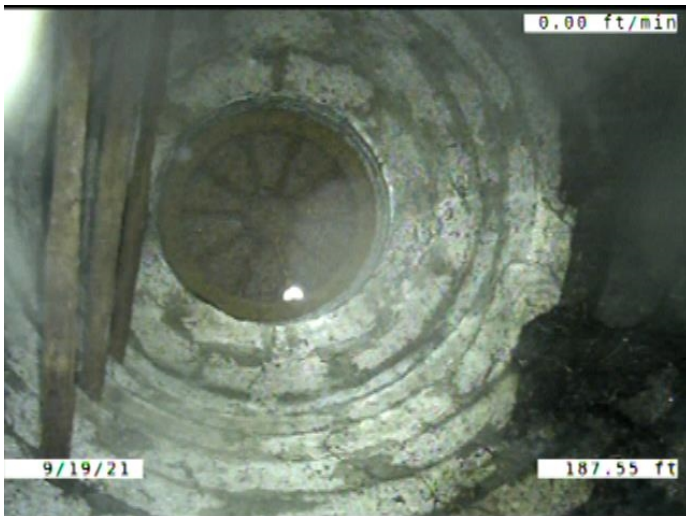
Code: **AMH**
 Description: **Manhole**

Distance (ft): **187.5**
 Structural Grade: **0**
 O&M Grade: **0**
 Clock Start/From:
 Clock To:
 1st Value:
 2nd Value:
 Value Percent:
 Continuous Index:
 Within 8" of Joint: **NO**
 Remarks: **M-503-021**
